HiMA Long-Term Pavement Performance Study

Prepared for presentation at RPF
24th Meeting
CSIR ICC
Pretoria, 6 & 7 November 2012

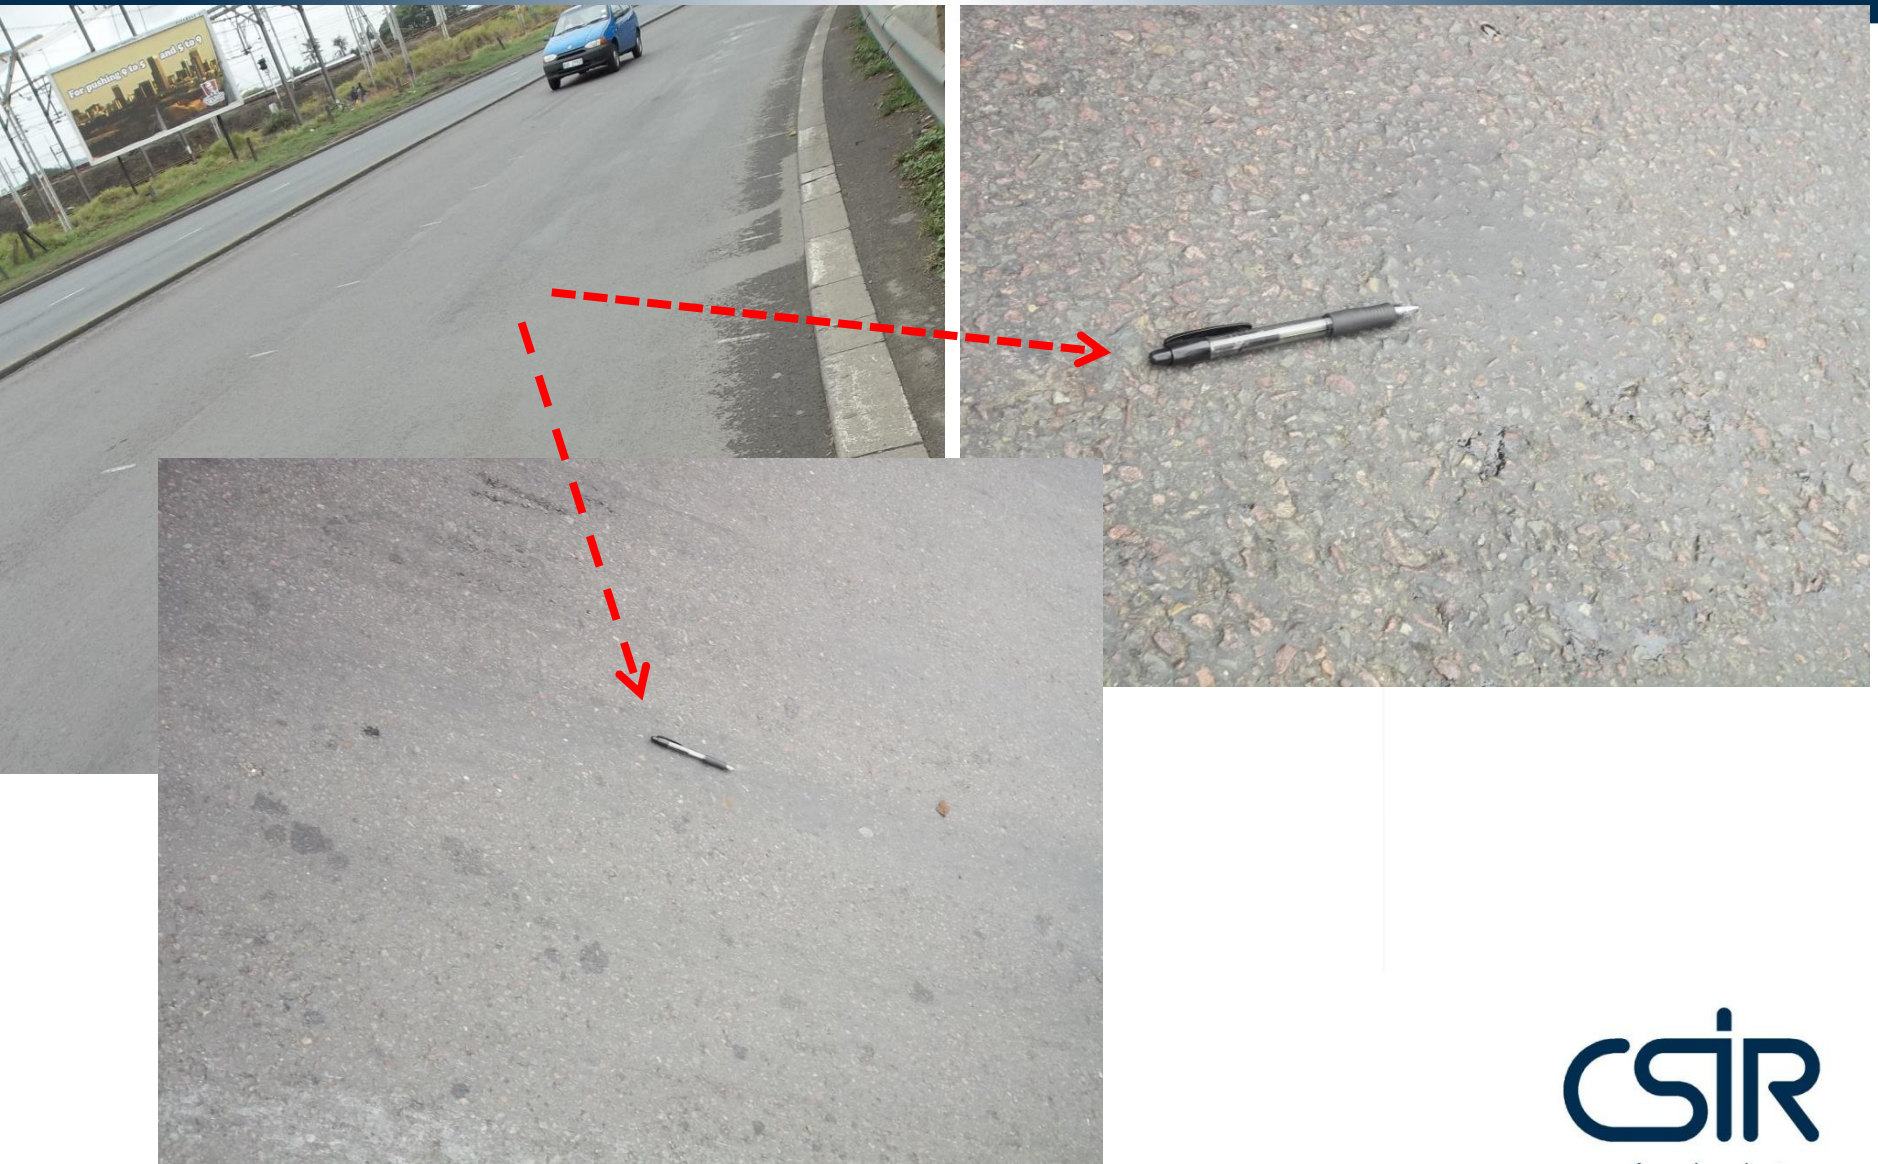
Pics taken during inspection

- Overall condition of the pavement is rated good
- Few defects of degree not more than 3 (condition not yet warning)
- SMA is flushing in places, almost voidless, loss of texture
- Fuel spillages are a frequent occurrence on section
- Drainage issues especially on the bridge
- No indication of damage to the HiMA layer yet

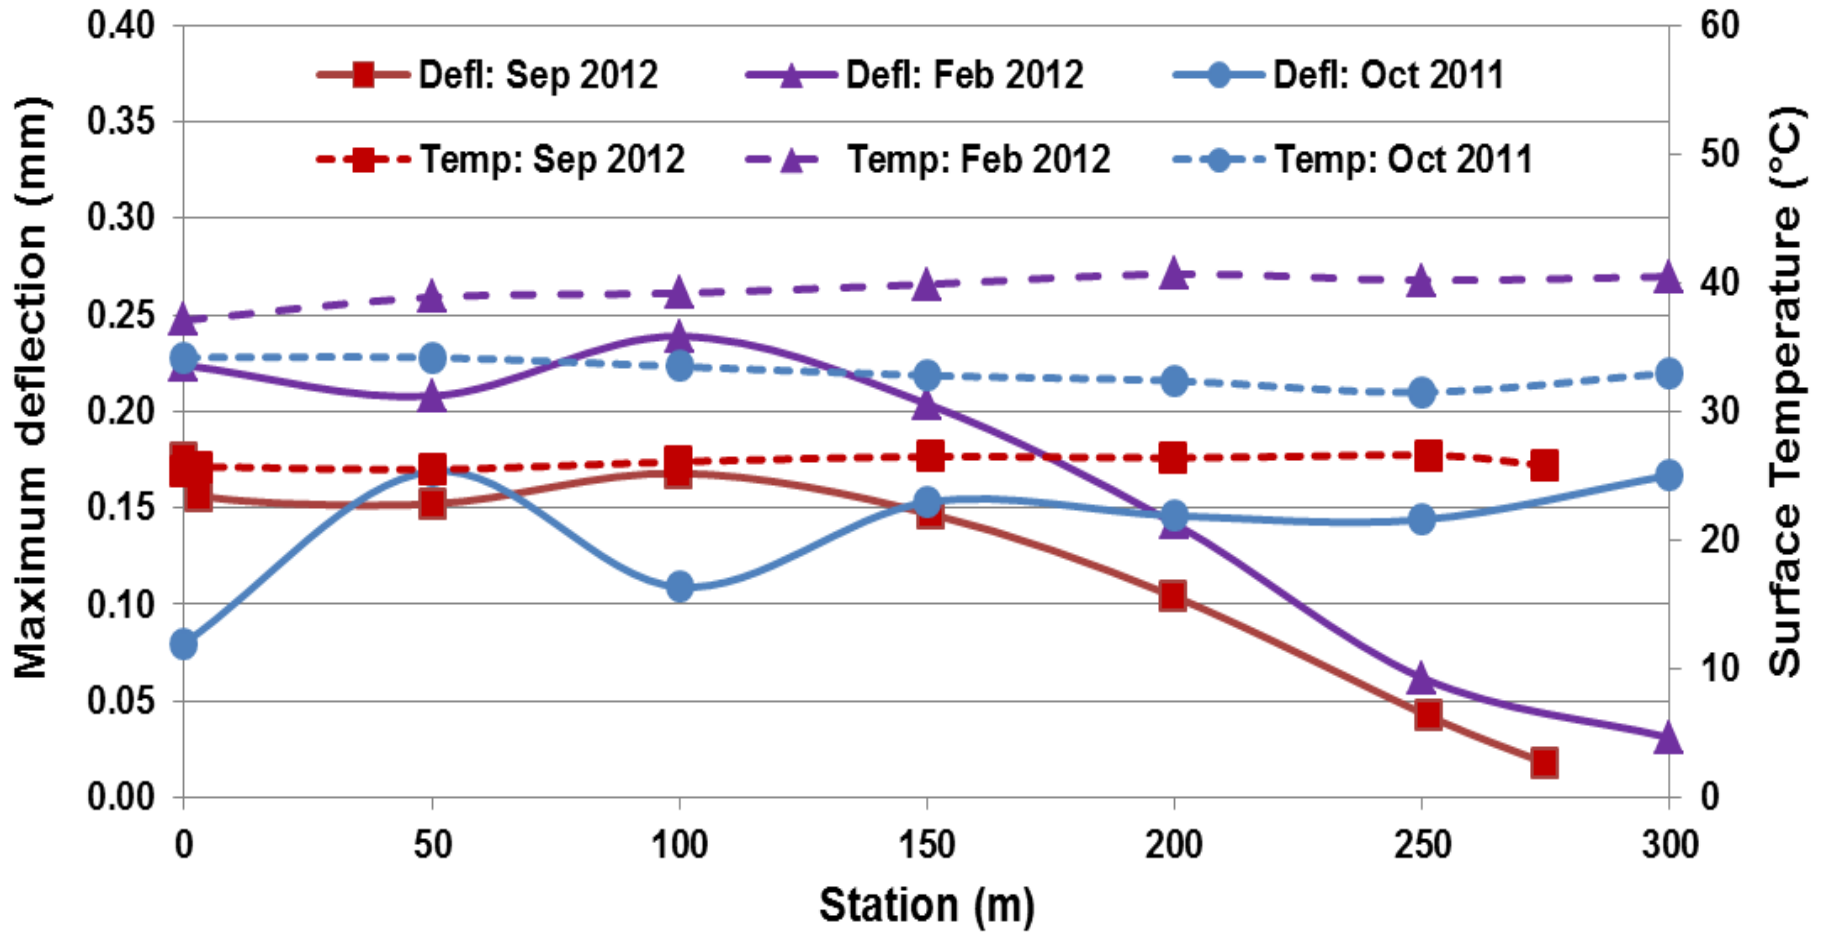
FWD Measurements: (40 kN load)

Slow lane

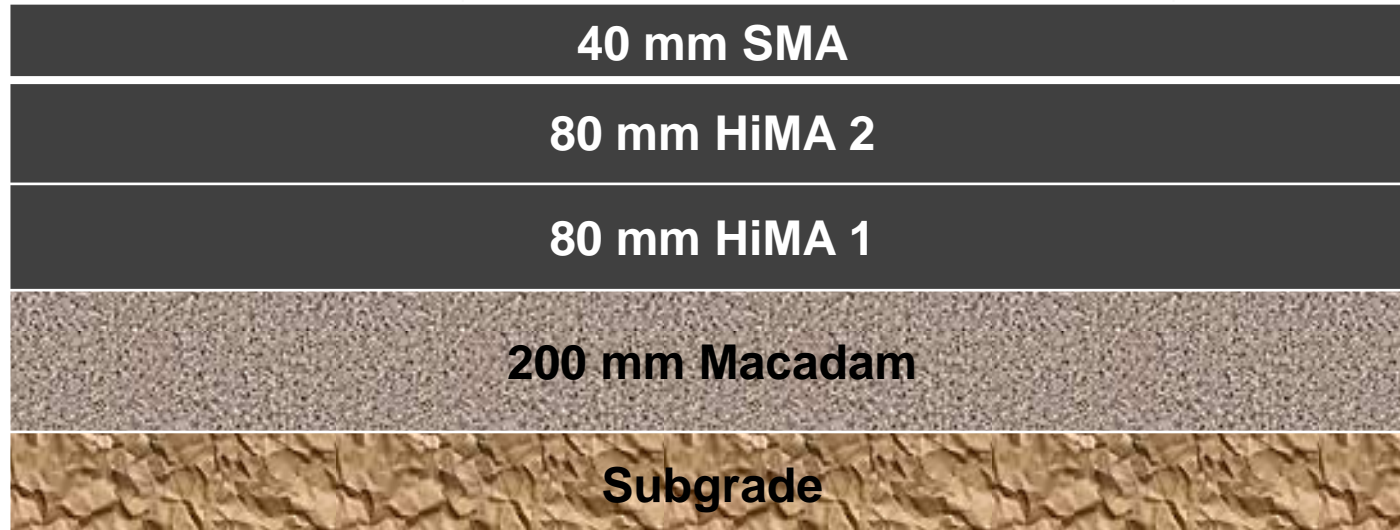
Back calculation results

Average Stiffness (MPa)				
		SMA	HIMA2	HIMA1	Macadam	Subgrade
SEPTEMBER 2012	Slow lane	7465	27482	16093	217	197
	Fast lane	3178	12561	13633	547	187
FEBRUARY 2012	Slow lane	832	10256	9238	503	160
	Fast lane	772	8600	10416	414	185
OCTOBER 2011	Slow lane	10085	23002	6562	1261	185
	Fast lane	4730	15246	6706	891	191
