# Repair to Concrete with Polymer Based Soil Stabilisation

## Road Pavements Forum

TWENTY-EIGHTH MEETING  
CSIR International Conference Centre, Gauteng  
19 & 20 November 2014

Krishna Naidoo

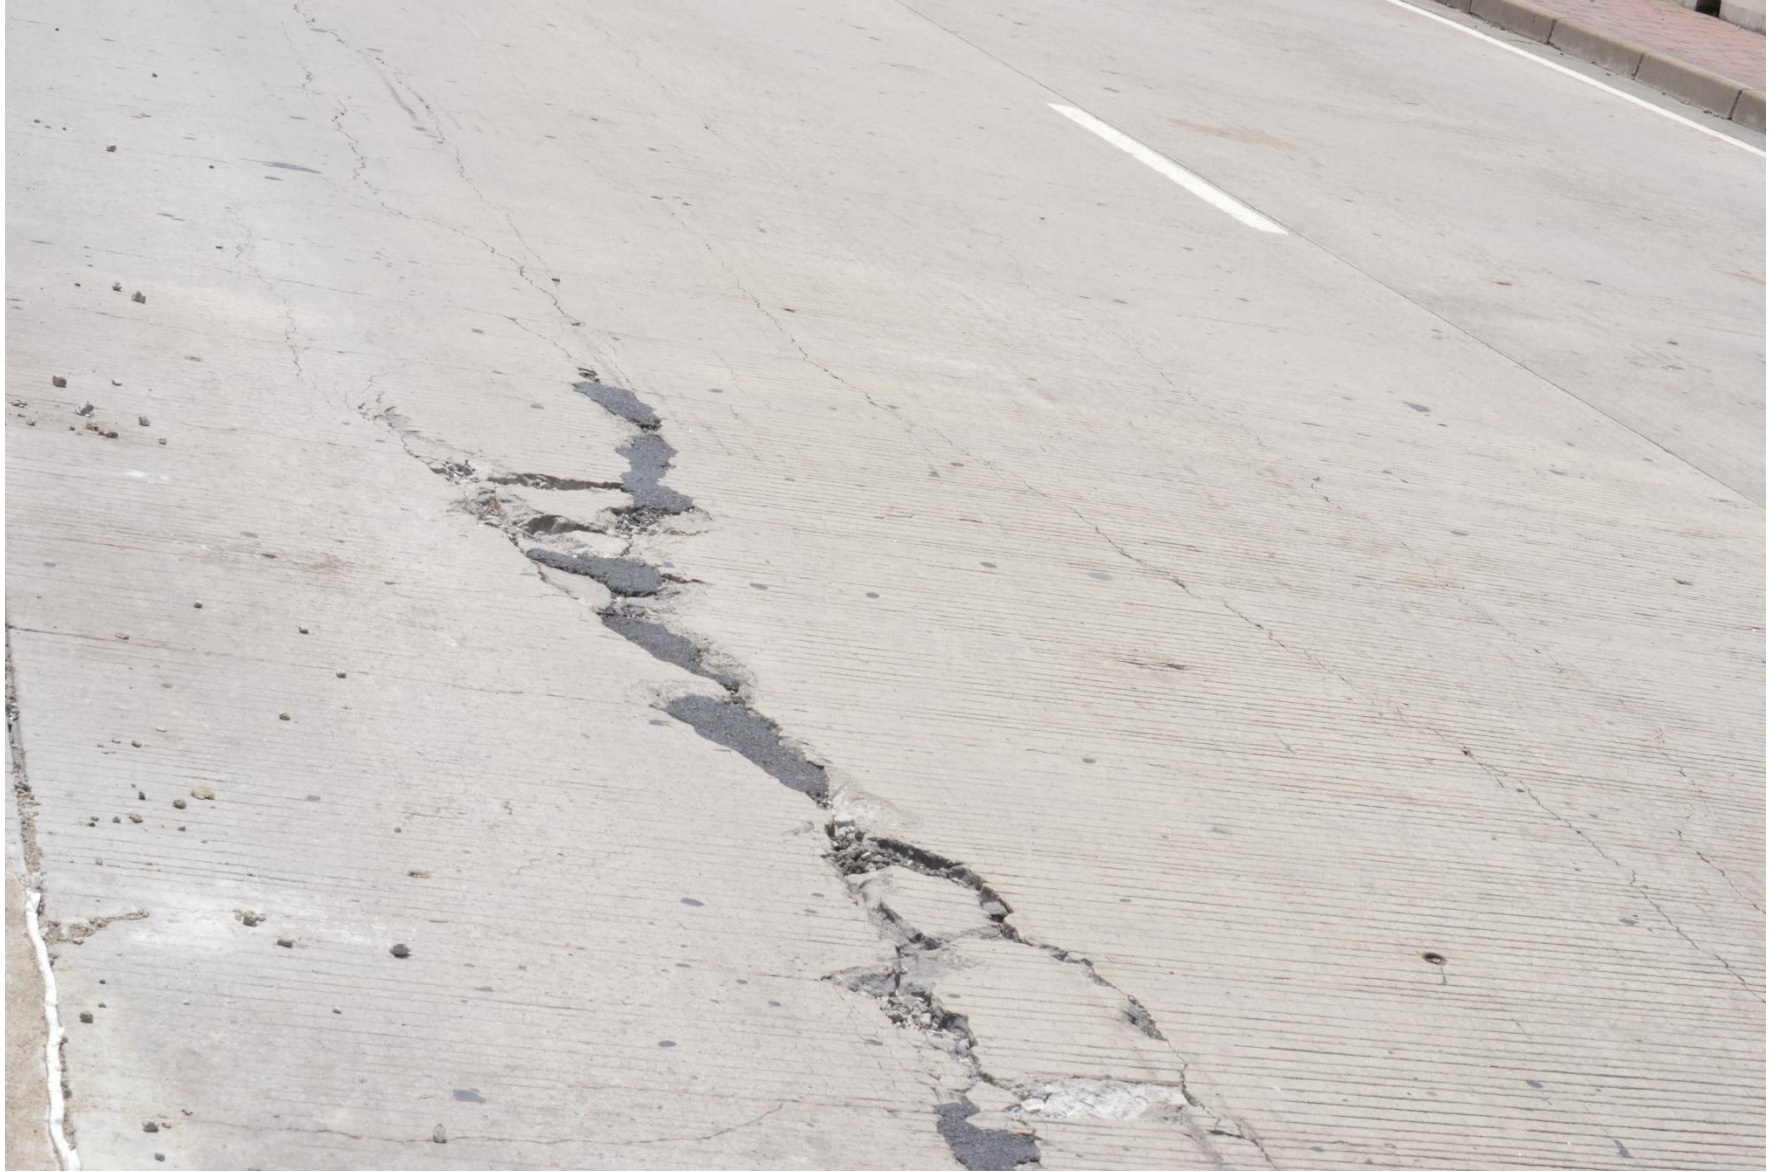
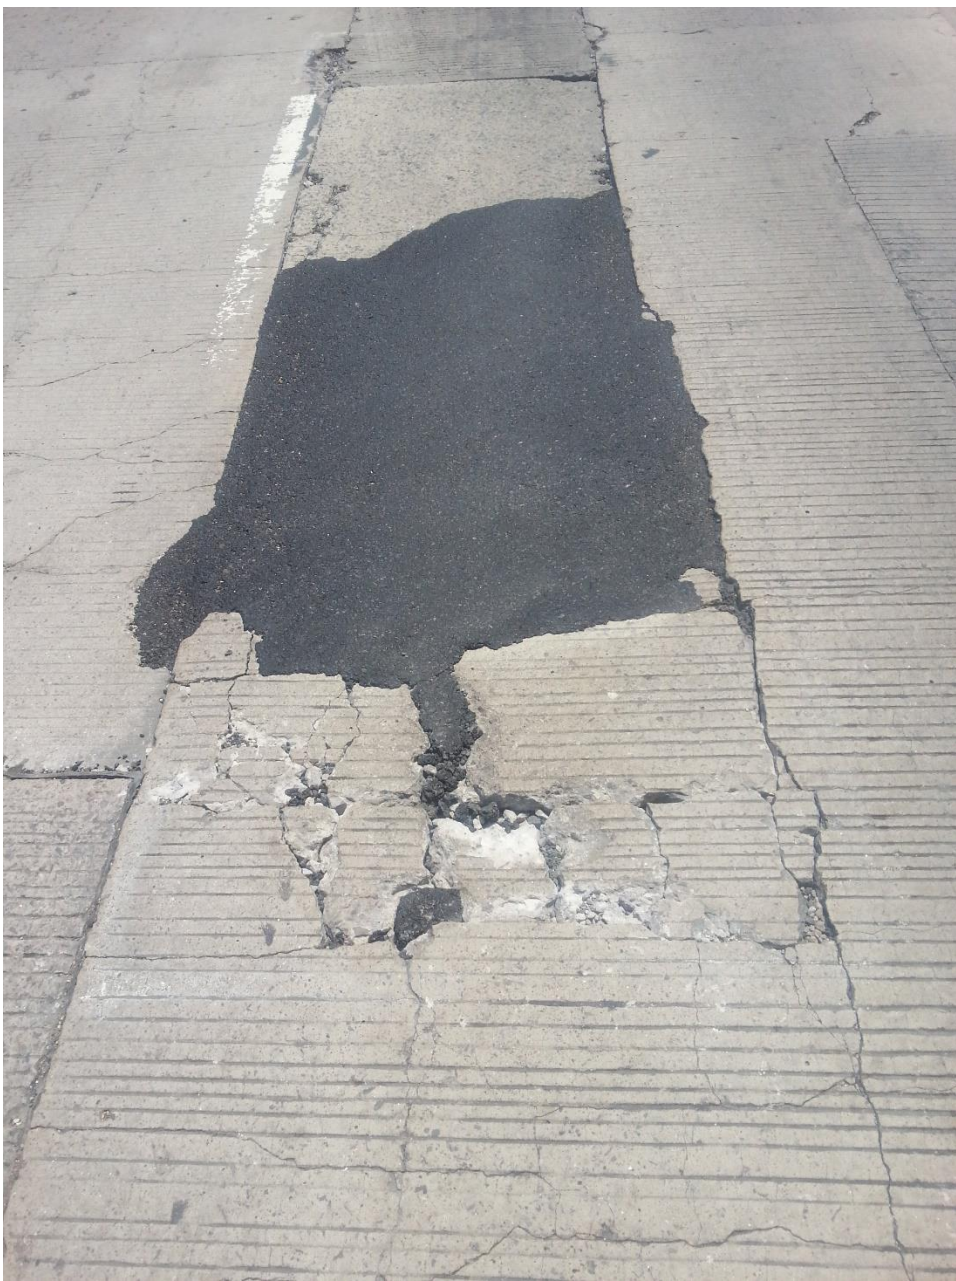
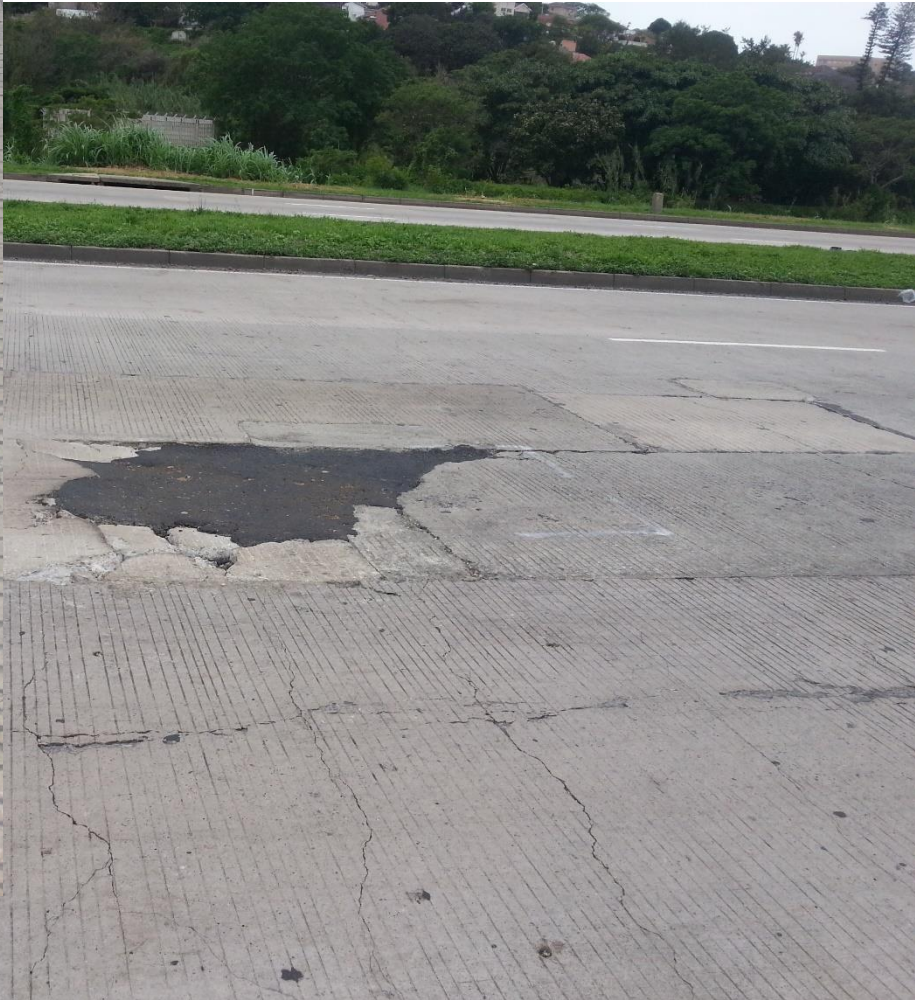
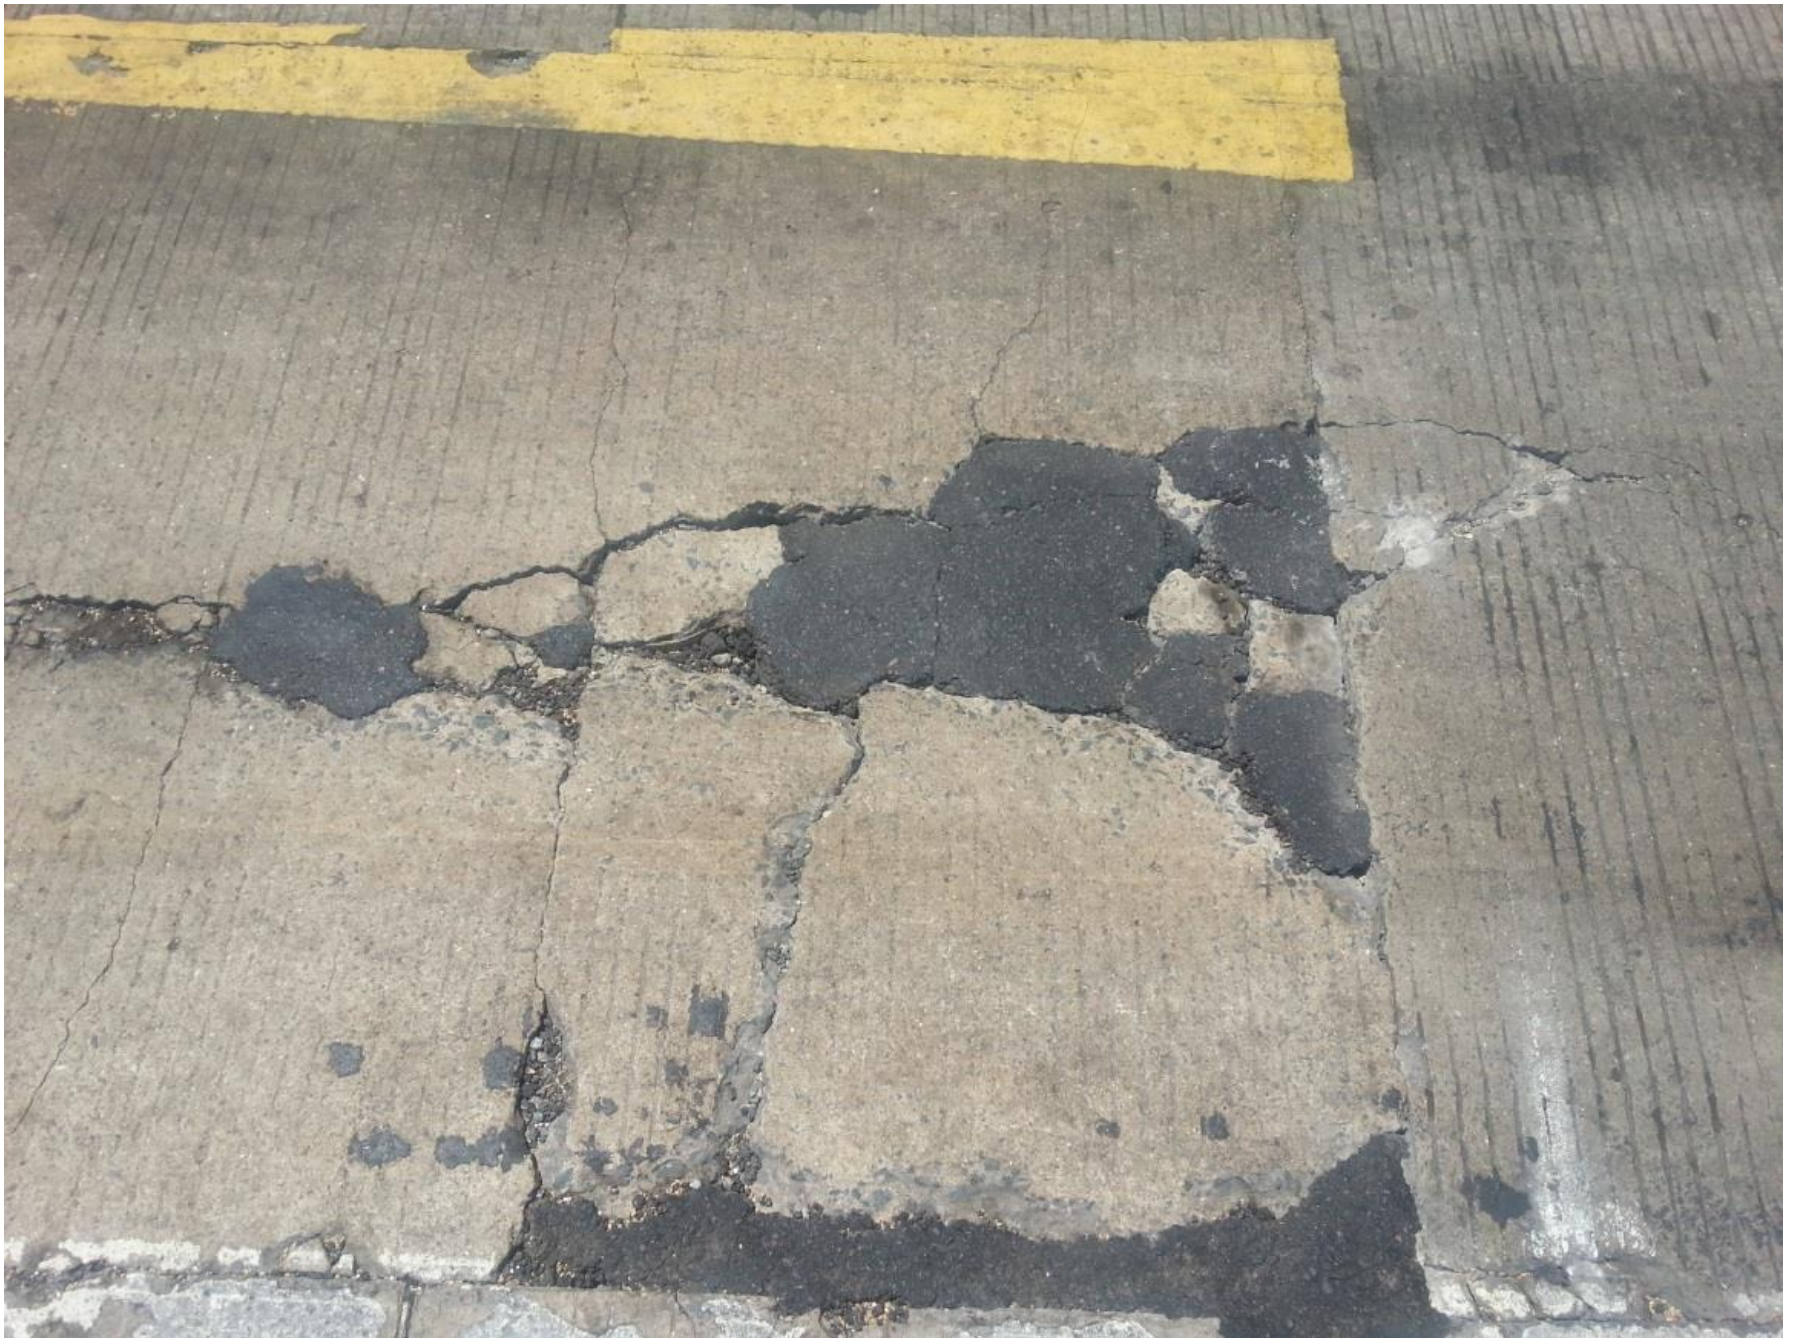
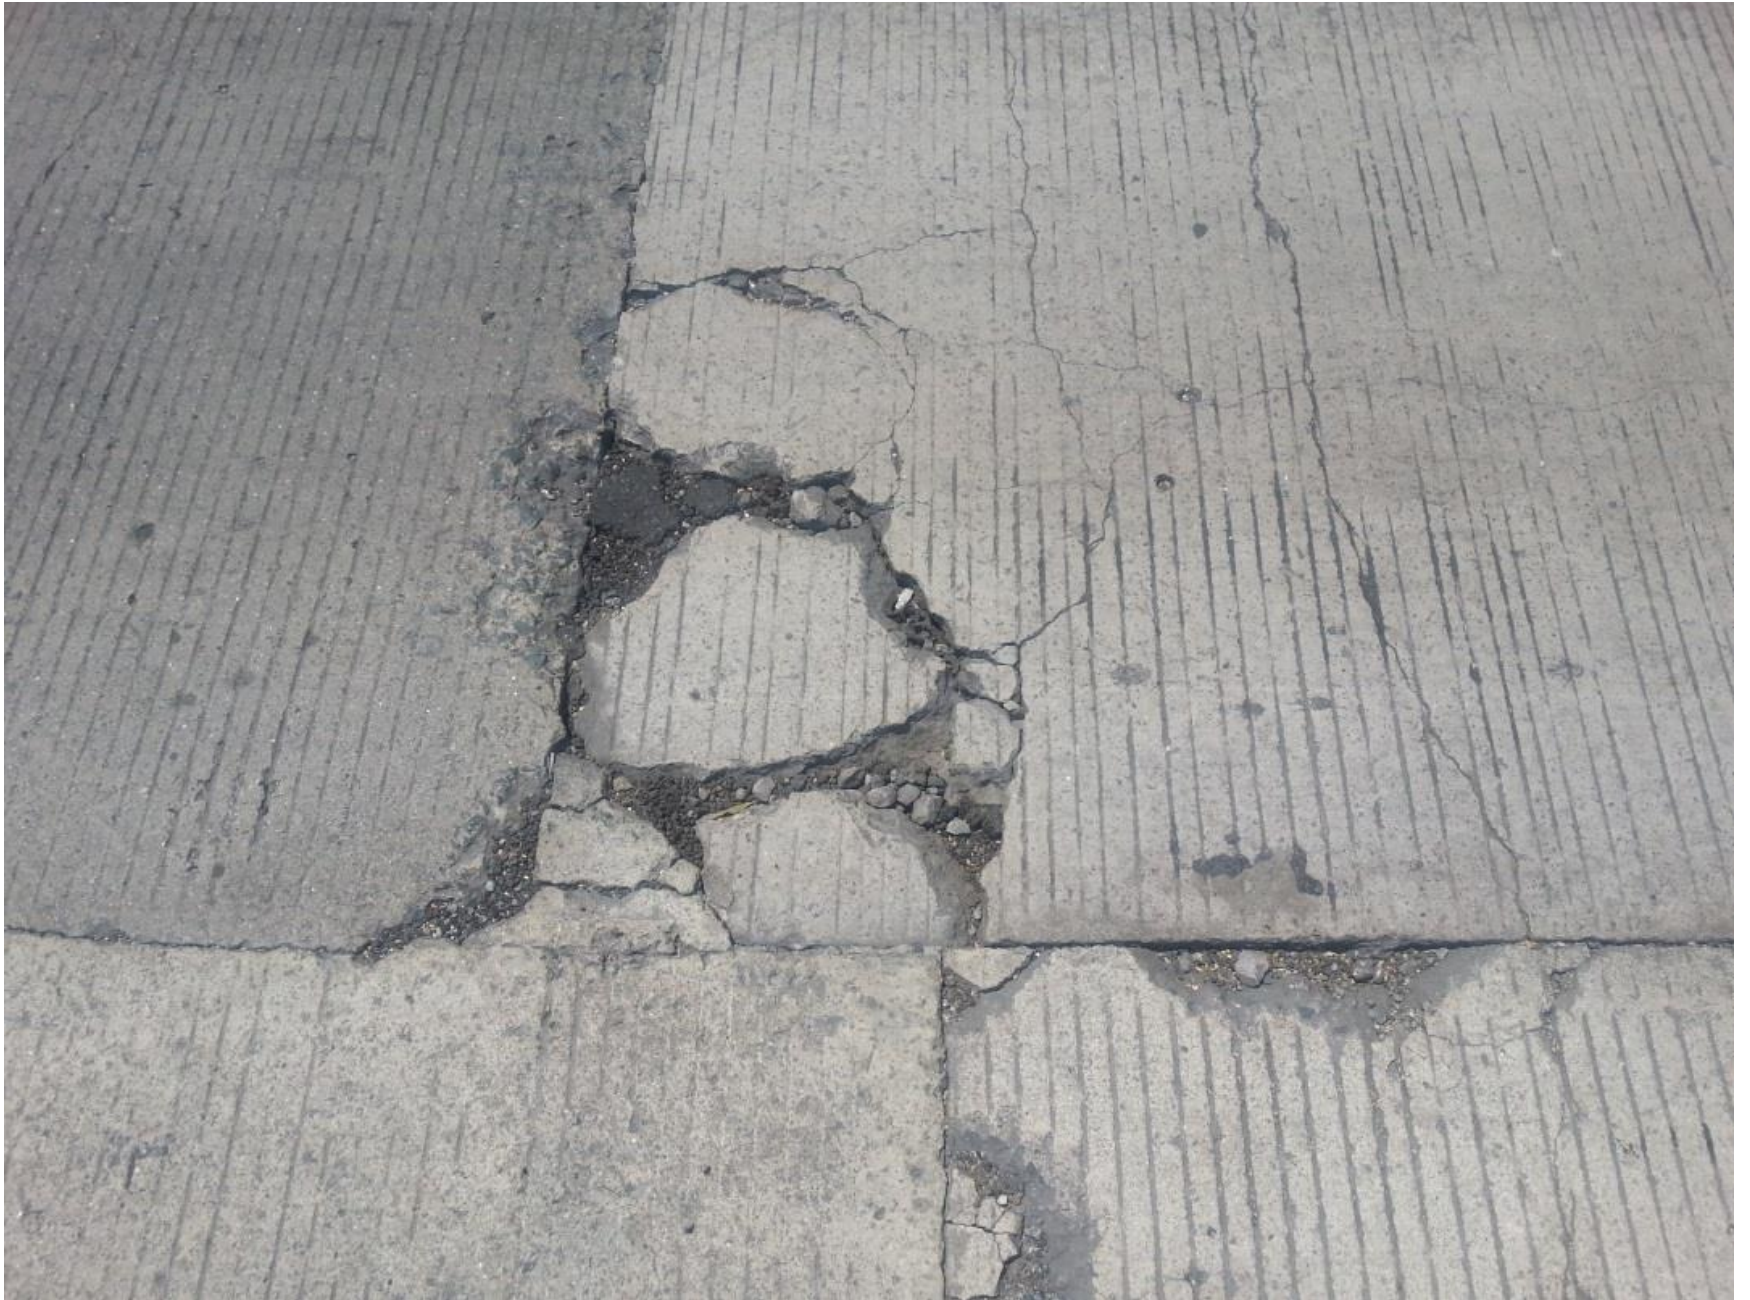
- As early as 2008 sections of 135mm CRCP paved over the existing road exhibited multiple distresses:
  - Longitudinal cracks
  - Secondary block cracks
  - punch outs

- Excessive ground water in the pavement (even during DRY periods)
- Severe stripping of interlayer (*20mm – 50mm eThekwini Mix A asphalt*) thus weakening support for the CRCP
- Situation is aggravated by heavy traffic loading

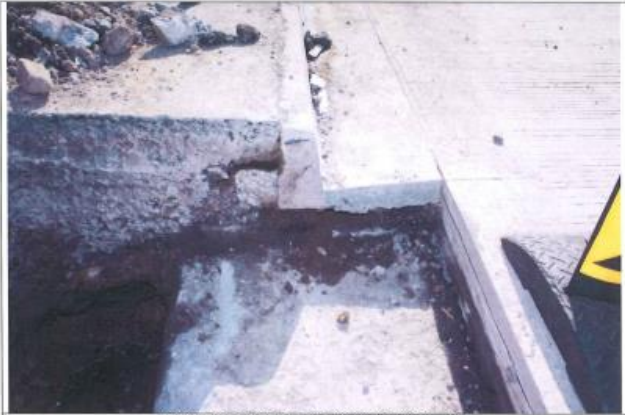
WESTBOUND CARRIAGEWAY IN CANYON – TP1

Remarks : Excavation stopped  
 Free moisture evident at interfaces of concrete and asphalt

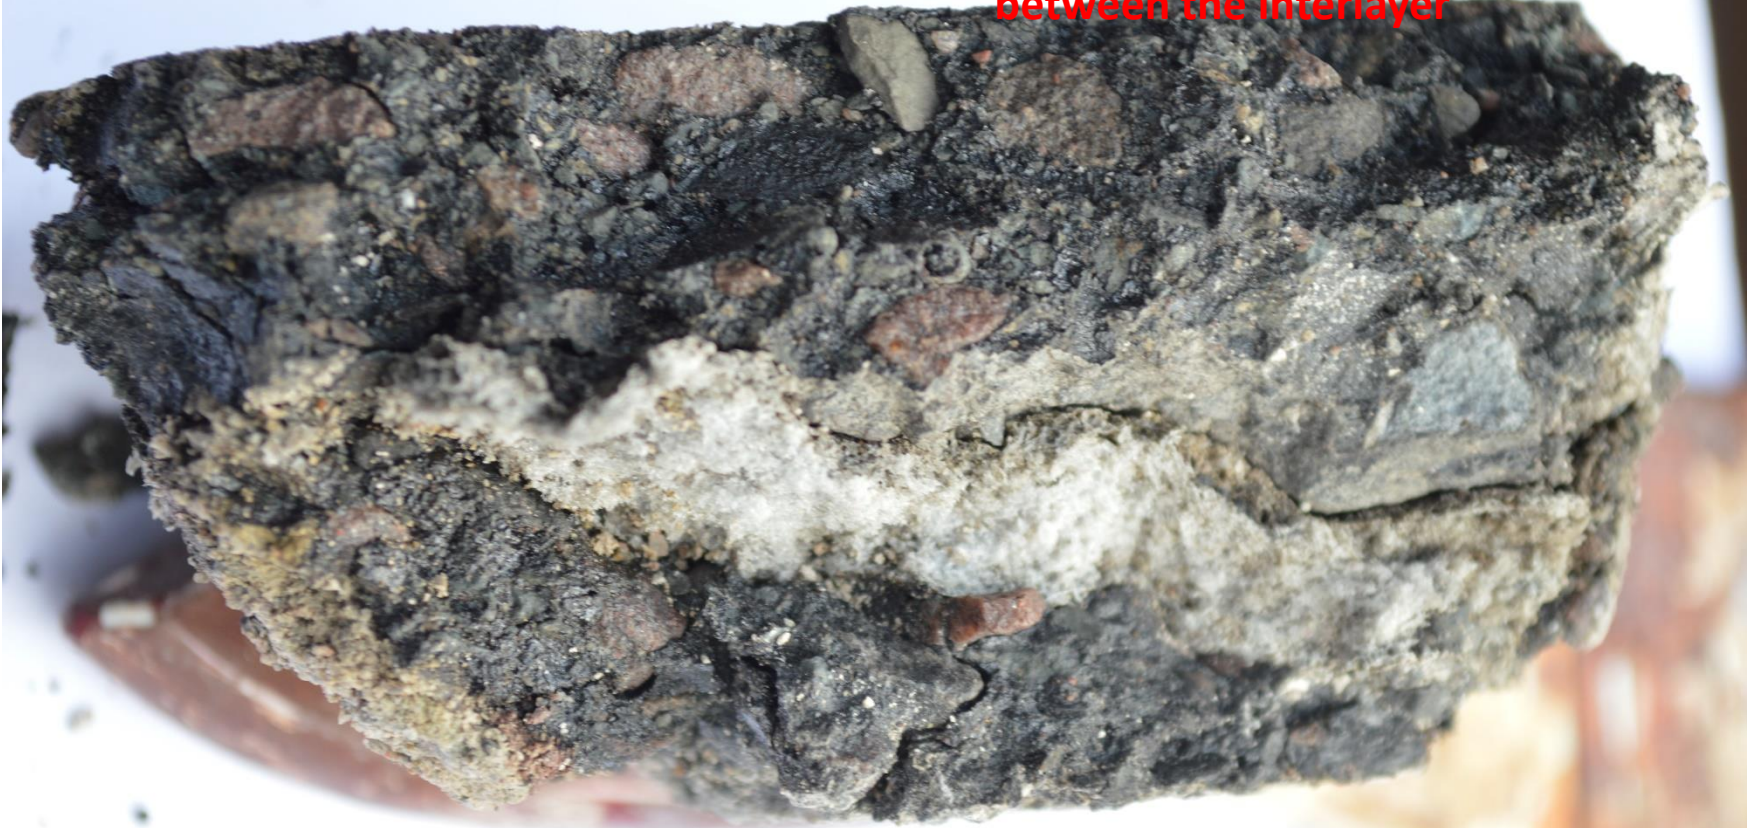
Chunk of asphalt interlayer picked up at punch-out repair.  
The grey is URETEK sandwiched between the interlayer

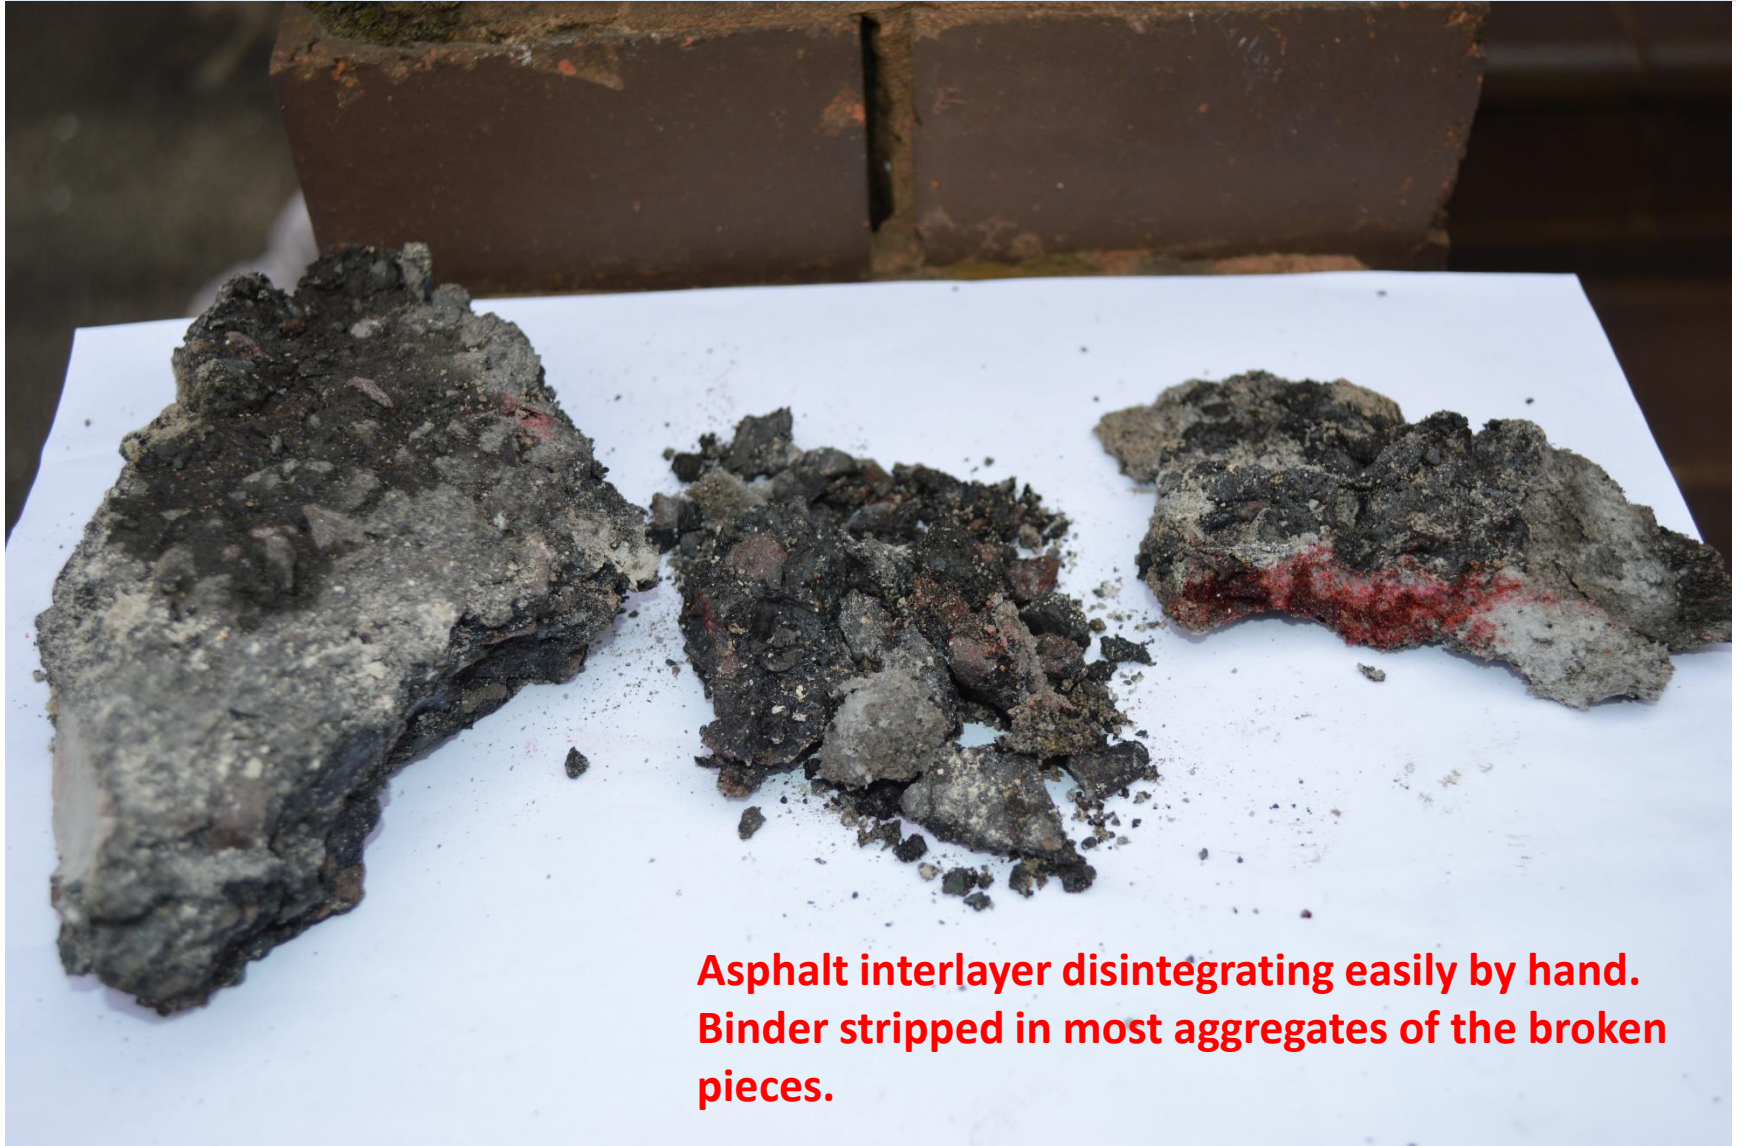
**Asphalt interlayer disintegrating easily by hand.  
Binder stripped in most aggregates of the broken  
pieces.**
