RPF May 2010: Progress Report on the SAPDM

Damage models for stabilised material

Damage modelling of stabilised material

Preliminary investigation site visits

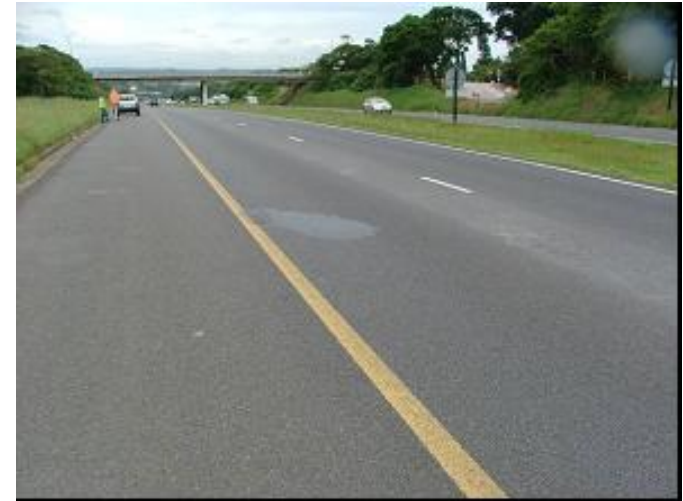
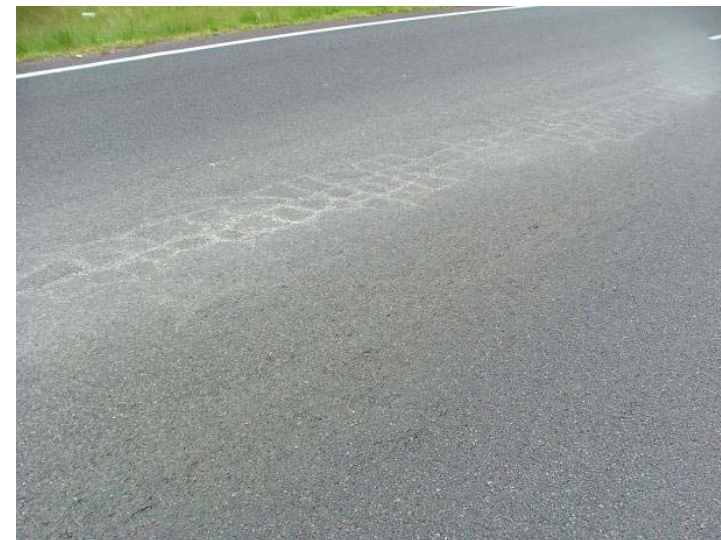
N2-24 Amanzimtoti

- Moist sub-humid area
- Structure
 - 138 mm HMA layers
 - 200 mm C2
 - 150 mm C3
- Constructed 1964
- ADT 18 000 to 30 0000
- Cracks with pumping but often on inner wheel-path!

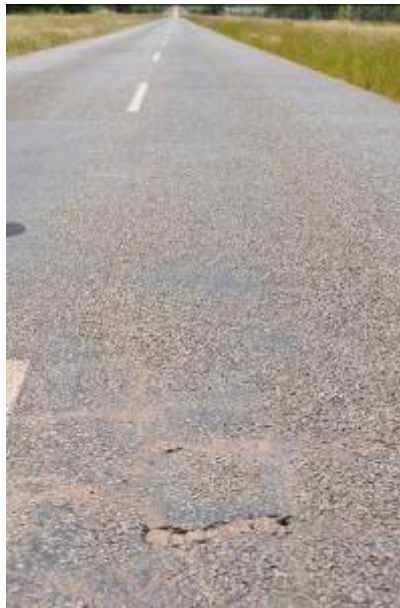
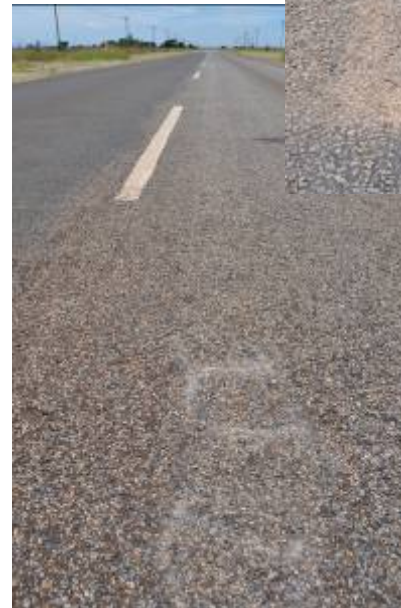
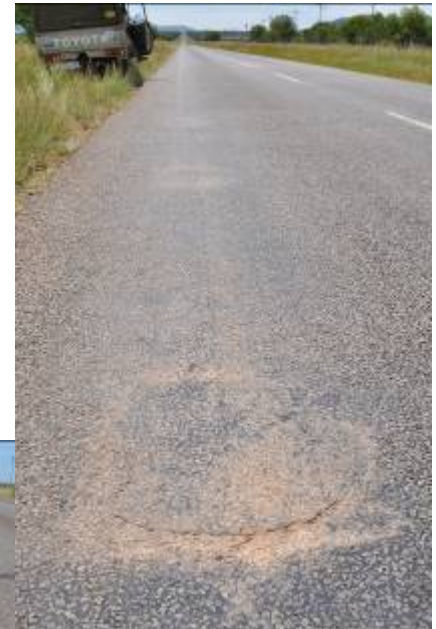
N11-12 Roedtan

- Semi-arid area
- 150 C3 on 150 C4
- Constructed 1961
 - Short section north of Roedtan reconstructed
- Cracks with pumping but often on inner wheel-path!

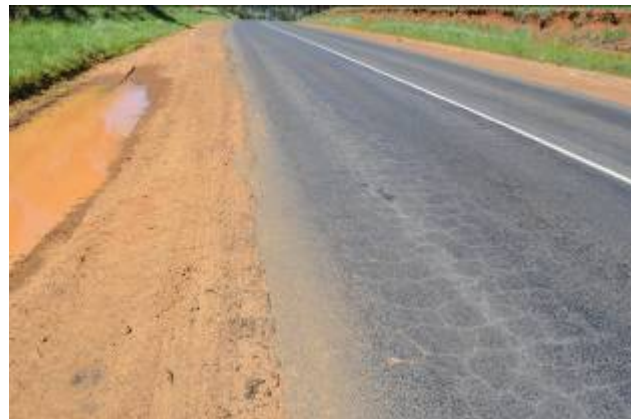
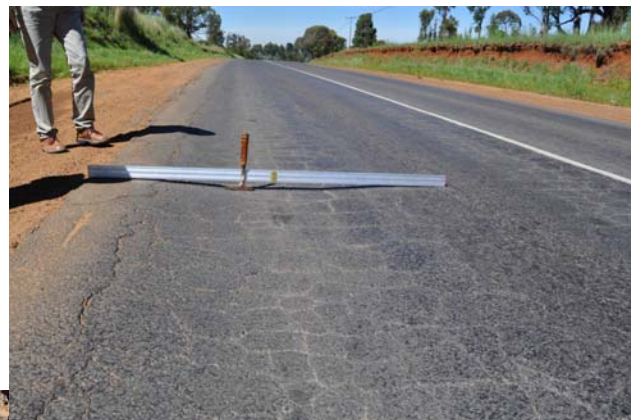
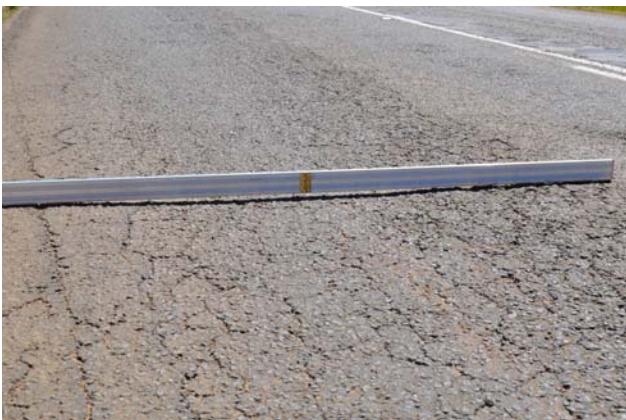
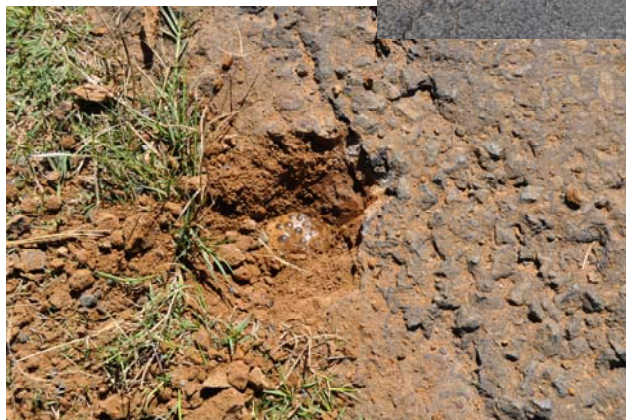
N17-5 Ermelo - Carolina

- Dry sub-humid area
- 100 C3 on G5 – km 0 to 9
 - 1958
- 100 C3 on 100 C3 km 9 to 25
 - 1968
- Fatigue and pumping in cut on 1st section, deep rut
- Wide 20 mm rut on second section

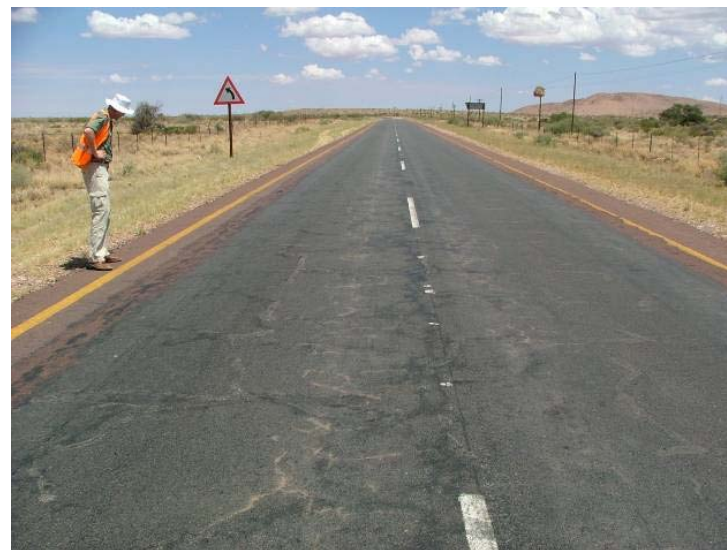
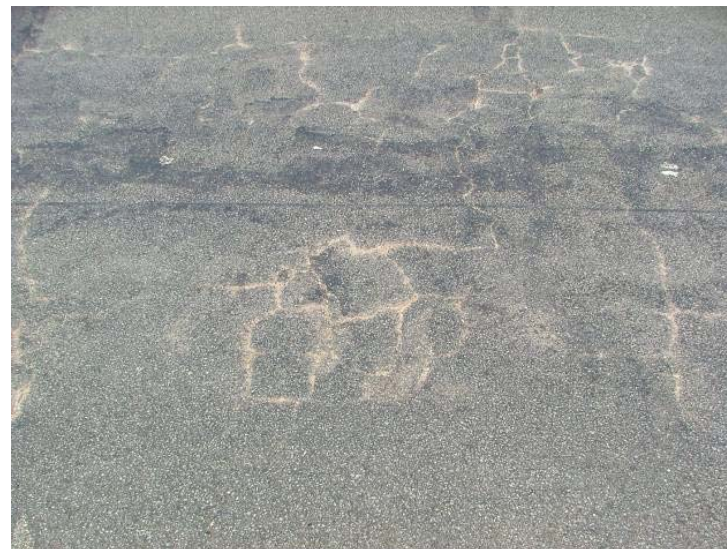
N14-5 Upington

- Arid area
- Structure
 - 16 mm seals
 - 100 mm C3
 - 100 mm C4
- Constructed 1935
- ADT 455
- Cracks with pumping but often on inner wheel-path!

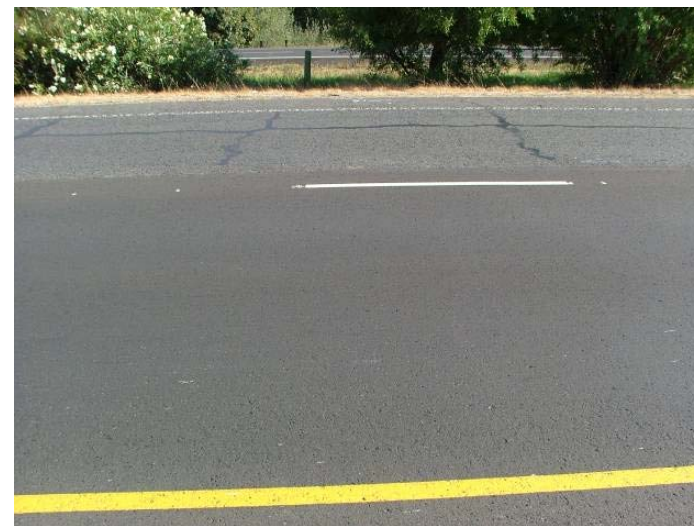
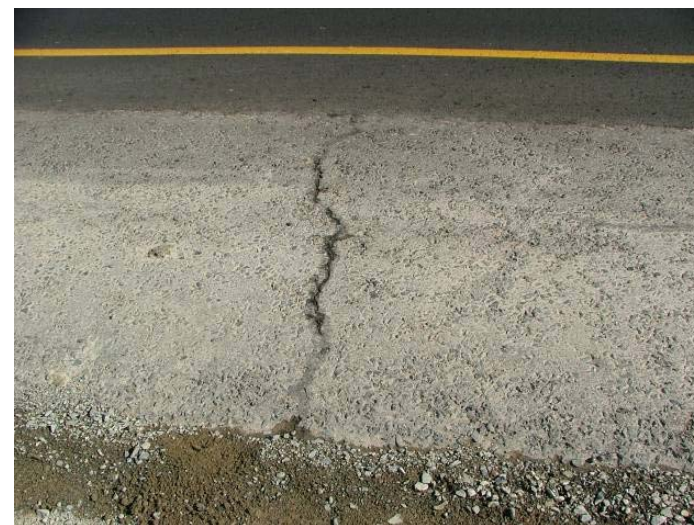
N1-1 Kraaifontein

- Dry sub-humid area
- Original CTB pavement
 - Recycled 1984
- Structure
 - 40 mm gap on 40 mm continuous
 - 100 mm ETB (1 % residual)
 - 100 mm CT subbase
- Surfacing milled and replaced
 - 1994
 - 2010

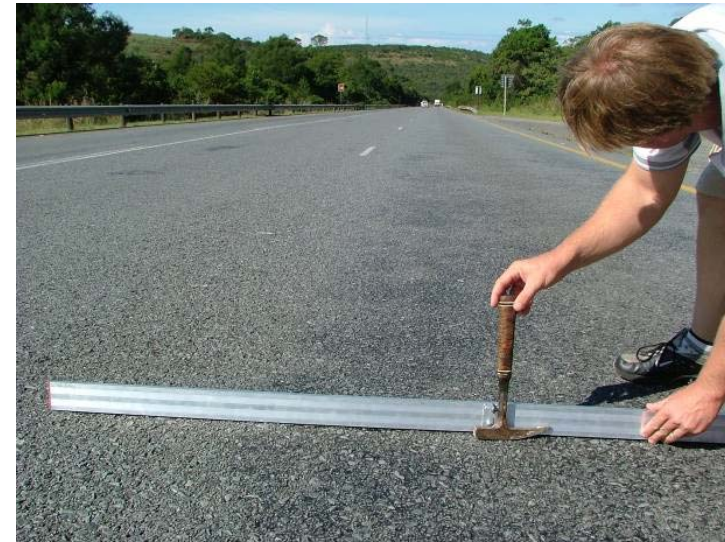
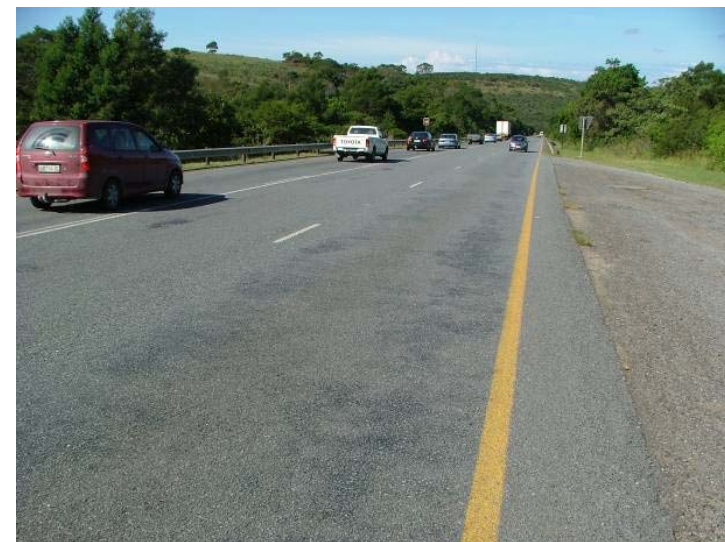
N2-16 East London

- Dry sub-humid area
- Constructed 1980/81
- Structure
 - 40 mm gap
 - 140 mm ETB sandstone (1 % residual, 1 % cement)
 - 150 mm subbase (1.5 % lime, 1.5 % slagment)
- Surfacing milled and replaced
 - 1994
 - 2010

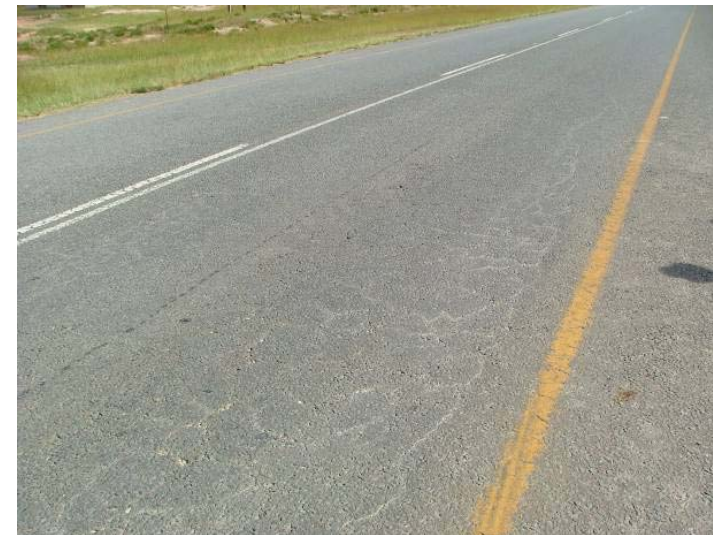
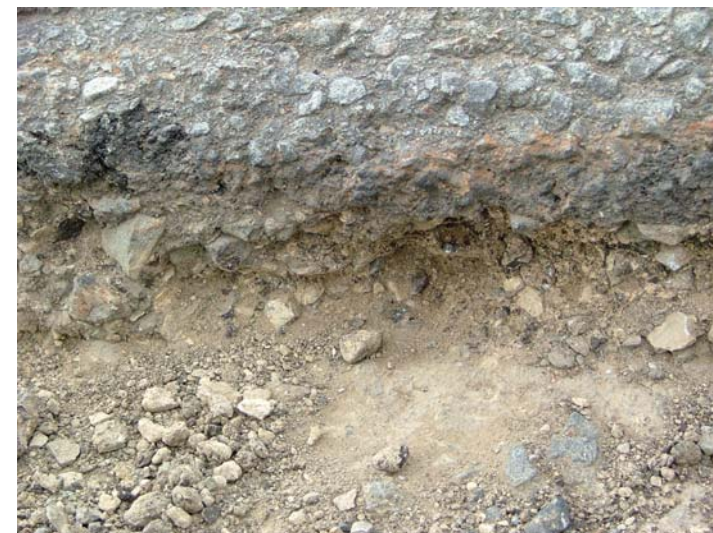
N2-20 Mount Frere

- Dry sub-humid area
- Constructed 1999/2000
- Structure
 - 35 mm AC
 - 180 mm ETB (1.75 % cement and 1.5 % residual bitumen)
 - 120 mm old C4 base
 - 150 mm old C4 subbase
- ADT = 2300
- Condition
 - Cracks and pumping in vicinity of Mt Frere
 - Better condition towards Mt Ayliff

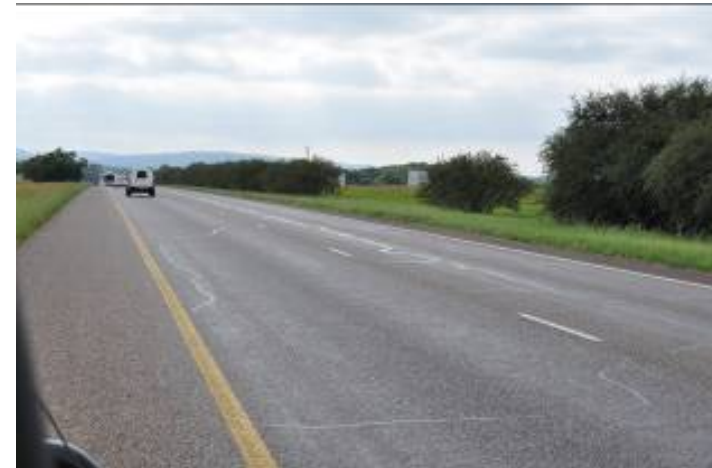
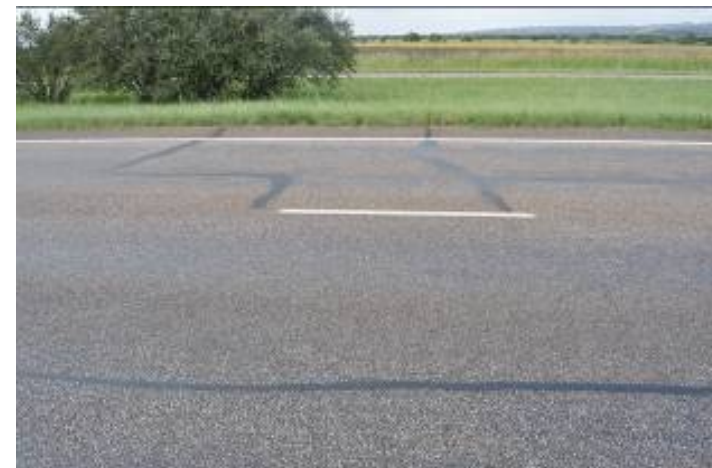
N4-1 100 mm ETB on old CTB

- Dry sub-humid area
- Original 200 mm C1 CTB pavement
 - Constructed 1969
 - UCS on cores 25 years after construction – 13 MPa
- Upper 100 mm recycled with ETB in late 1990s on the slow lane
 - Fast lane still CTB
- High traffic volume
- Block cracks sealed
- No fatigue and pumping

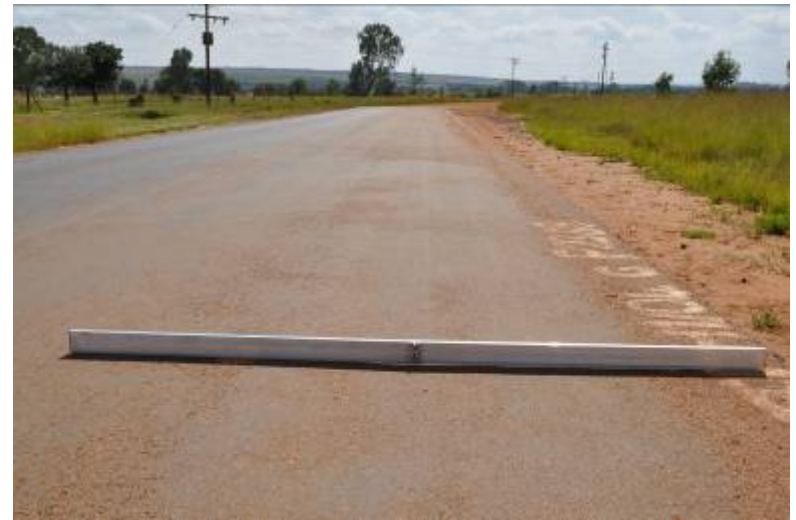
D2388 100 mm ETB on "cemented" subbase

- Dry sub-humid area
- Constructed in 1997
 - 0.9 % residual binder
 - 1 % cement
- Very little traffic
- No structural distress

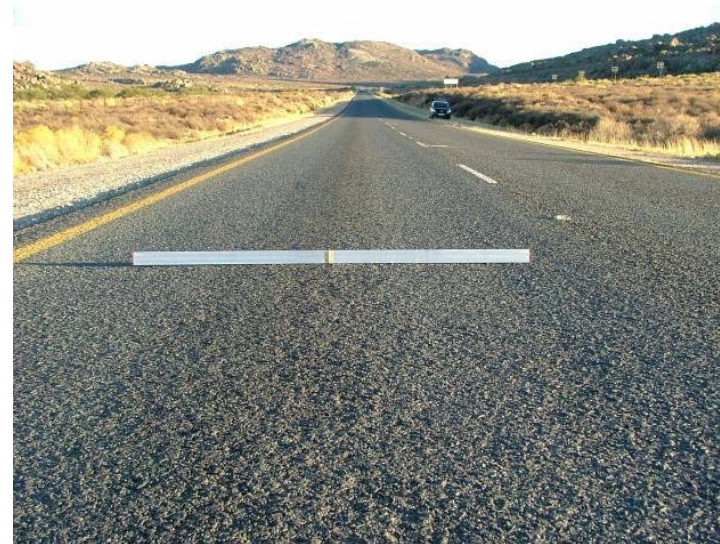
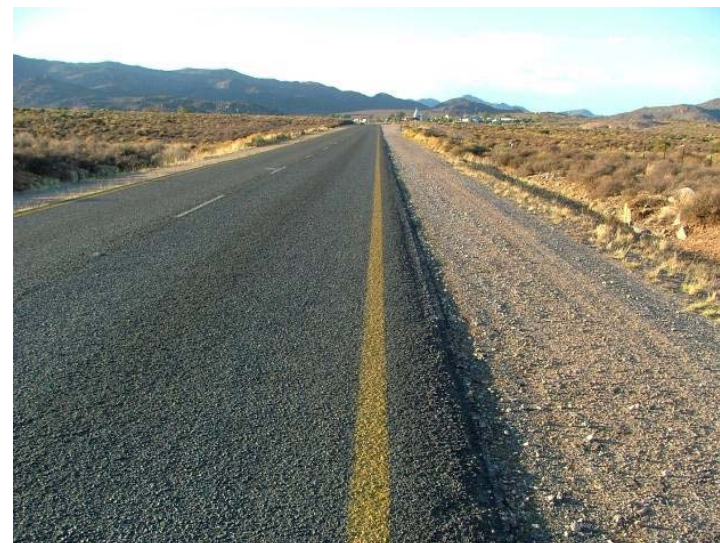
N7-07 Kammieskroon

- Arid area
- Constructed in 1987
- Structure
 - Seals
 - 150 mm ETB (2 % emulsion, 1 % cement)
 - 50 mm old CT subbase
- Very little traffic
- No structural distress

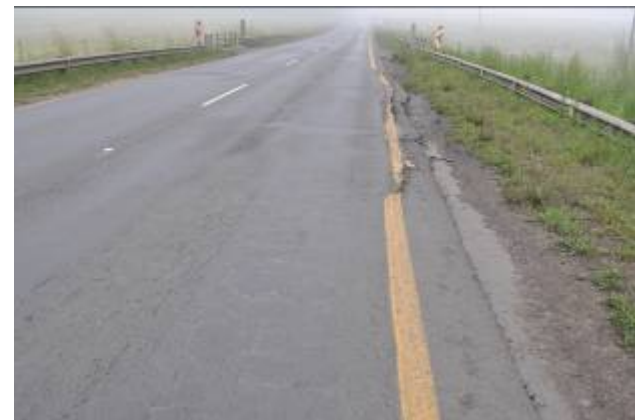
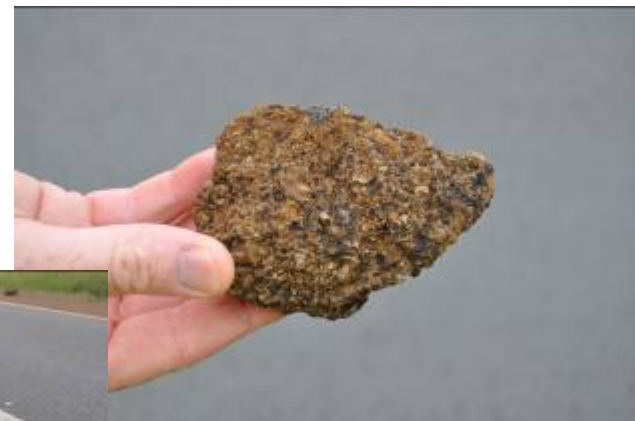
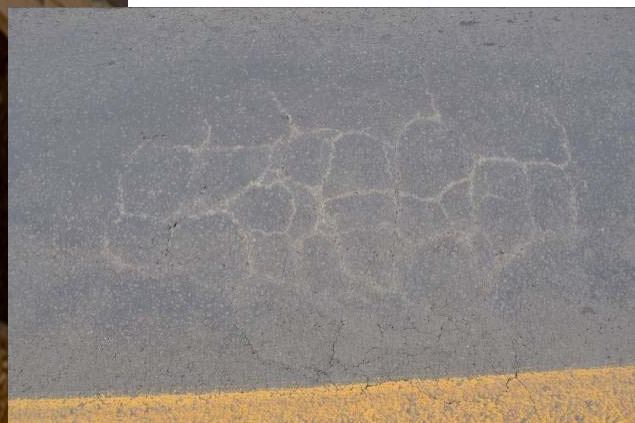
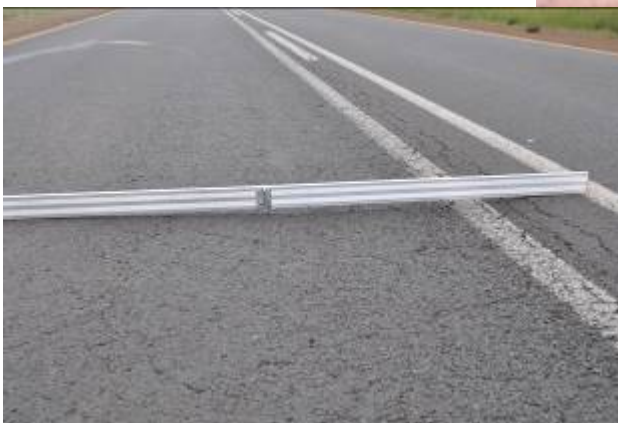
N11-08 Hendrina

- Moist, sub-humid
- 180 mm foamed bitumen treated dolerite
 - Constructed 2003/04
 - 1.5 % foam
 - 1 % cement
- Localised shear failure
- Rutting on inner wheel-path

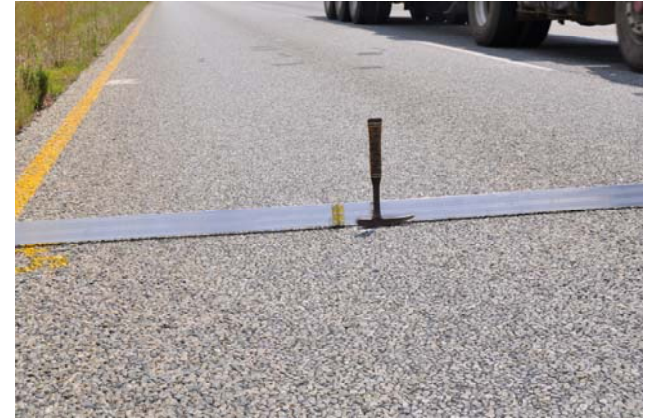
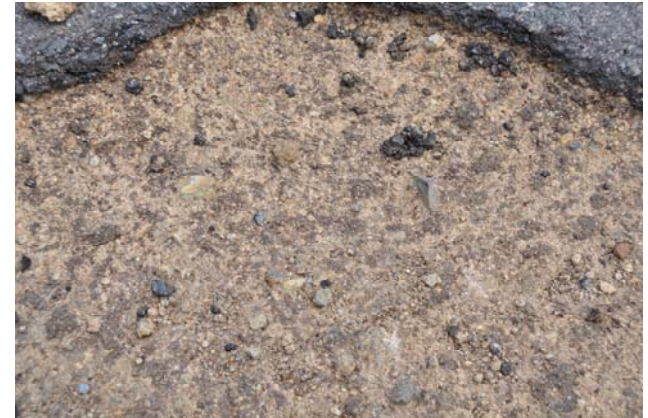
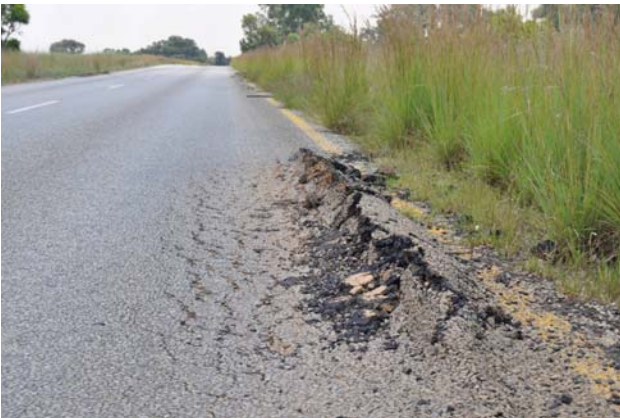
P243 Vereeniging

- Dry sub-humid
- 250 FTB
 - Constructed 2000
 - 1.8 % foam
 - 2 % cement
- Localised shear failure
- No structural distress on remainder of section

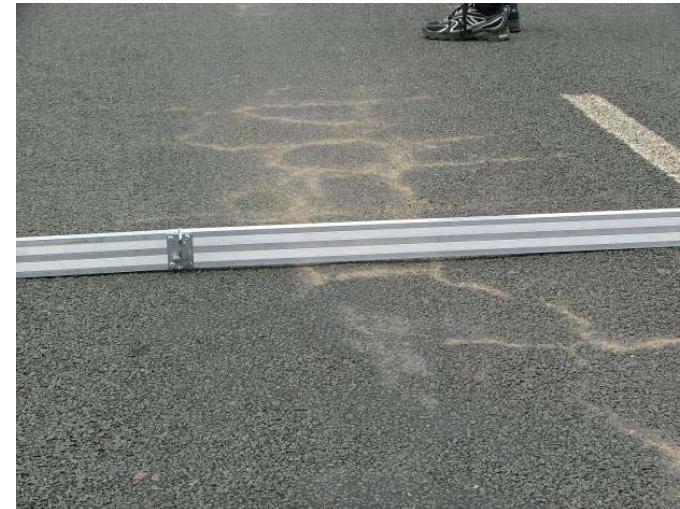
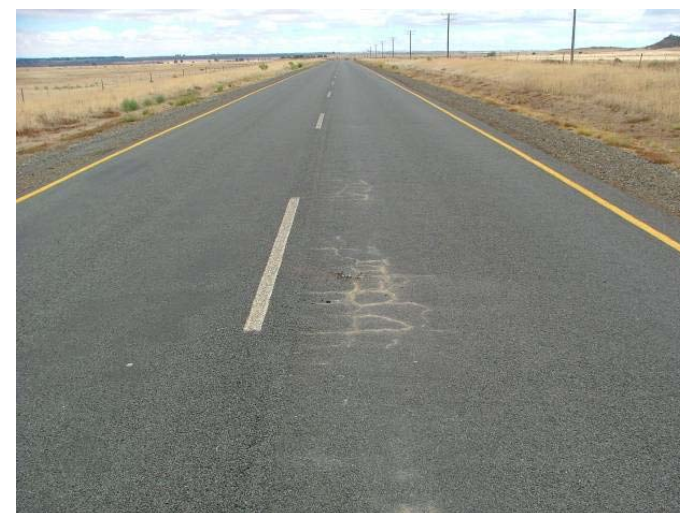
R27 Nieuwoudtville

- Arid area
 - Appears wetter than Upington and Kammieskroon
- Constructed in 2003
- Structure
 - Double seal
 - 200 mm FTB
 - 2.5 % foam
 - 1 % cement
- Cracking and pumping in inner wheel-track

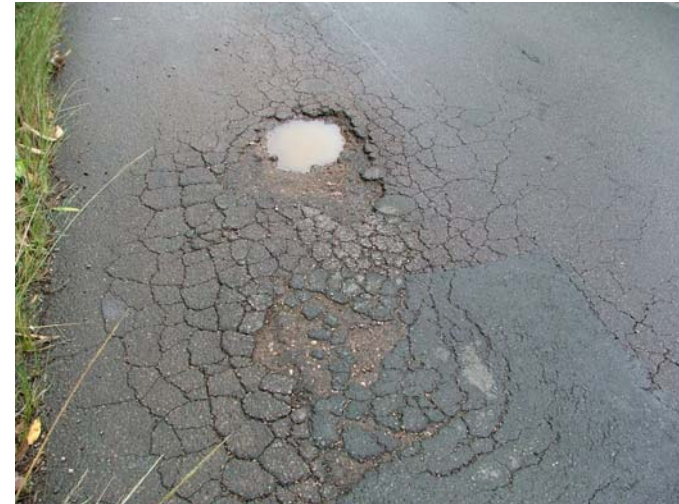
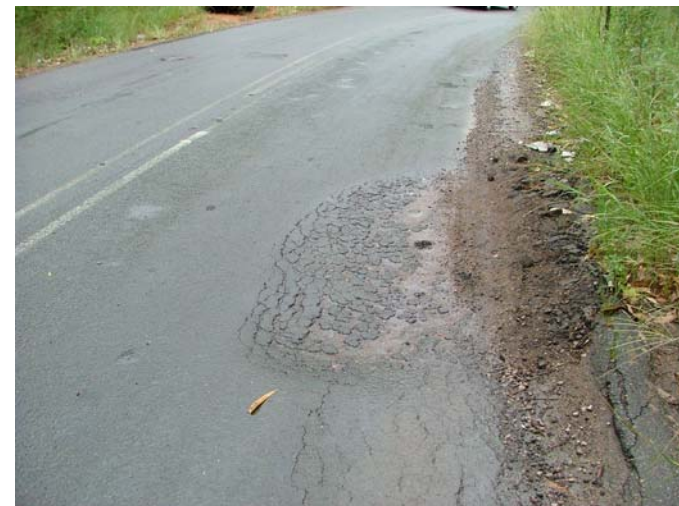
P504 Cliffdale Road

- Moist sub-humid area
- Constructed in 1995
- Structure
 - Slurry seal
 - 175 mm FTB
 - 3.5 % foam
 - 1 % lime
 - Decomposed granite subbase and in situ
- AC overlay 3 years after construction
- Condition
 - Surface disintegration but little material loss from base
 - Substantial deformation in places

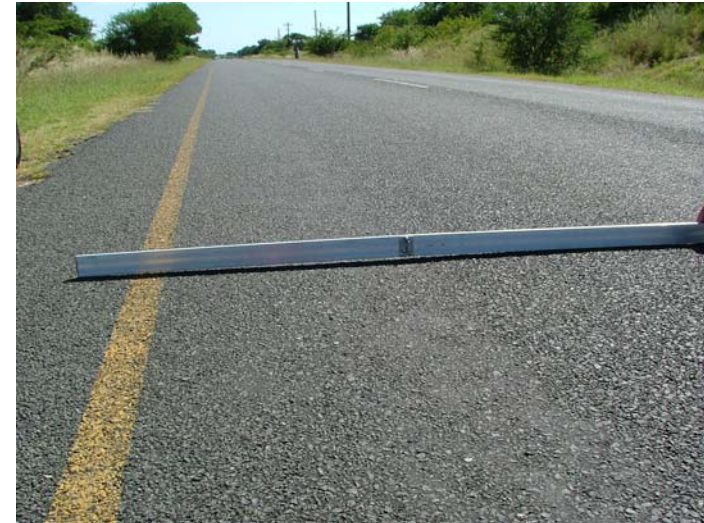
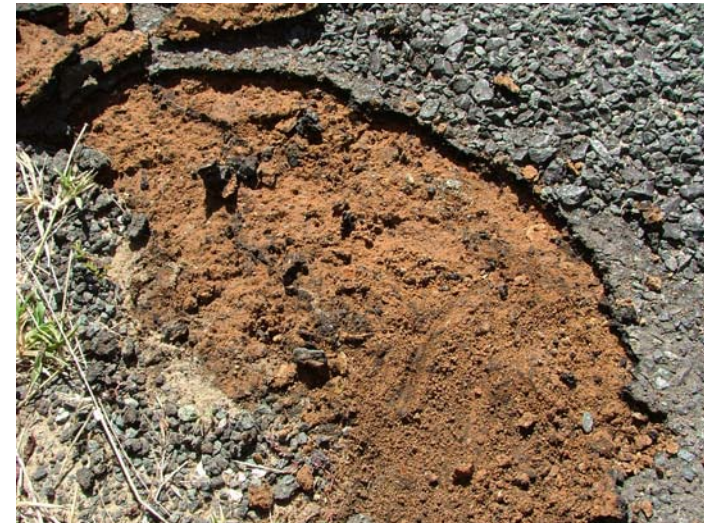
R22 Mseleni

- Semi-arid area
- Constructed in 2002
- Structure
 - Coarse slurry seal
 - 250 mm FTB
 - 4 % foam
 - 2 % lime
 - Sand and calcrete mixture in base
- Double seal 4 years after construction
- About 10 mm rut but overall sound structural condition
