Heavy Vehicle Simulator evaluation of the Super-Slab® pre-fabricated concrete panels for pavement rehabilitation

Louw du Plessis
20 – 21 May 2014

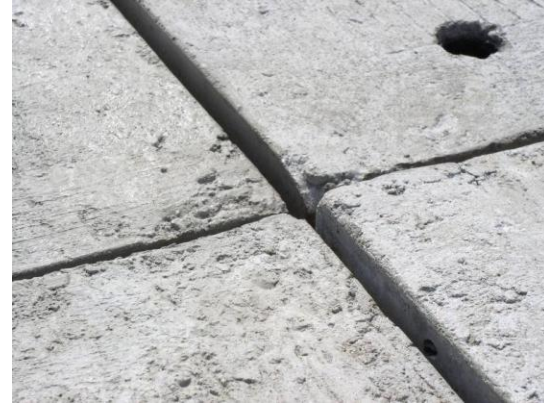
Misalignment of adjacent slabs causing surface irregularities

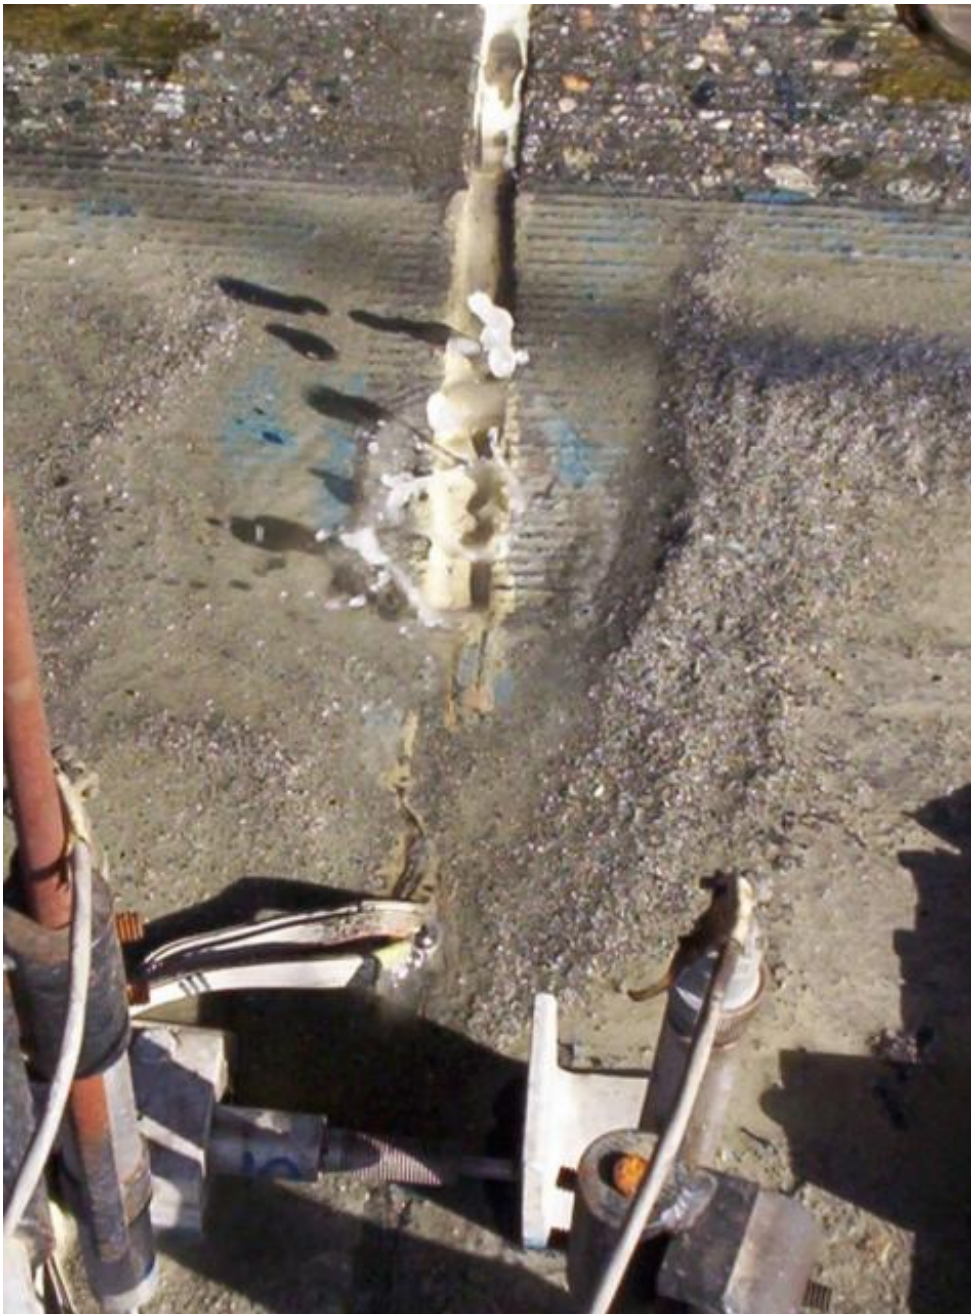
Pumped material

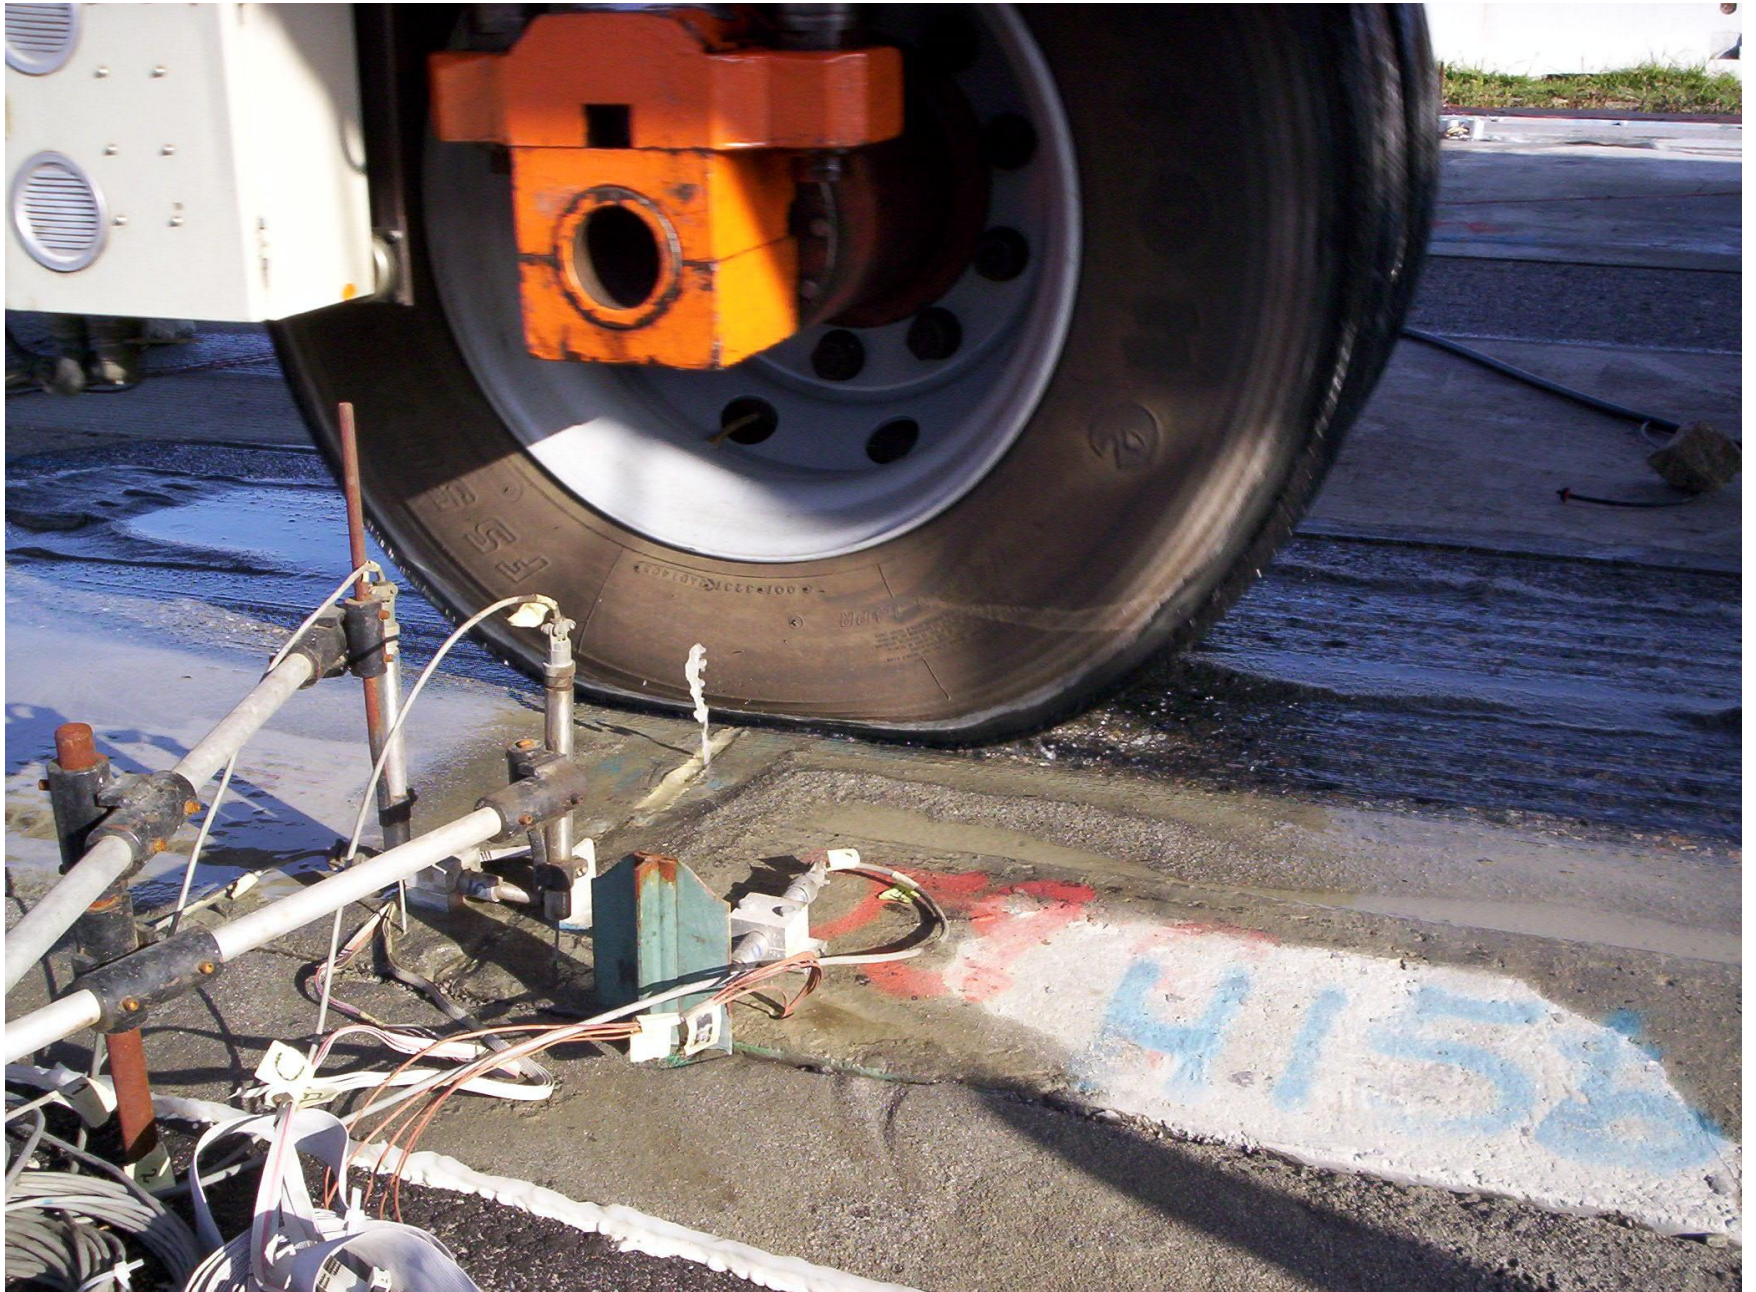
Pumping through the joint

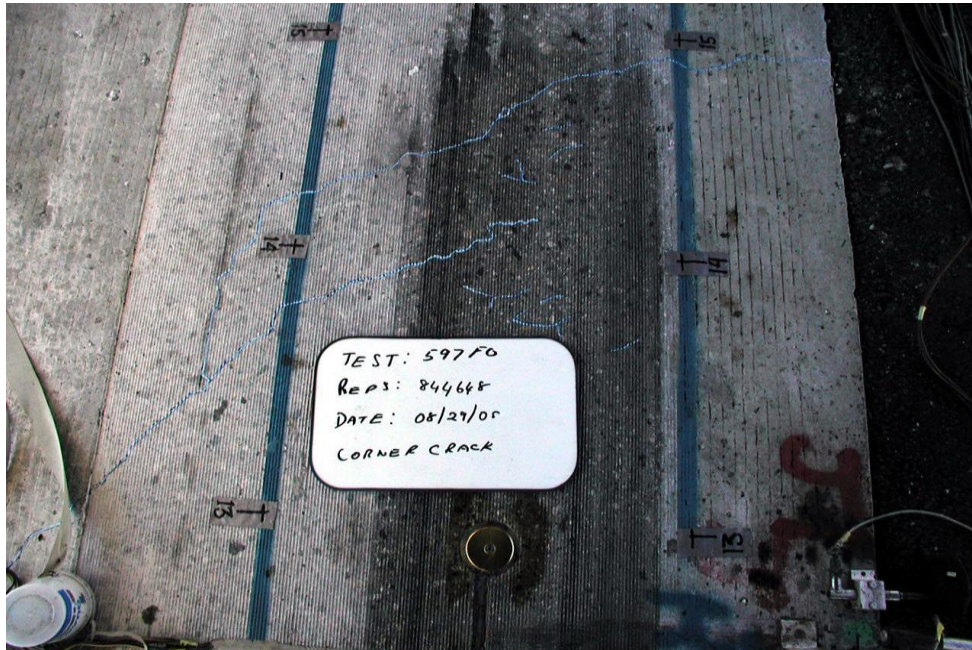
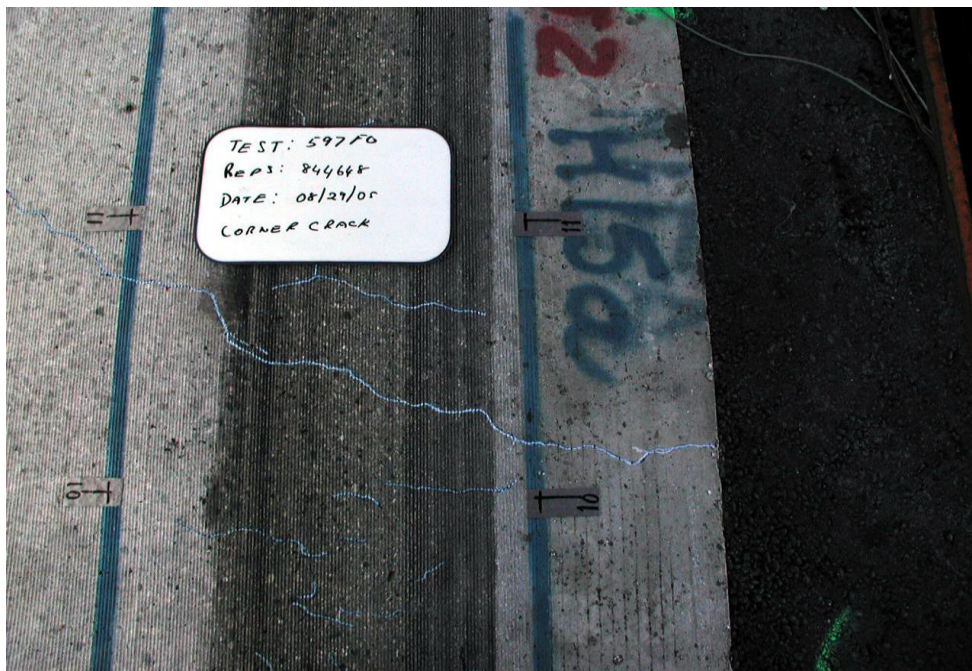
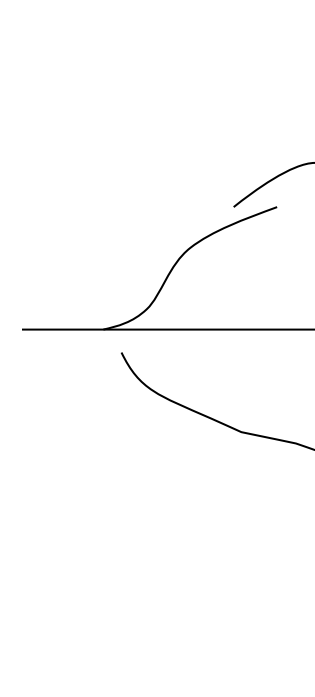
Corner cracks (dry testing)

Cracks on either side of the transverse joint fully developed and extending from the transverse joint to the shoulder joint.

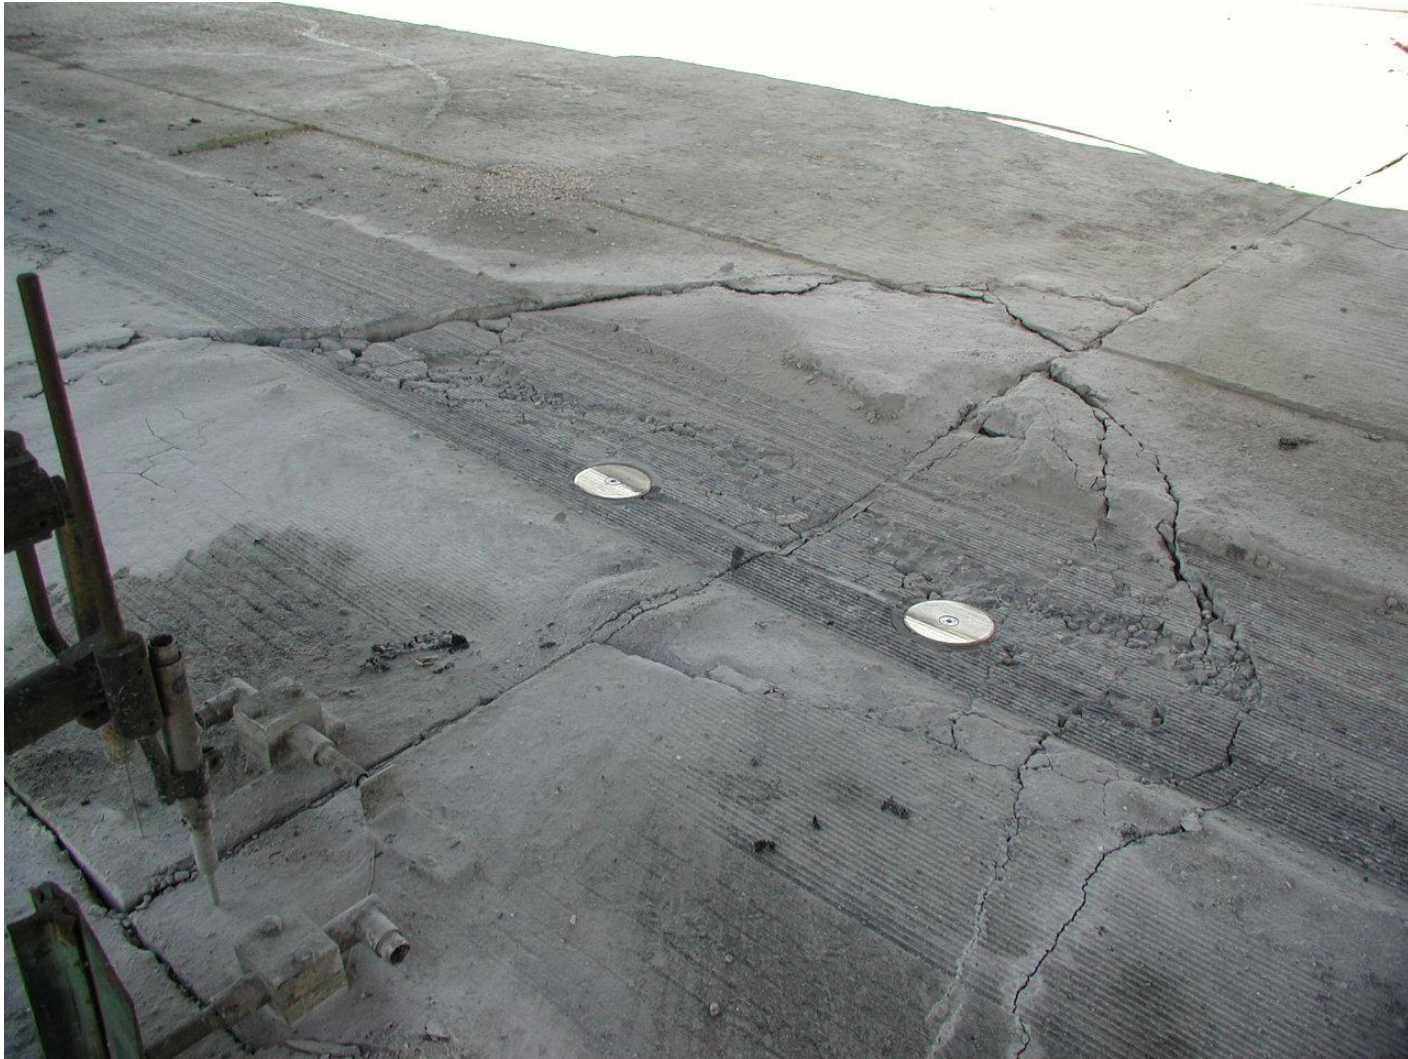
Section 1 wet, cracking

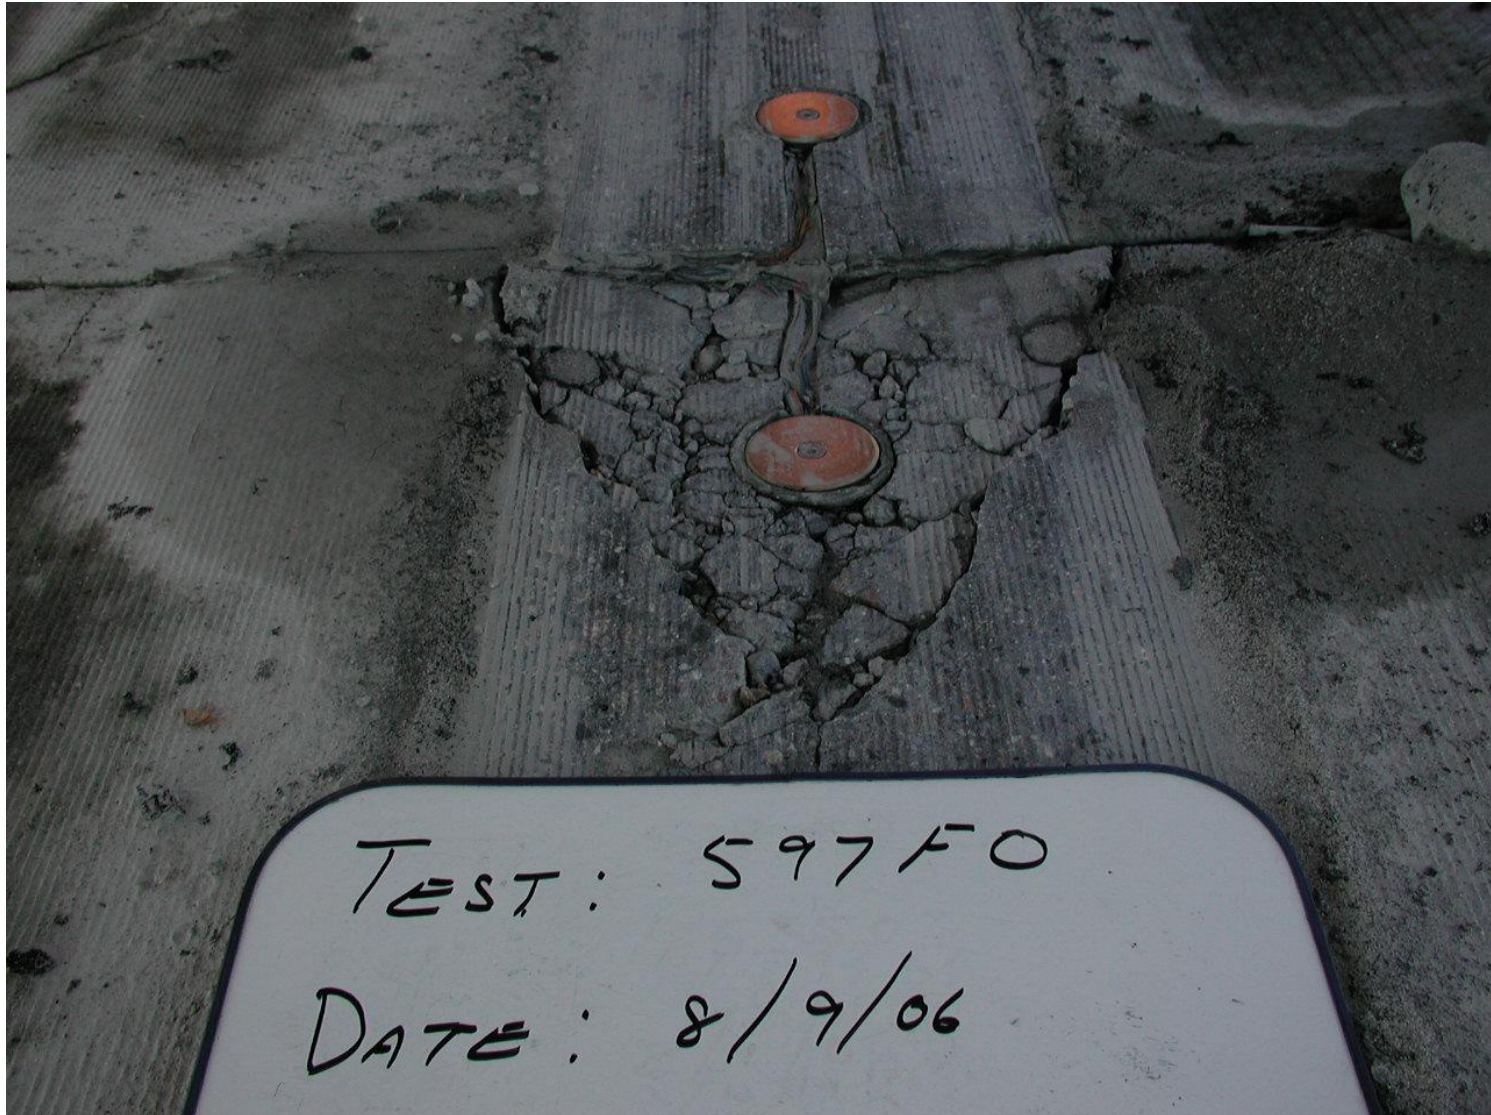
Section 1 wet, cracking

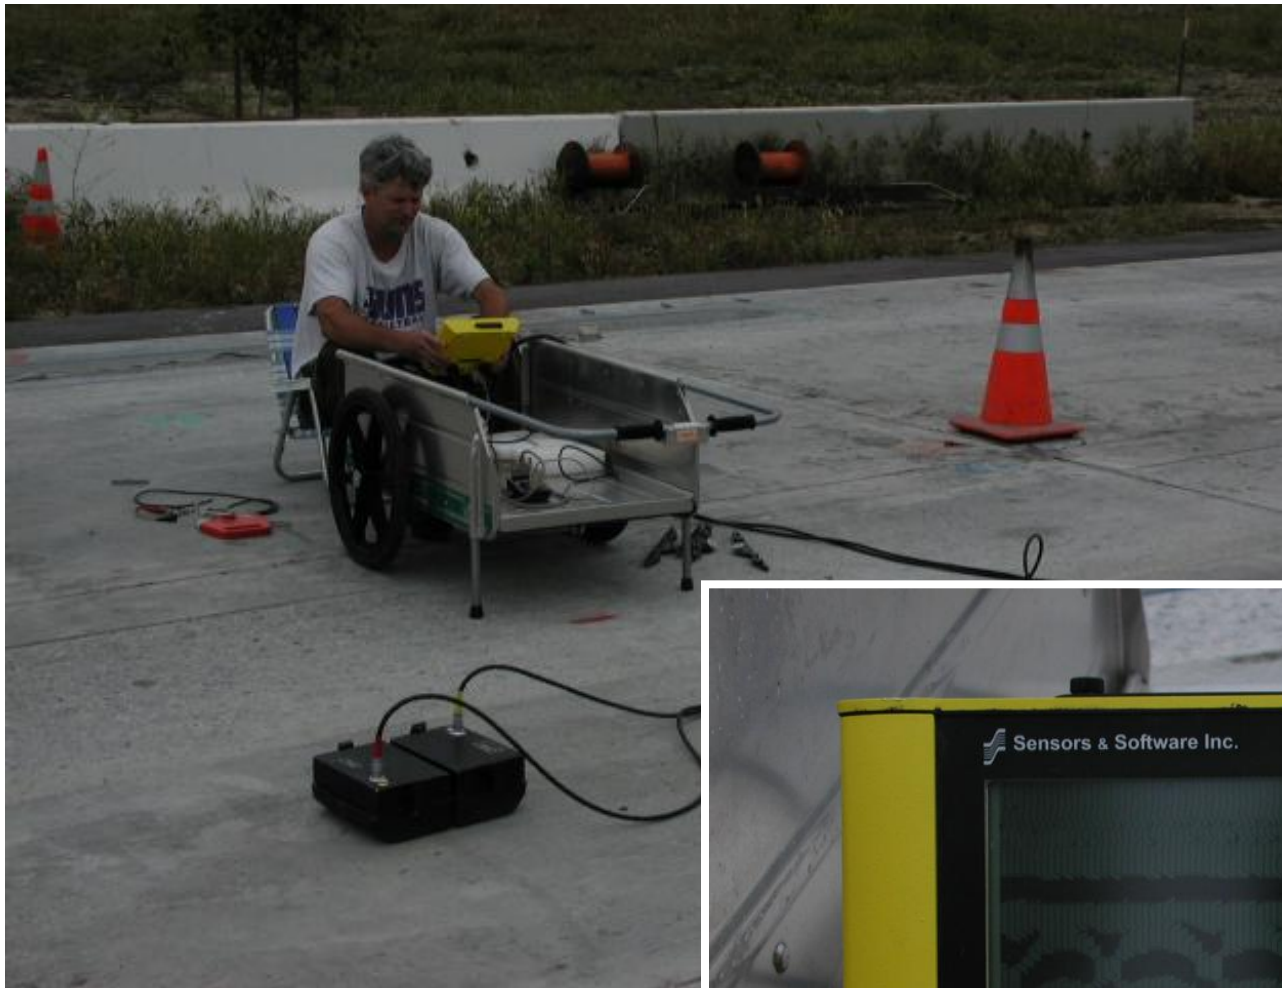
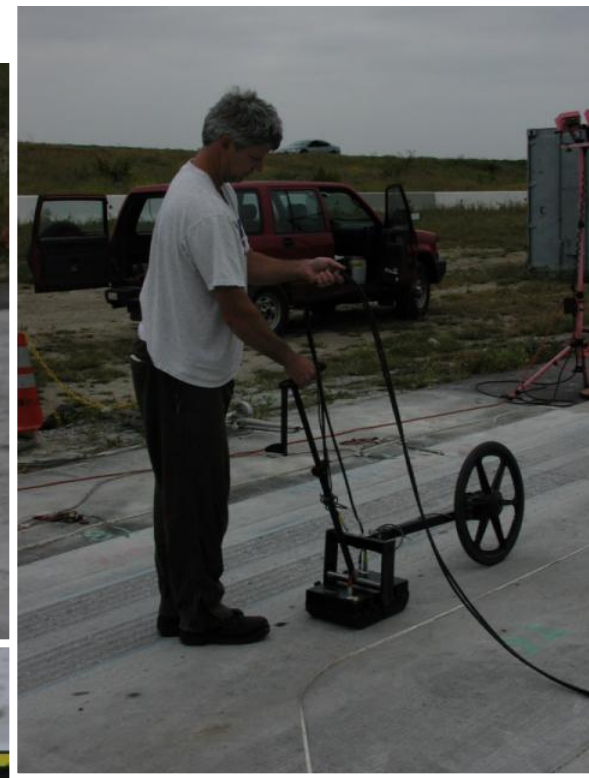
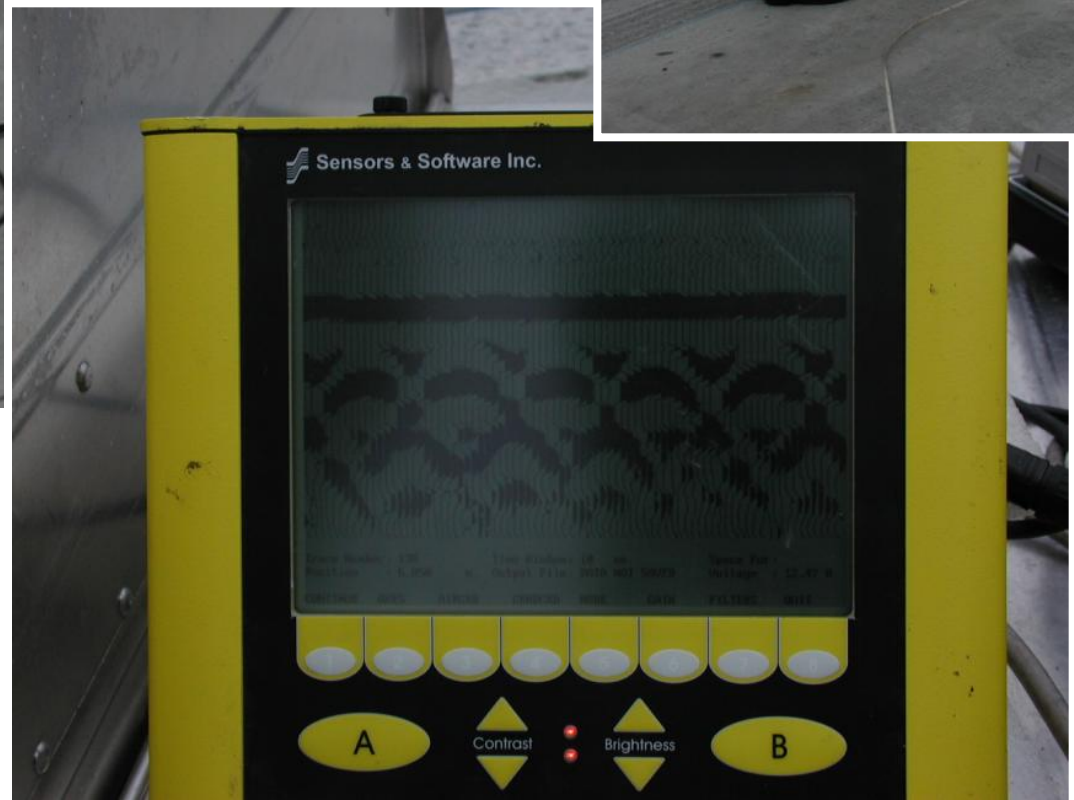
- Considerable amount of material pumped from under the slab during wet trafficking
 - Void under the slab
- GPR (Ground Penetrating Radar) attempt
- Concrete segments removal
 - Dowel load transfer investigated after loading
 - Bedding material inspected
 - Transverse joint grout investigated
