## **National Route 2 Section 1: East of Baden Powell Interchange at Km 29.0 to East of the Broadway Boulevard Interchange at Km 40.202**

### **Using Bitumen Rubber Asphalt to Rehabilitate an Alkali-Silica Affected Jointed Concrete Pavement**

### **Reflection Cracking & Structural Performance**

**Thirty-Sixth Road Pavements Forum  
13 November 2018**

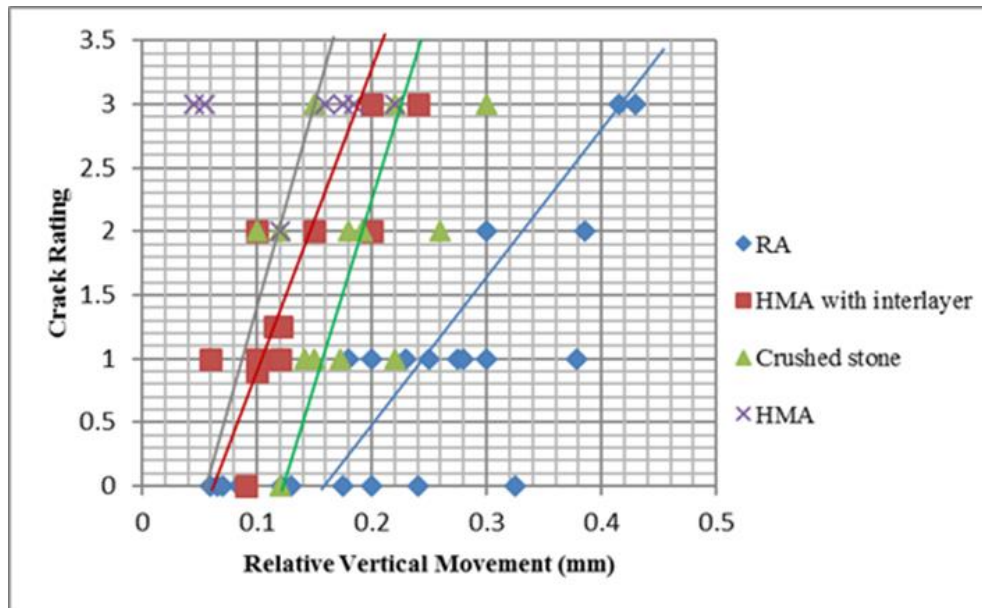
### Degree of Reflection Cracking for some Experimental Sections

- The first barely visible reflection cracks appeared 3 years after the experimental overlays were initially constructed (2x10<sup>6</sup>E80's);
- Extensive cracking was observed after about 6 years (4x10<sup>6</sup>E80) of service;
- The Bitumen Rubber Asphalt (BRA) and the HMA with interlayer showed superior performance, when compared to the other surface overlay option;
- This already indicated that stress reduction at the contact between the overlay and the JCP was critical;

- It became clear that relative vertical movement at the transverse contraction joints, had to be taken into consideration, when designing an overlay to reduce the risk of reflection cracking.

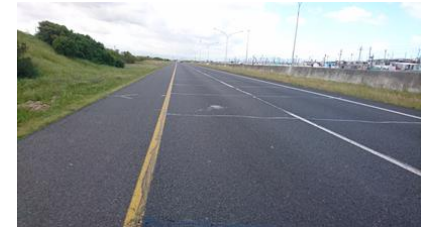
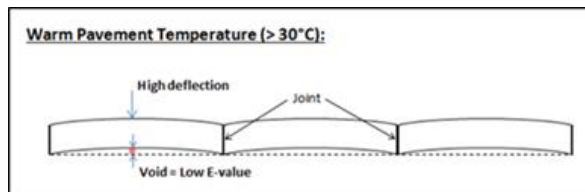
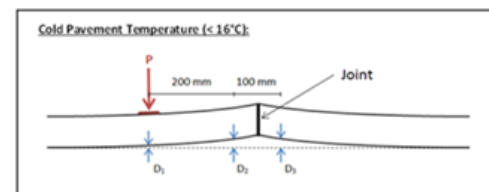
- Transverse reflection cracks were observed in the Bitumen Rubber Asphalt at a regular four-meter interval, across all four lanes of the dual carriageway;
- Transverse cracks were caused by a combination of:

- Relative Vertical Movement, due to action of rolling wheels that crosses the transverse contraction joints; coupled
- Warping and Curling effect of the concrete slabs (still in state of compression) under high and low pavement temperatures; and

- Loss of bond between the concrete and the bitumen rubber asphalt.

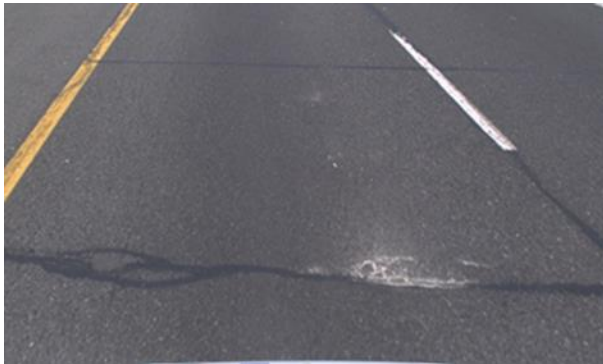
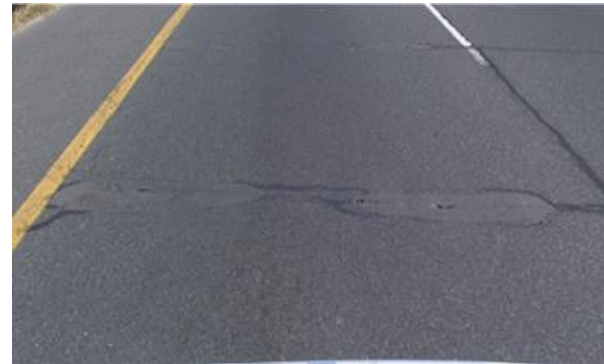
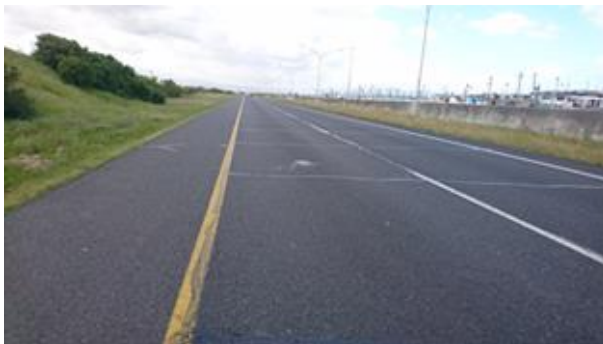
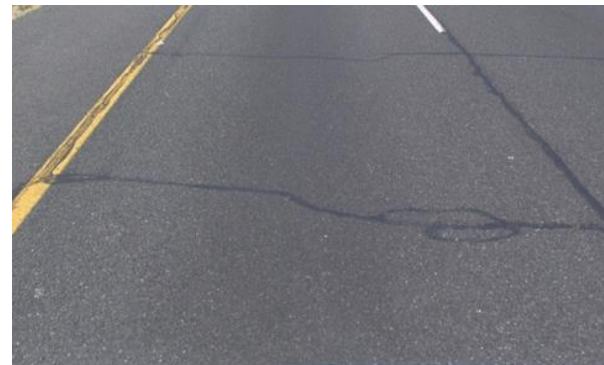
- Most of the transverse cracks have been sealed but a number of secondary cracks developed mainly in the slow lane, in addition to the transverse cracks.

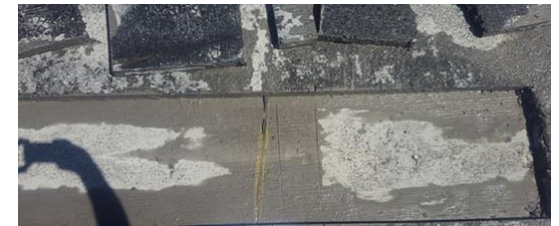
- Lateral movement of the sealed transverse cracks was also observed;

This indicates a loss of bond between the concrete and the asphalt surface overlay

- Confirmed during the coring and when the asphalt surfacing was removed from the concrete slab at two transverse contraction joints;

Approximately 80 per cent of the 100 mm diameter composite cores displayed delamination of the asphalt surfacing from the concrete

- The loss of bond between the Bitumen Rubber Asphalt overlay and the old Jointed Concrete Pavement, occurred due to the:
  - Migration of moisture up, through the contraction joints (spaced at 4m intervals);
  - Accumulation of moisture at the interface between the concrete and the bitumen rubber single seal (stress absorbing inter layer);
  - Horizontal movement of moisture due to the action of traffic loading (rolling wheels) over time;
  - Warping and Curling effect of the concrete slabs (still in state of compression) under high and low pavement temperatures.

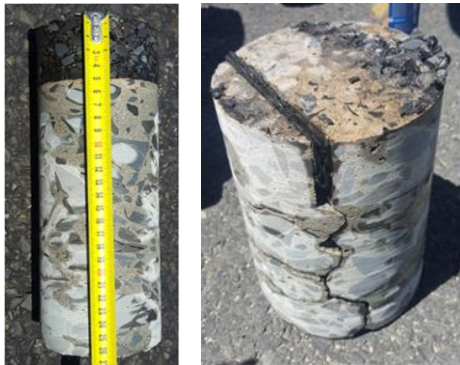
- Concrete cores confirmed that the concrete in general, was still in a good structural condition, except at the joints where some of the cores showed longitudinal cracking at various depths below the surface;

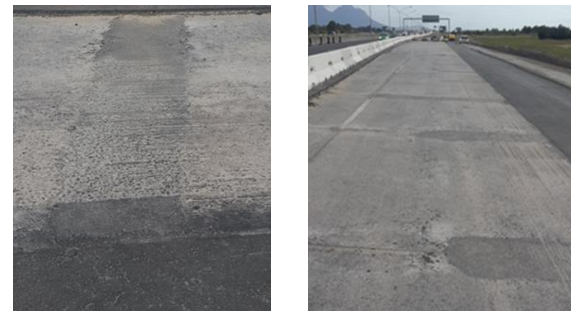
- Concrete from patches that were completed in 1986, to repair severely damaged transverse contraction joints, were found to be in a structurally sound condition.

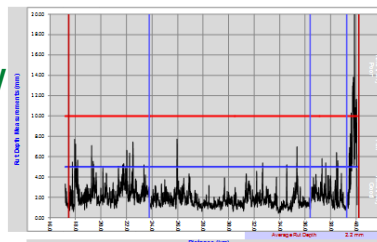
Rutting is only now touching warning levels

Contract: NRA/N\_002-0-0-2017-0-F, km 17.47 to km 39.511  
Average 10 meter Rut Depth  
Direction: East - Slow Lane - Left Wheel Path - 2016  
page 20

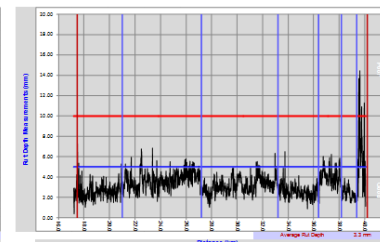
Contract: NRA/N\_002-0-0-2017-0-F, km 17.47 to km 39.511  
Average 10 meter Rut Depth  
Direction: East - Slow Lane - Right Wheel Path - 2016

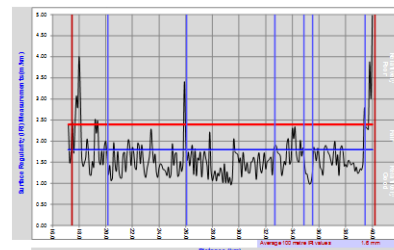
Contract: NRAN.022-0-0-2017-9F, km 17.47 to km 38.81  
 Average 100 metre IRI value  
 Direction: East - Slow Lane - Left Wheel Path - 2016

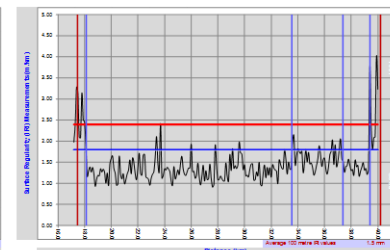
Contract: NRAN.022-0-0-2017-9F, km 17.47 to km 38.81  
 Average 100 metre IRI value  
 Direction: East - Slow Lane - Right Wheel Path - 2016

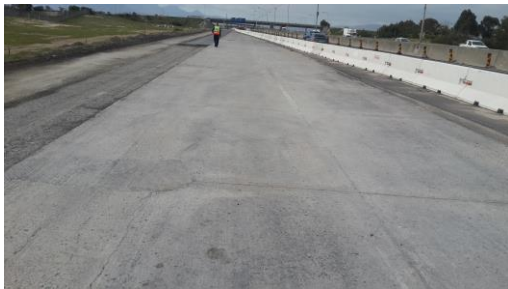
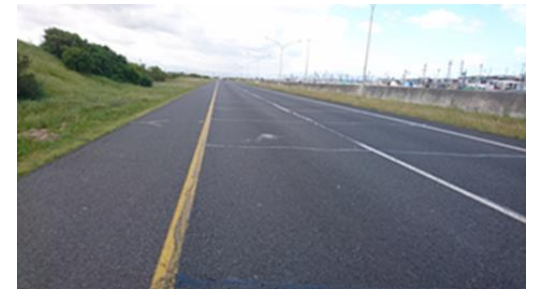
- The condition of the Jointed Concrete Pavement in general indicated very little signs of structural distress.

- The obvious presence of reflective cracking of the concrete joints in the asphalt surface overlay, had been attended, with crack sealant and the majority of these seals are still functional;
- Remedial measures were therefore mainly required to address:
  - Condition of the Aged; and
  - De-bonded Bitumen Rubber Asphalt Surface Overlay;

- Remove the deboned Bitumen Rubber Asphalt and 14 mm Stress Absorbing Membrane Interlayer;
- Repair only Severely Damaged Transverse Contraction Joints; (Partial depth repairs / joint spall repairs)
- Design and Construct a New Asphalt Surface Overly:
  - with improved binder elasticity and relaxation properties to accommodate;
