# LTPP Results of EME placed on South Coast Road – After 10 years

Prepared for presentation at the 50<sup>th</sup> RPF Meeting

Julius Komba

16 May 2023

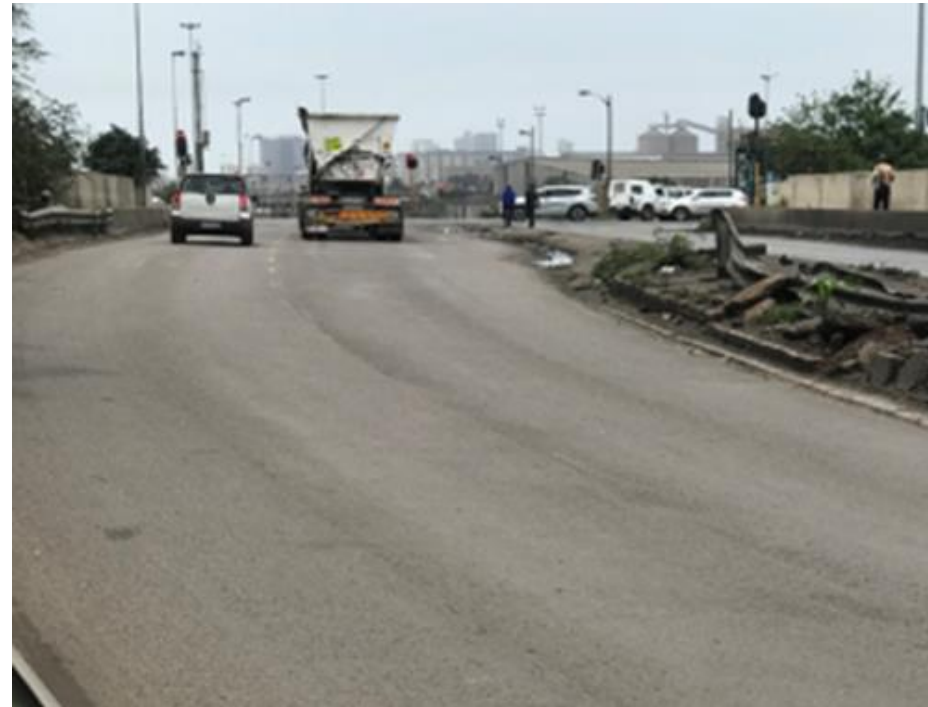
10 years after rehabilitation

- Overall condition is good

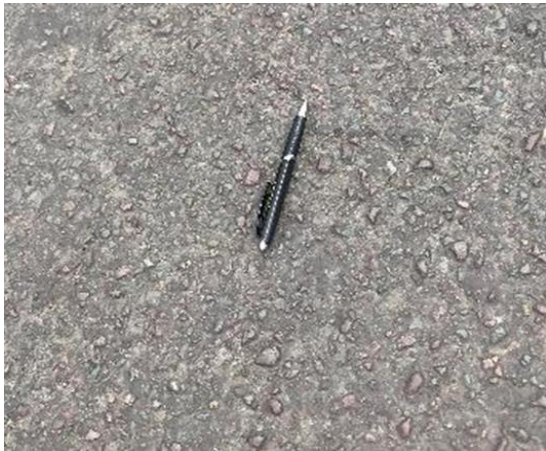
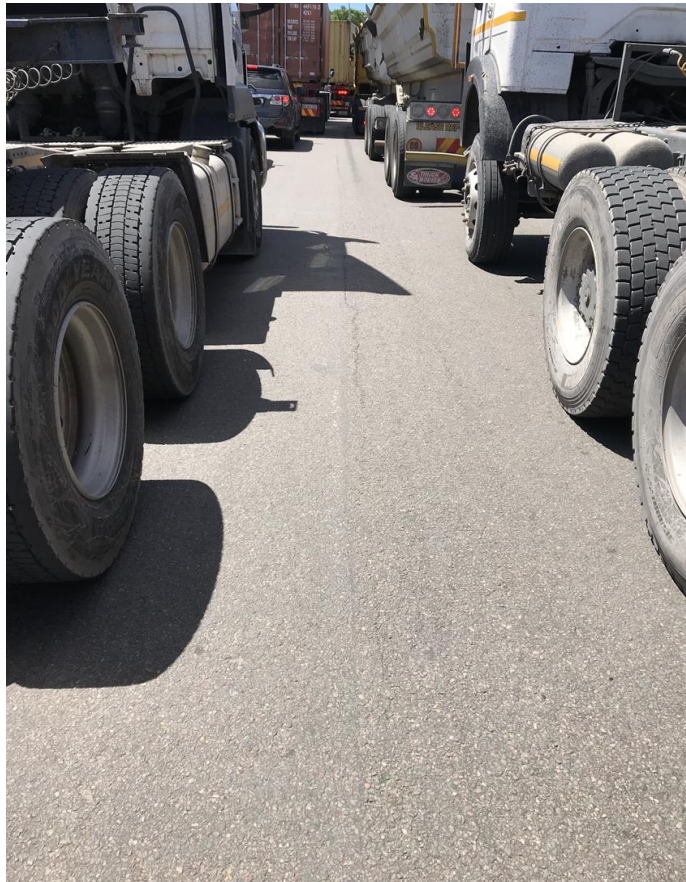
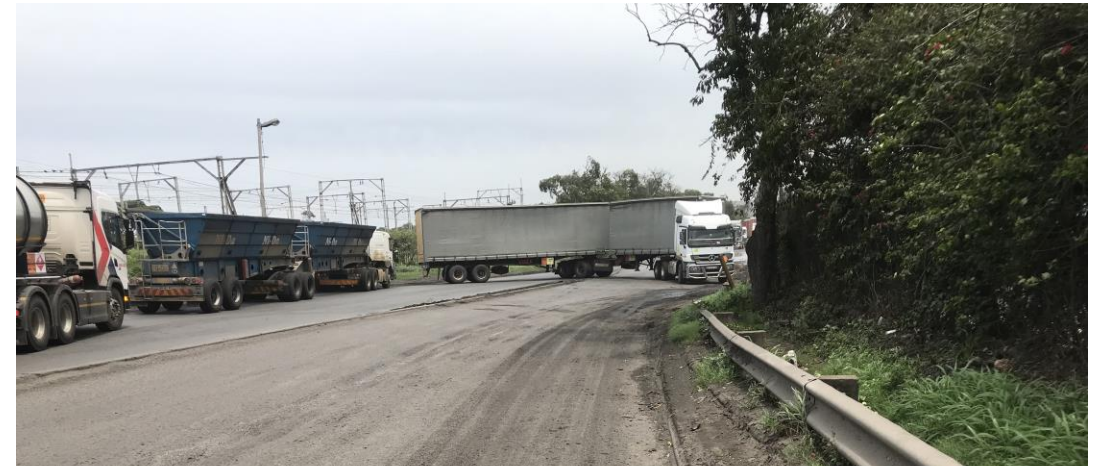
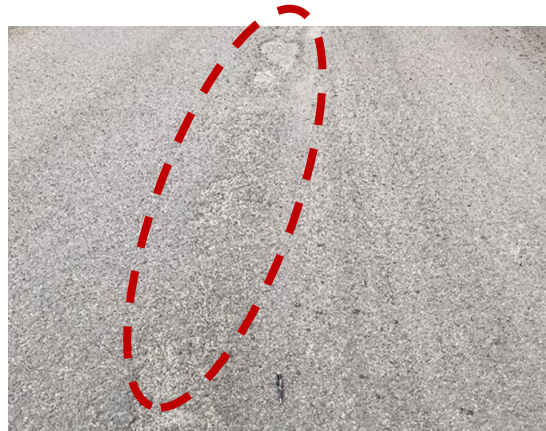
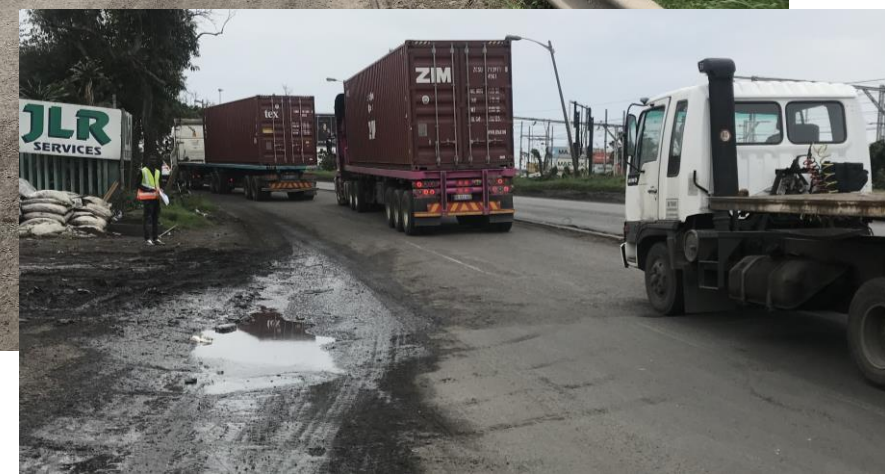
- SMA aggregate polishing
- SMA surface failures
- Joint cracks observed during the previous surveys are not deteriorating further
- Water ponding and gravel accumulation at beginning of the section

- The overall performance is satisfactory, taking into considerations the high traffic loading
- The condition of the SMA surfacing layer is deteriorating
- Maintenance intervention to improve drainage at the start and end of the section is required

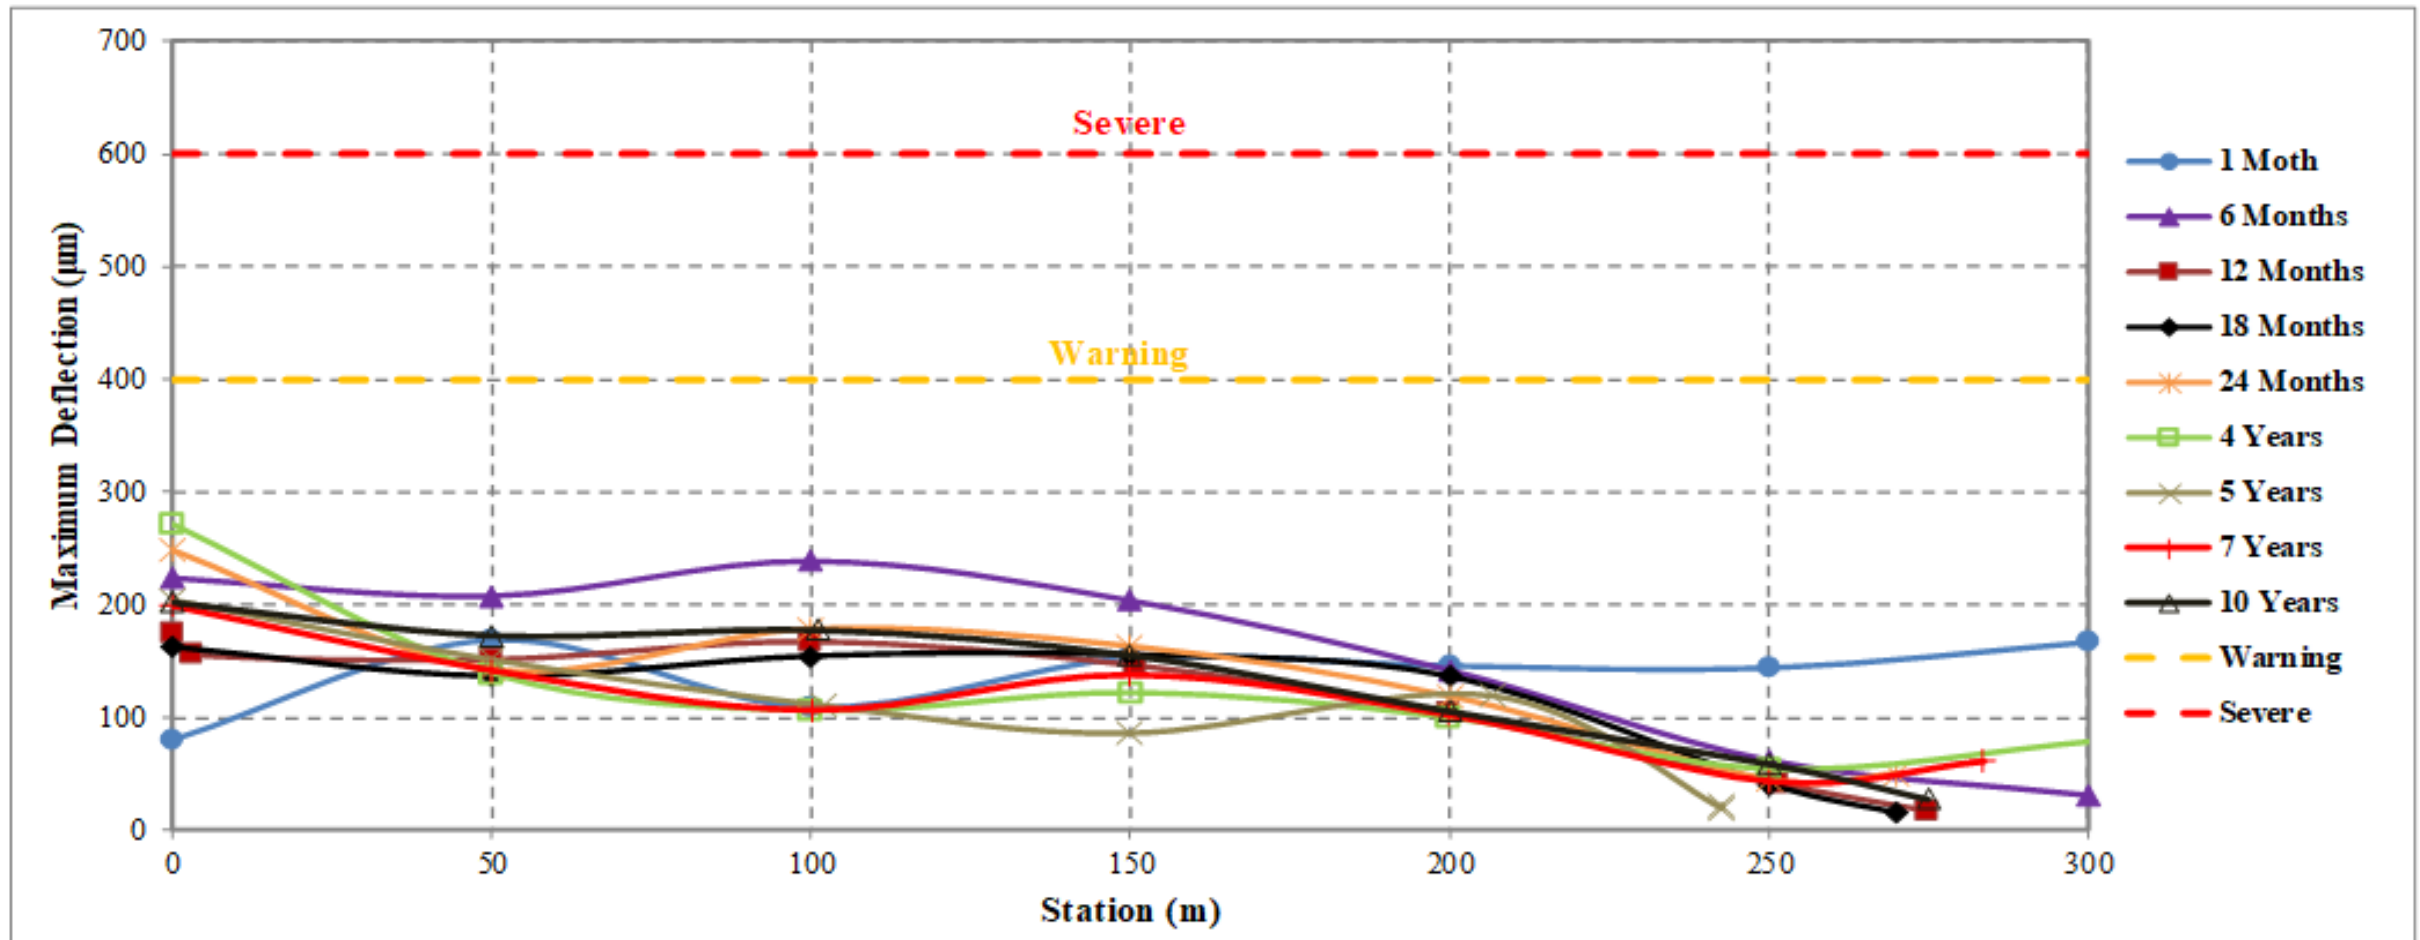
- Very low maximum deflection values

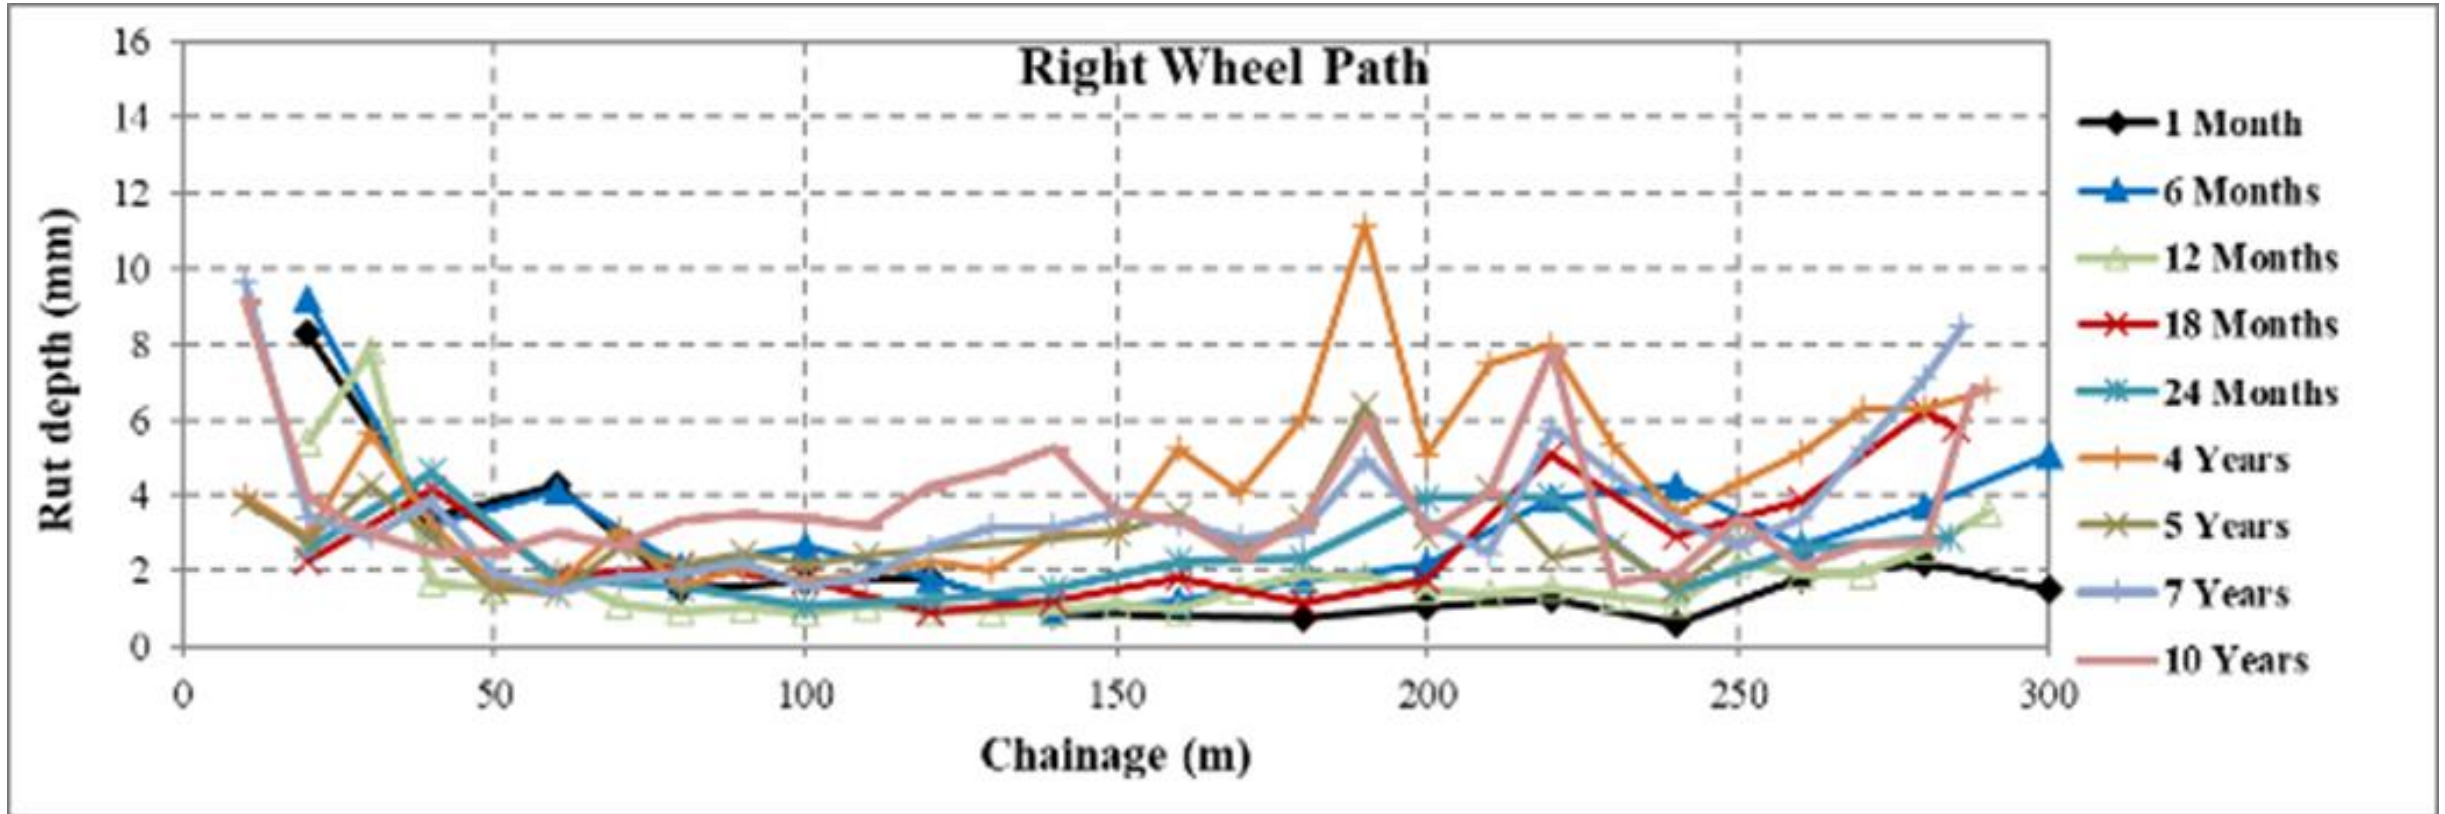
- Increasing rut trend on isolated locations

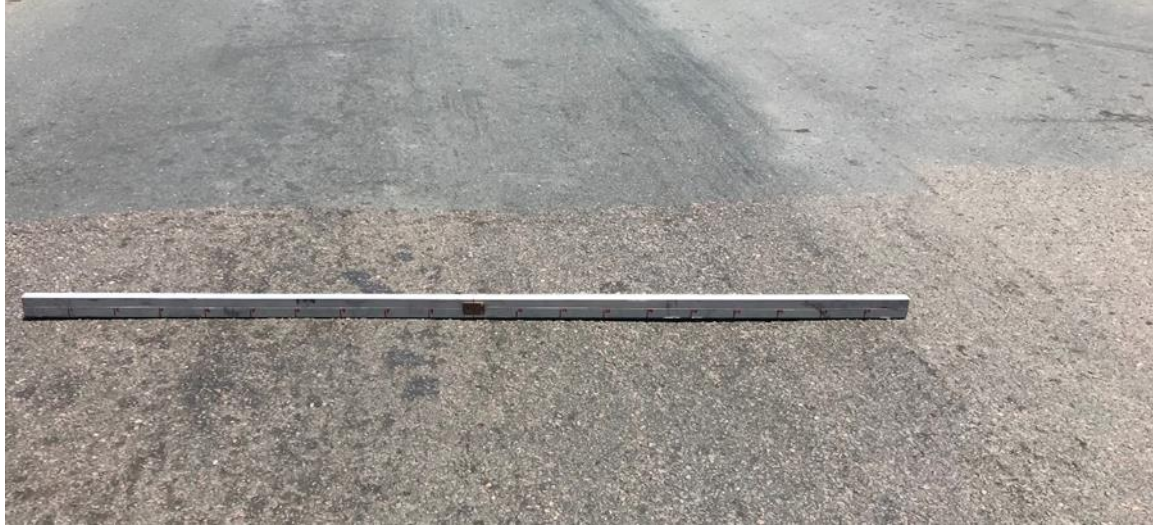
EME – Insignificant rutting

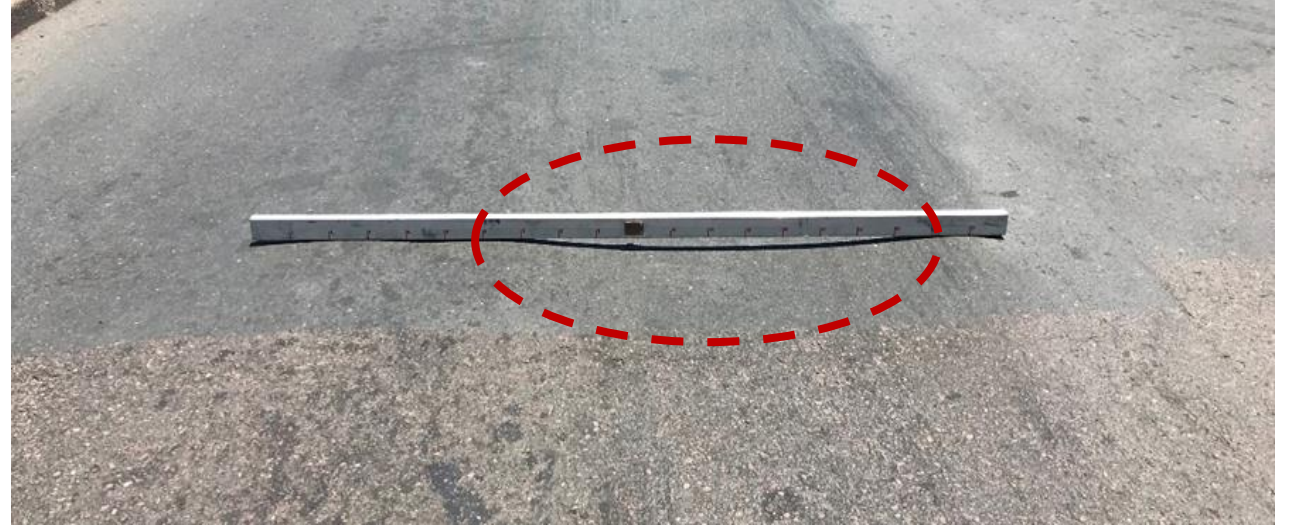
Conventional asphalt – significant rutting
