CITY OF CAPE TOWN & SABITA

PROGRESS OF THE GREY WATER STUDY

32nd ROAD PAVEMENT FORUM

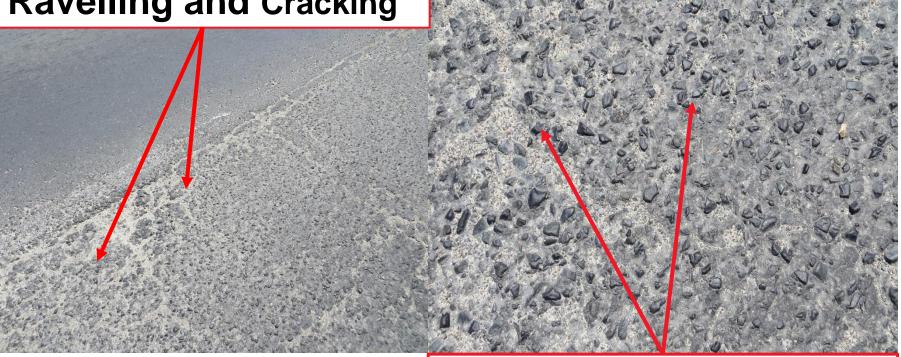
SURFACING DISTRESSES

Ravelling and Cracking

Loss of Filler & Small **Fractions**

- What did we find?
- Identified failure mechanisms
 - Mastic , Stone and Bitumen Loss
 - (Adhesion & Cohesion)
 - Ravelling
 - Cracking
 - Patches
 - Pavement Failure

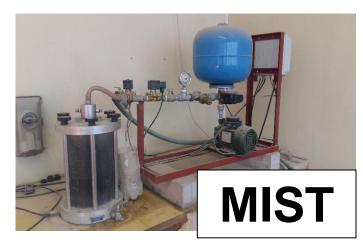
- MIST conditioning Clean and grey water at 60°C
- MMLS3 trafficking 100 000 dry and wet load cycles at 40°C
- Grey water concentration 0.5% Sunlight[®] liquid + 0.5% OMO[®] laundry detergent per 100 litres of clean water
