# Revision of the South African Pavement Design Method Phase 3

Project SAPDM/D-3: Stabilised Material

# R35 Bethal - Objectives

- FWD deflection recorded on all sections up to Aug 2014
- Detail investigation during April 2014
  - Not full 2 year service – assess condition after relatively wet summer
  - Sections revisited
    - 1) 200 C3(2) SB
    - 2) 200 ETB2 SB
    - 3) 200 FTB2 SB
    - 4) 200 FTB1 km 22
    - 5) 200 FTB1 km 30

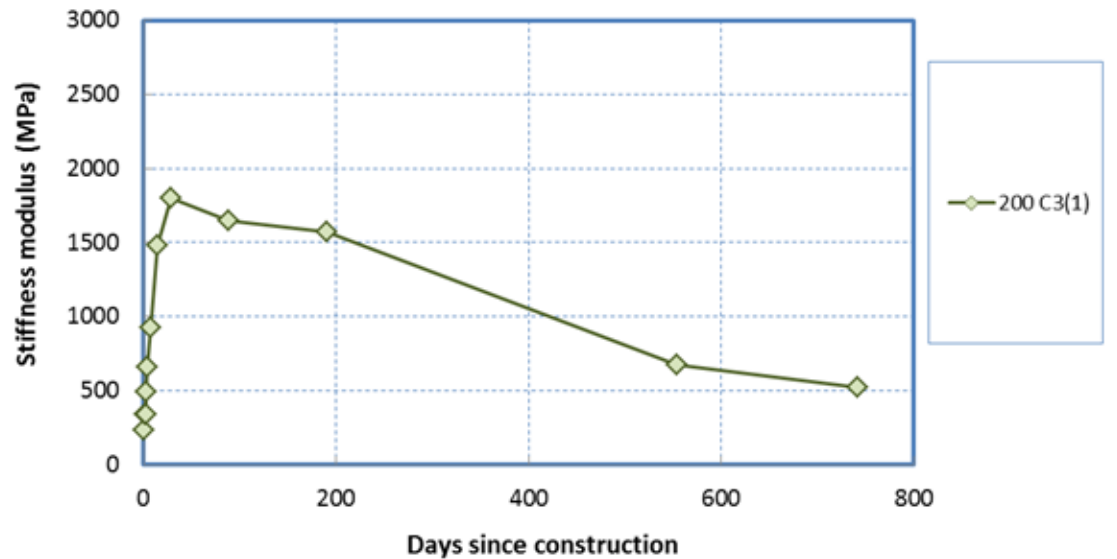
**Northbound**

**Base Modulus  
Cement-treated sections**

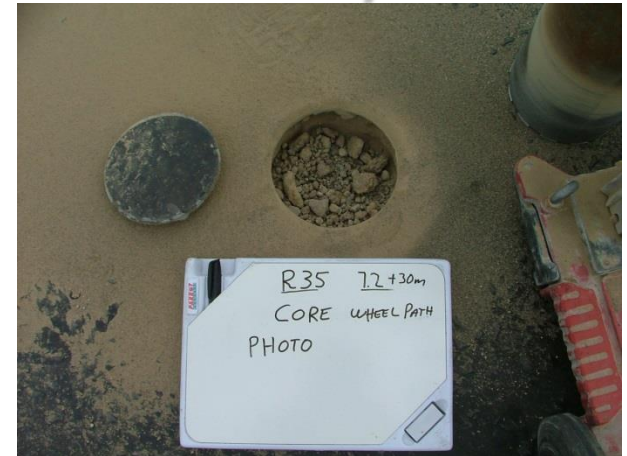
# Comparison with design – Cemented crushing

- Design estimate of area affected by crushing after 1 meSA
  - Asphalt surfacing – 10 %
  - Cape seal – 30 %

- Very difficult to determine extent but some crushing may have been observed at core locations on cape seal sections
