# Revision of the South African Pavement Design Method

## SAPDM: Environmental Monitoring

Project SAPDM/E-1

P Paige-Green

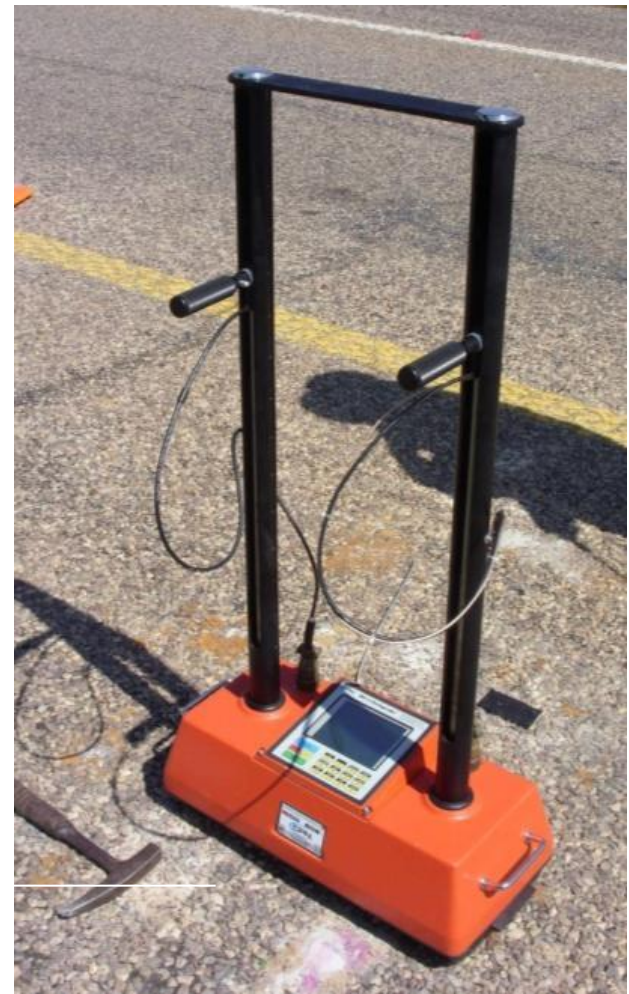
# Stratagauge

- ± Once every 5 weeks (between 4 & 19 times)
- Moisture content & wet density using Stratagauge
- Temperature buttons

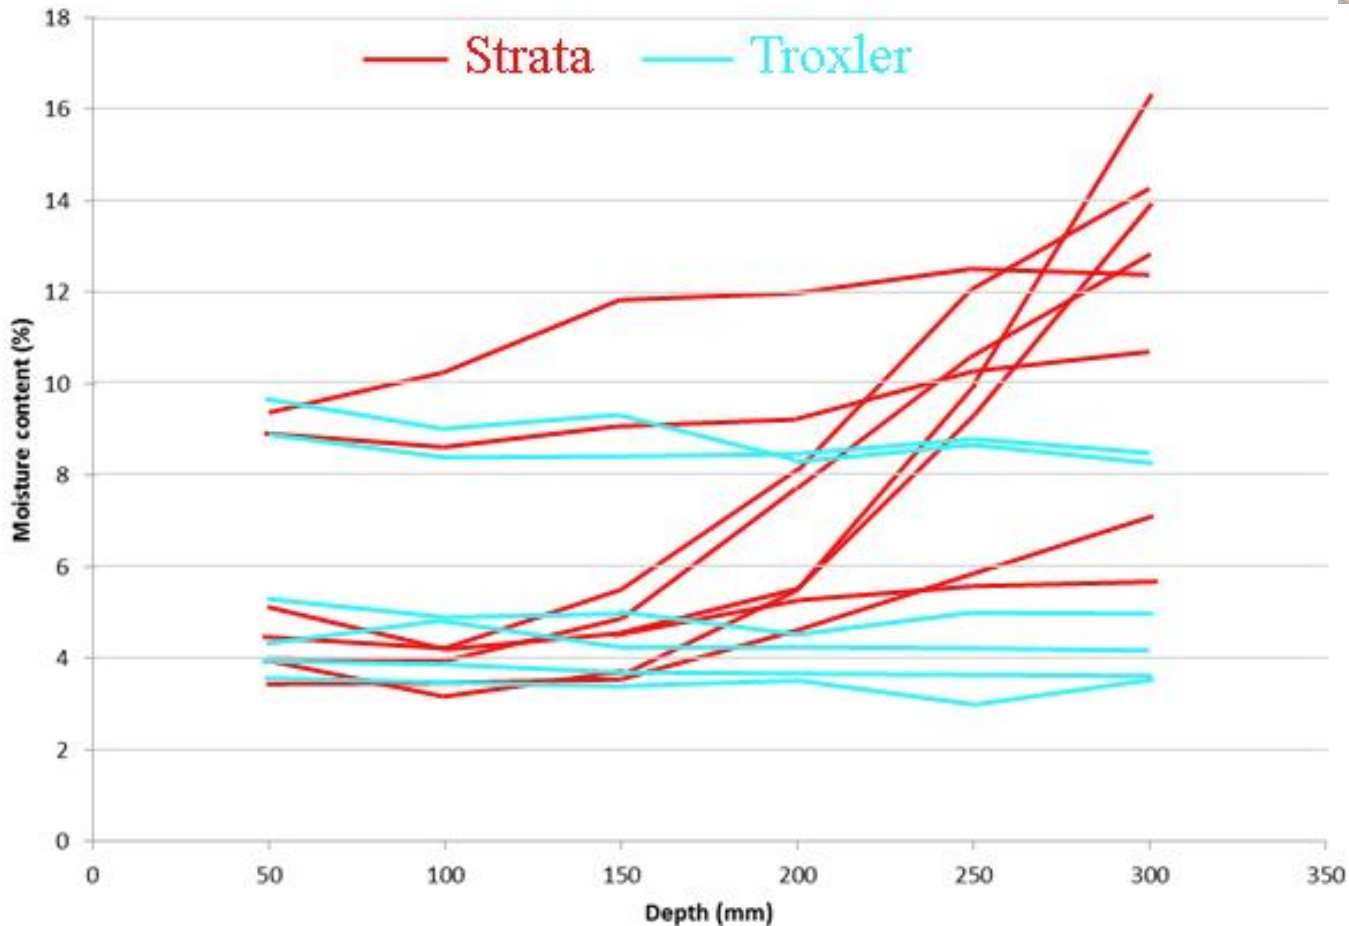
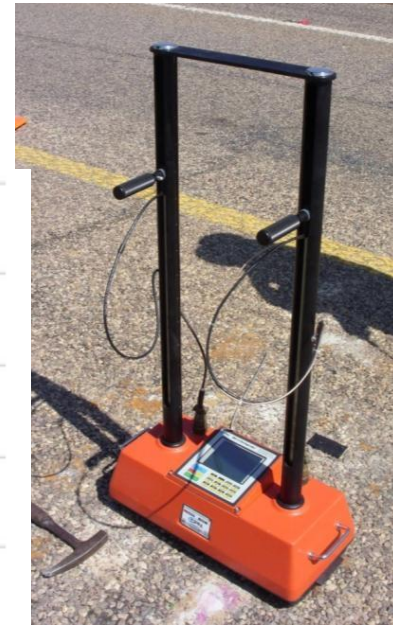
- Poor correlation between Troxler & StrataGauge
- Also at R35
- Compared results

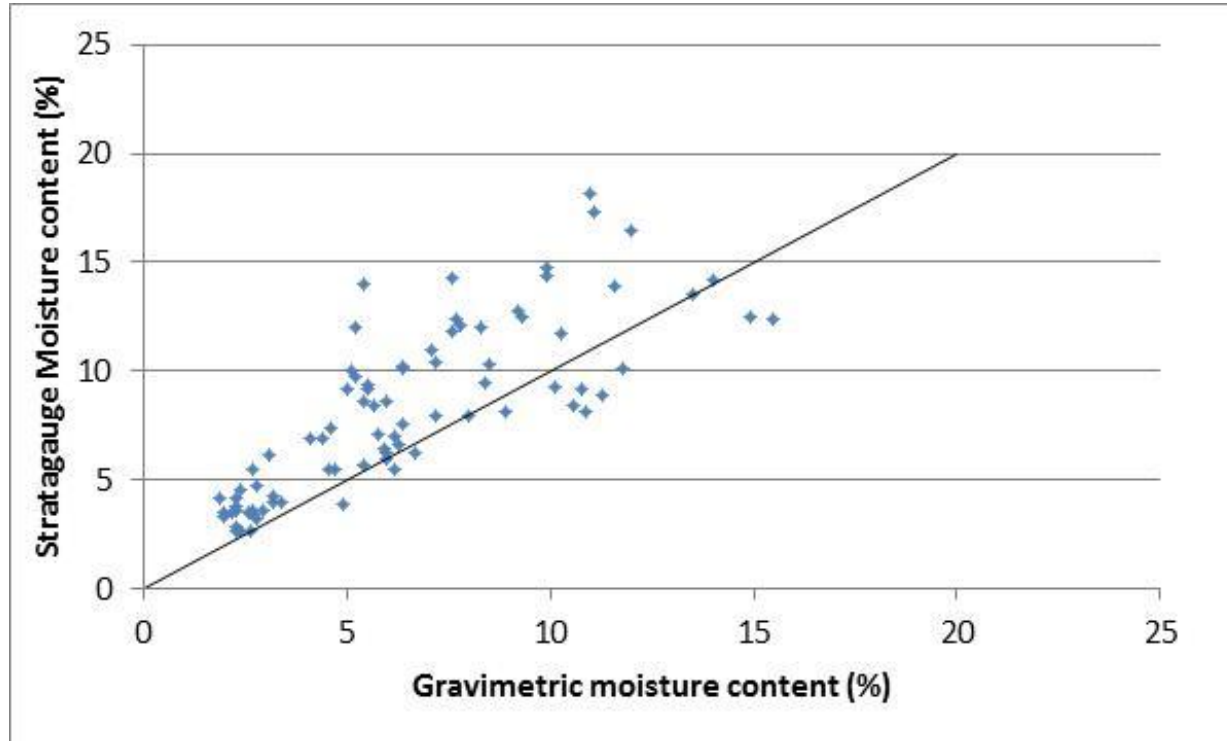
- Depth of measurement (mm) =  $280 - (0.27m)$

where  $m$  = moisture in  $\text{kg/m}^3$

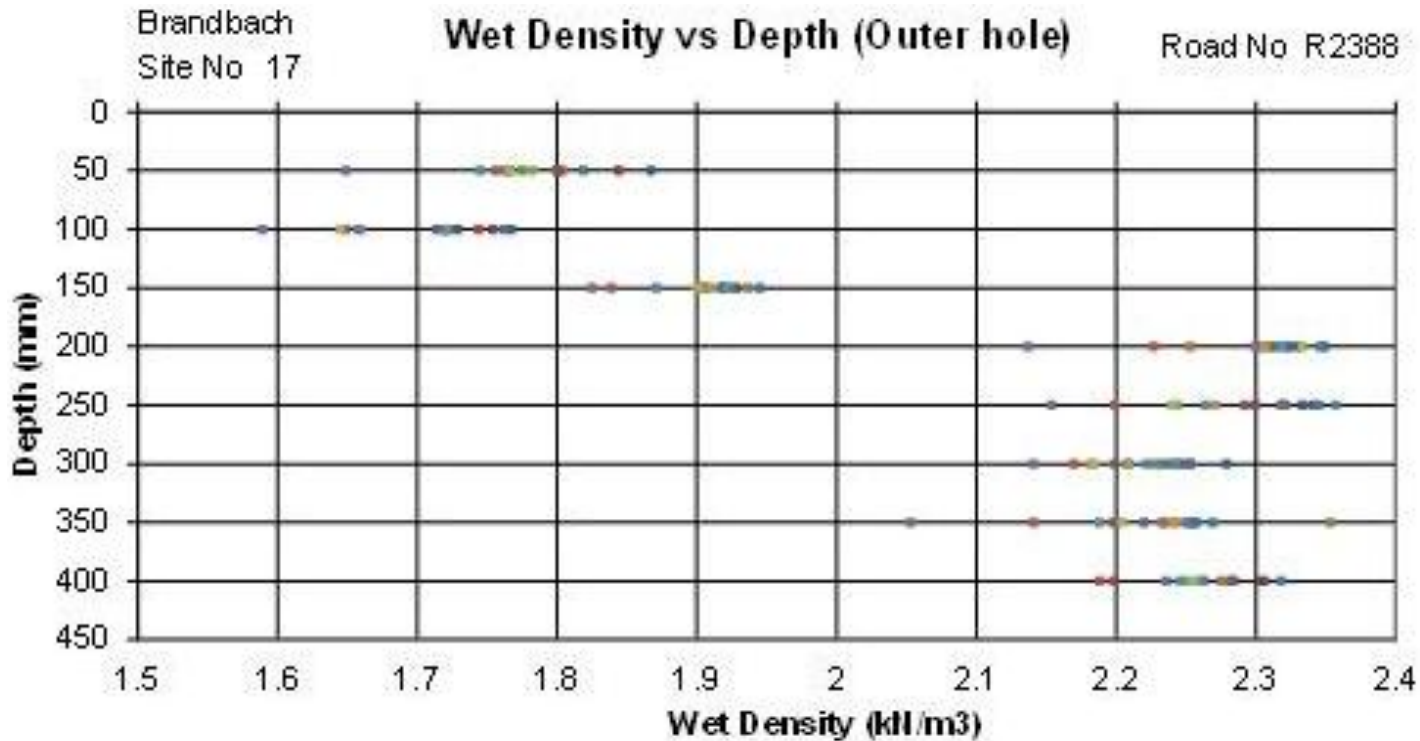
- Results (outer holes)
  - Strong trends
    - Expected variation
    - Related to seasonal moisture variation

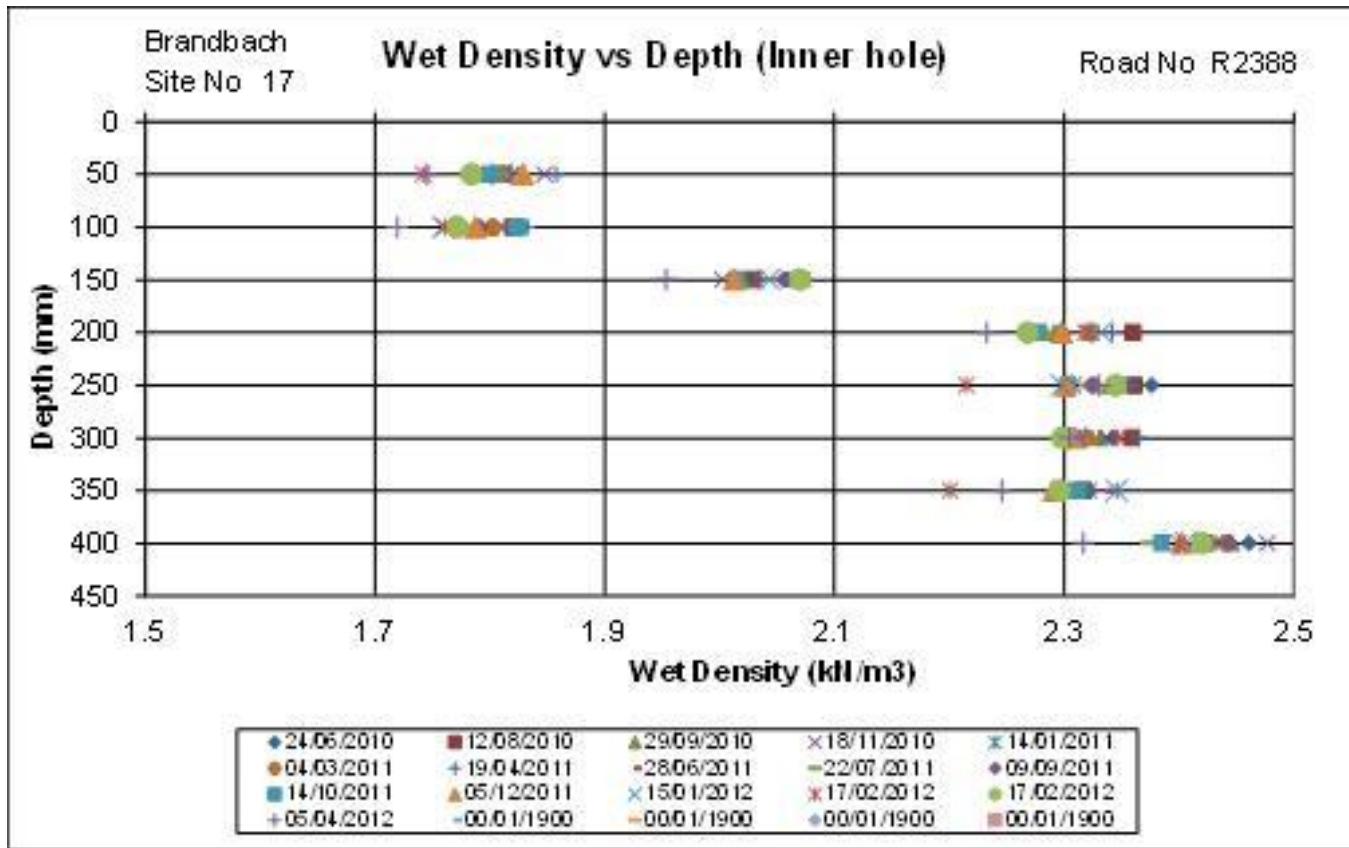
- Results (inner hole)
  - Strong trends
    - Variation is less
    - Even so, more than expected 1500 mm from edge of seal

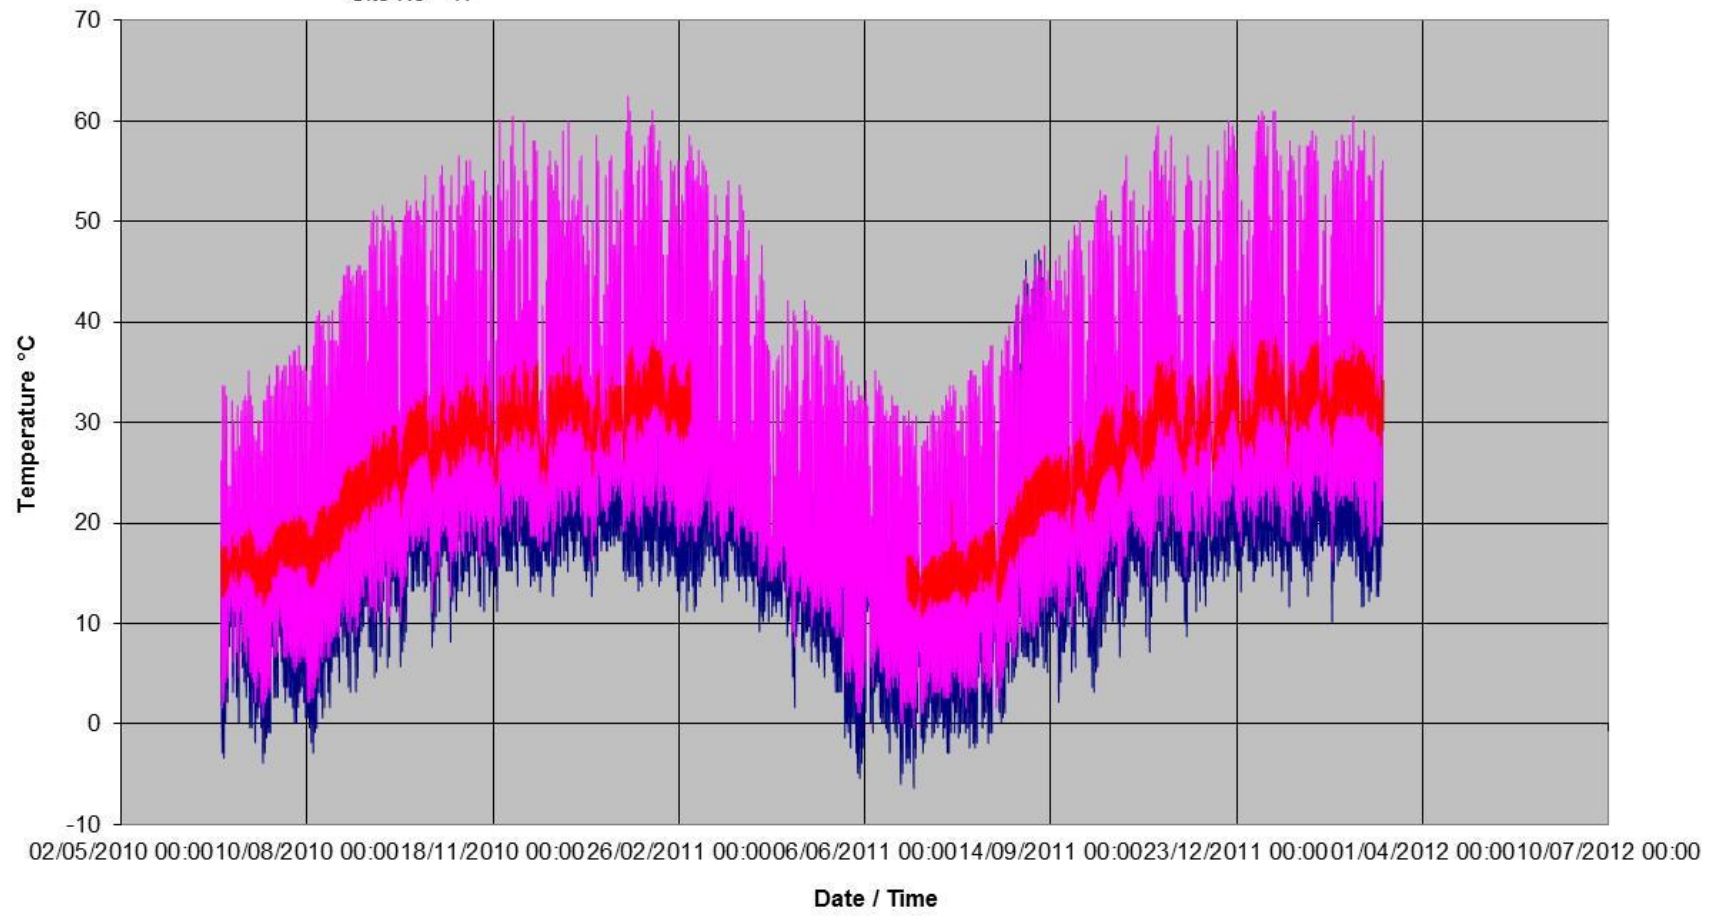
Brandbach  
Site No 17

## Temperature Measurements

— Air — Top — Bottom

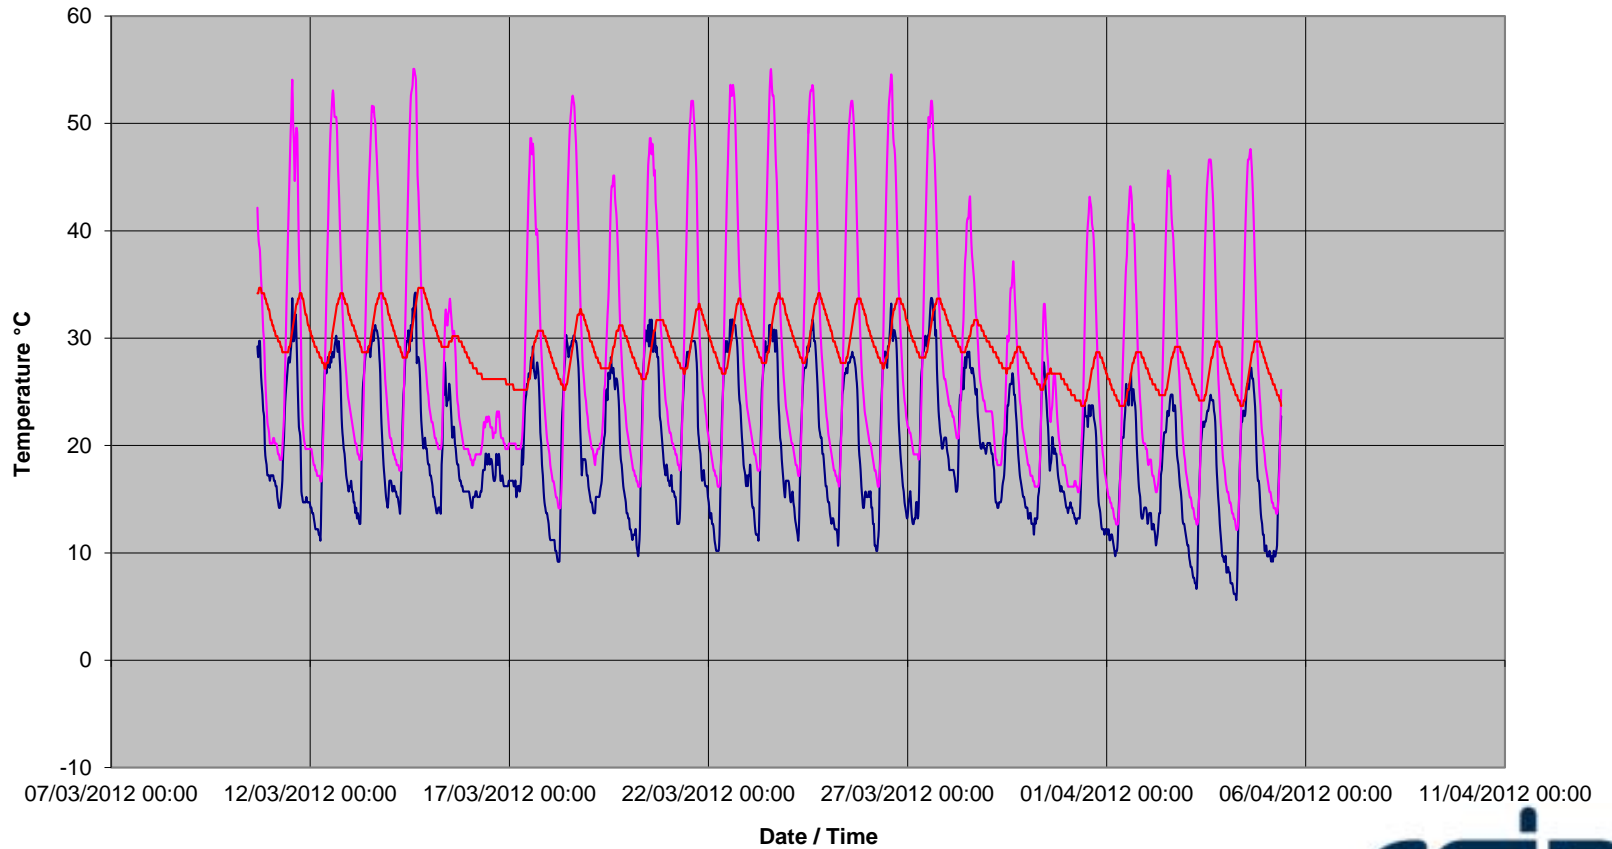
Brandbach  
Site No 17

## Temperature Measurements

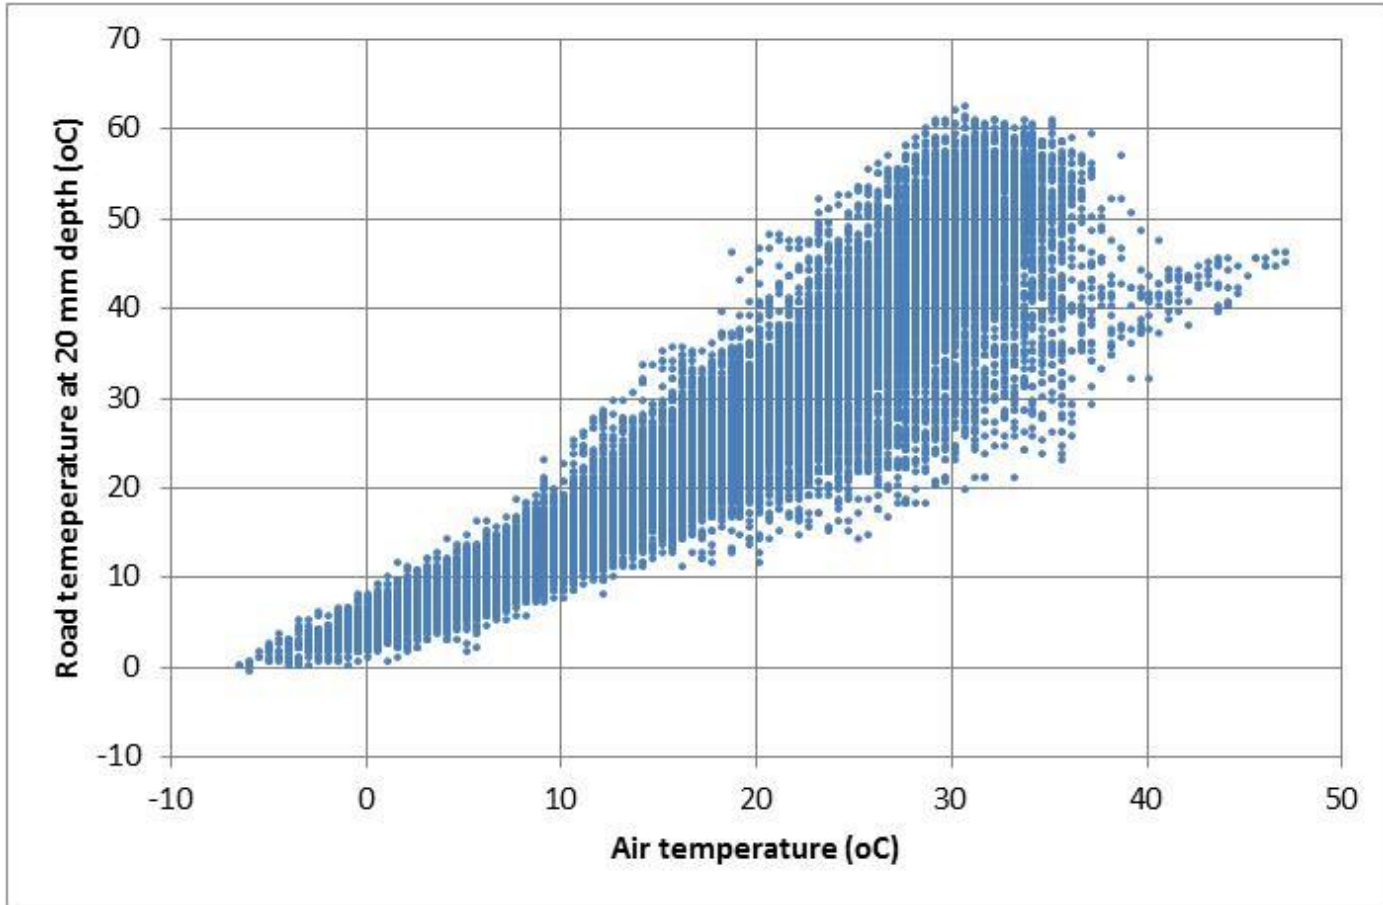
# Temperature (air and road "surface")
