Overview of Ben Schoeman CRCP Accelerated Pavement Test

Eben de Vos
9 November 2011
CSIR International Convention Centre,
Pretoria

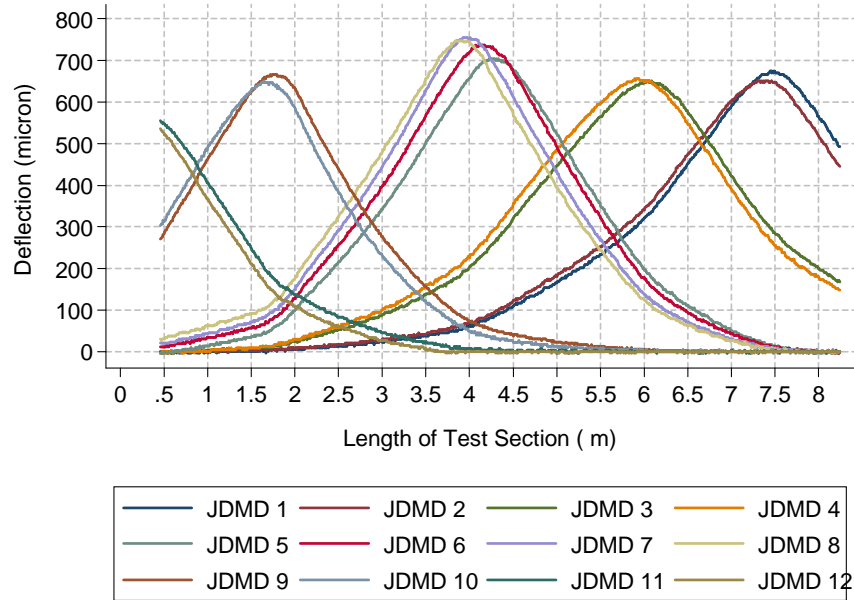
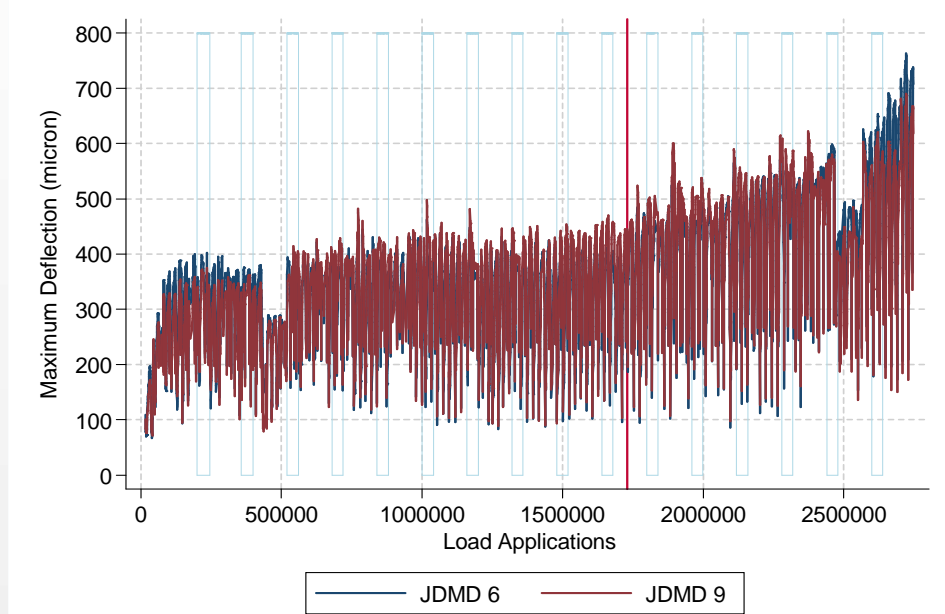
3.1.1 Surface Deflection

Deflection profiles under dynamic loading

Deflection at all load levels, including standard test loads

Vertical line – 1.73 mil improved load from 80 kN to 100 kN

Visible variation due to twice daily standard test loads of 40 kN

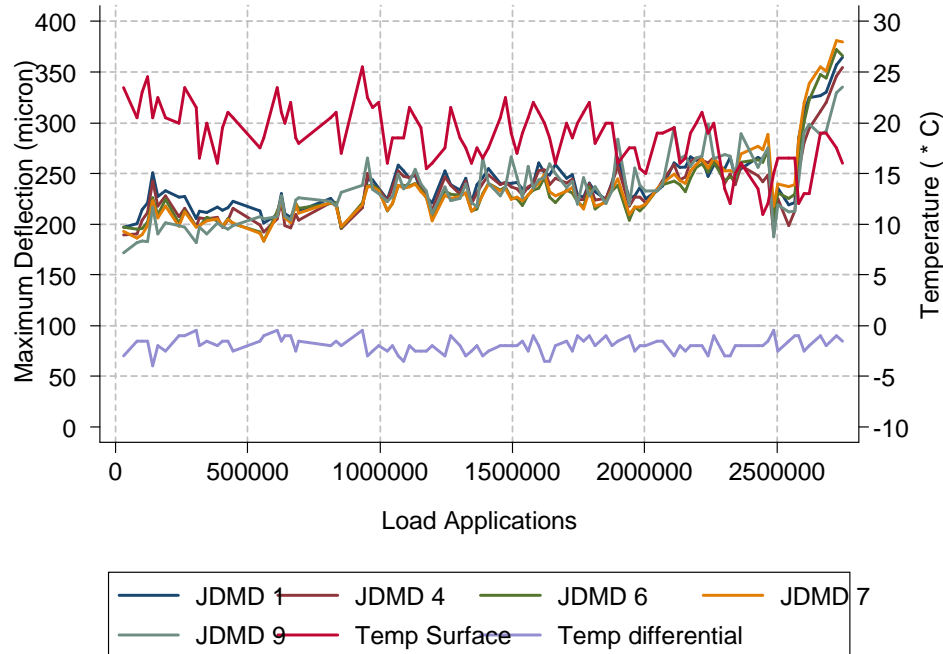
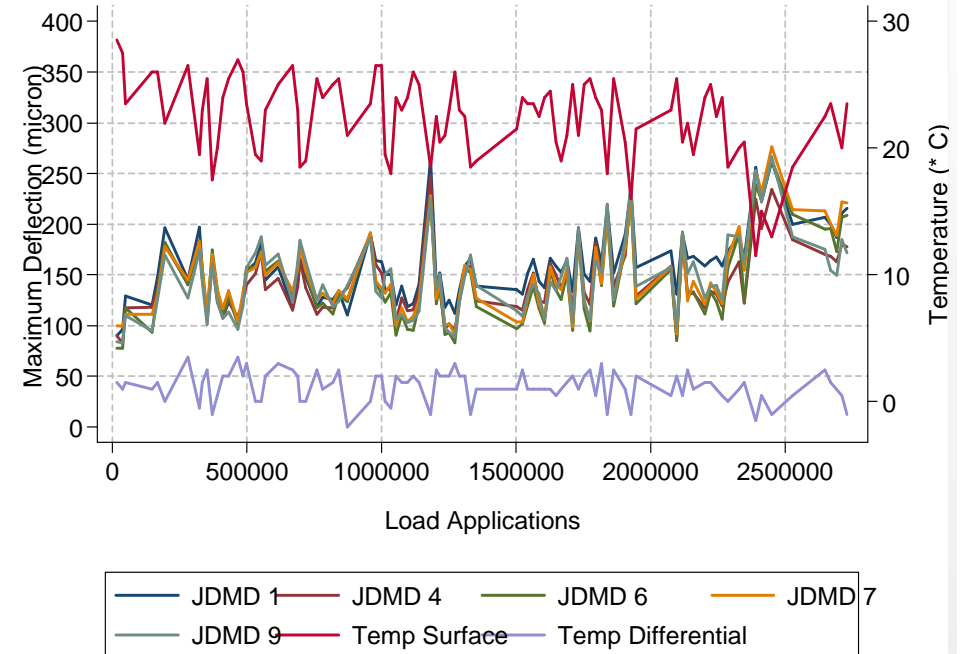
3.1.2 Surface Deflection – 40 kN

0500 h

1300 h

Deflection under twice daily standard load – 40 kN

Note inverse relationship between temperature and deflection

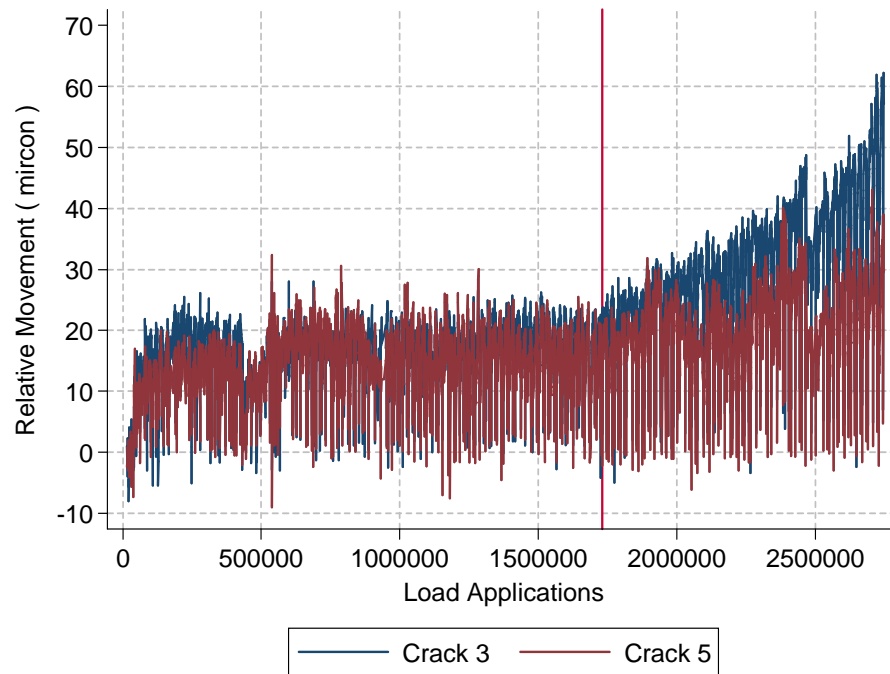
3.2.1 Relative Movement

Determined from JDMD deflection data

- When loading wheel was completely on one side of the crack
- Incorporated different tyre print sizes
- Variation is due to twice daily standard test loads

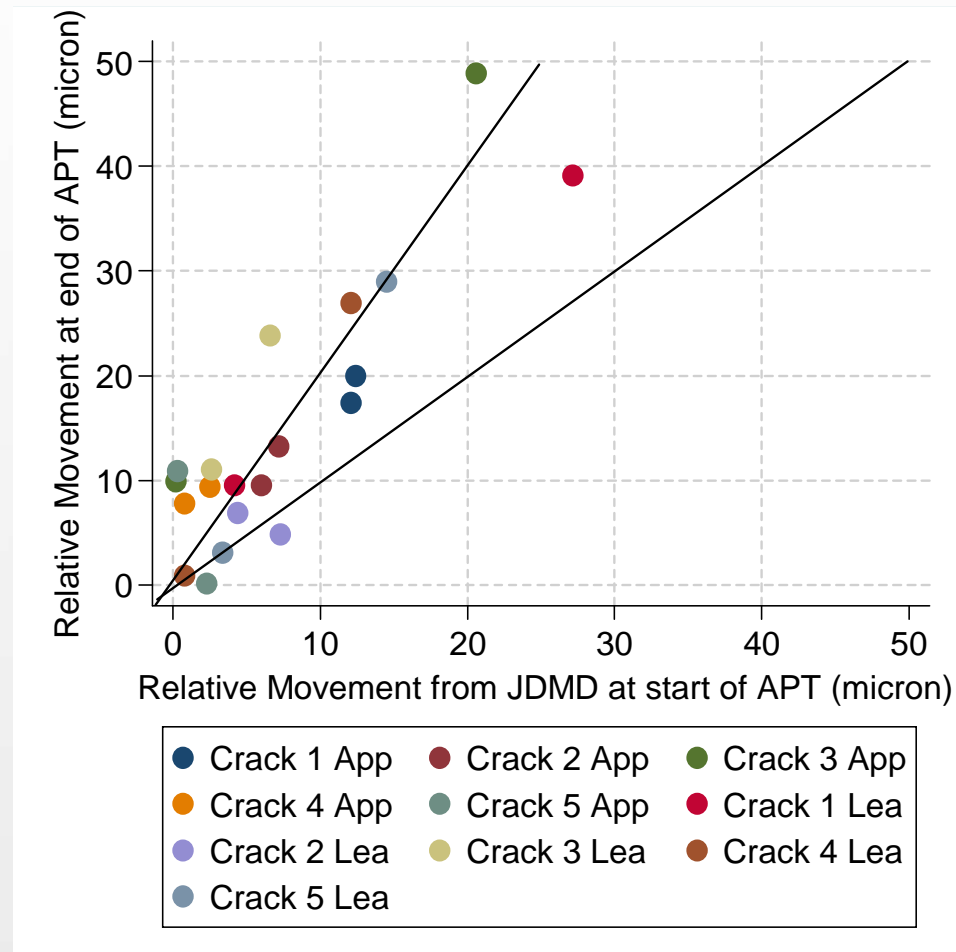
3.2.2 Relative Movement

- Comparison based on equivalent environmental conditions
- Average ratio between relative movement before and after = 2

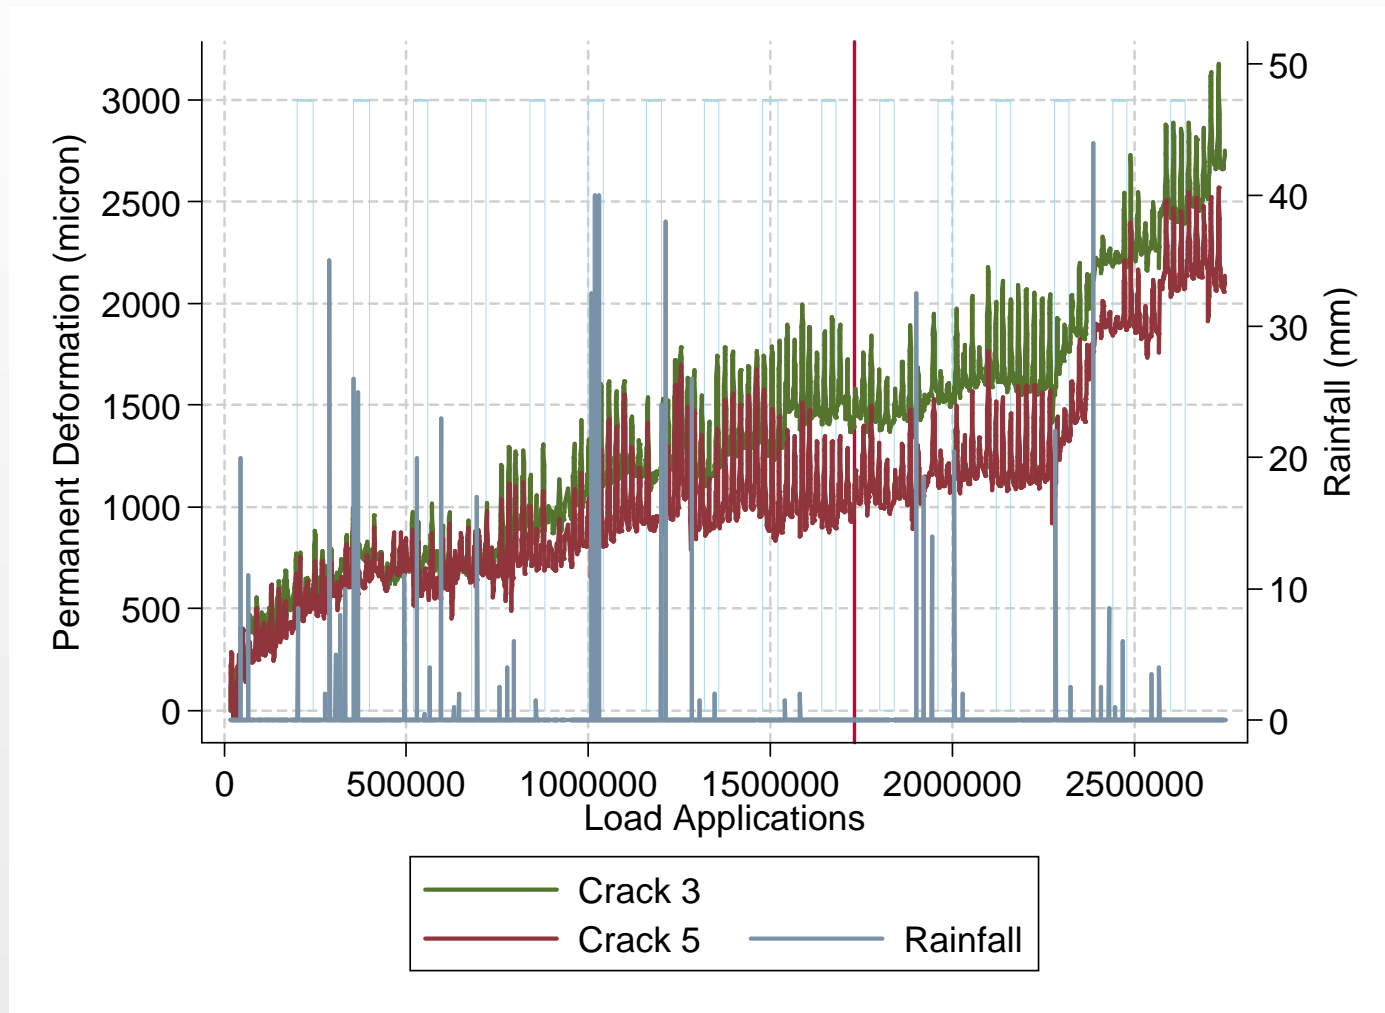
3.3.1 Permanent Deformation

➤ Cyclical nature: warping and curling caused by daily environmental fluctuations

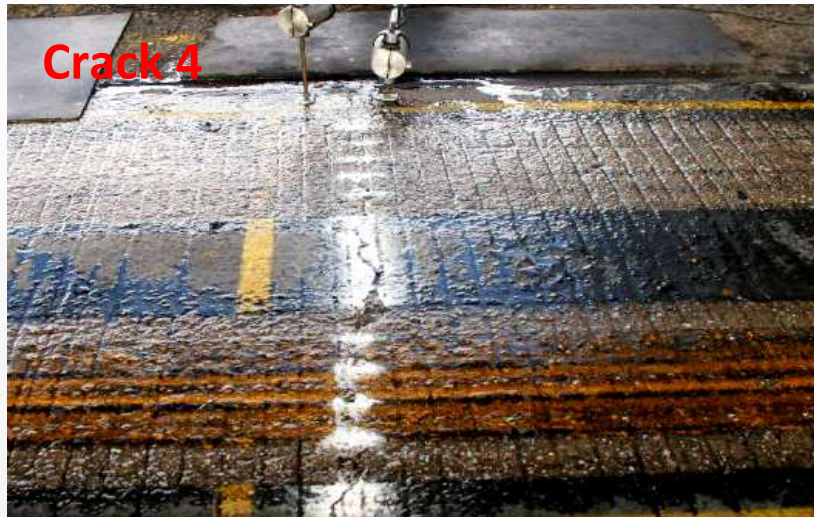
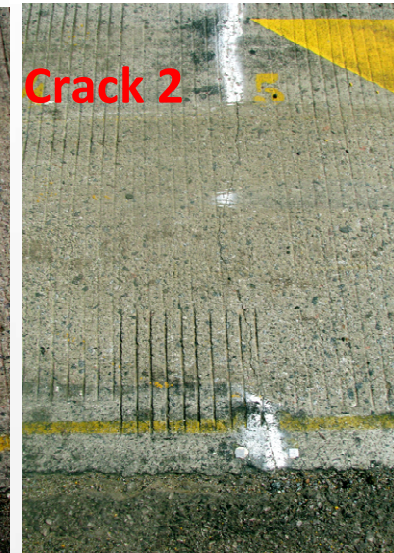
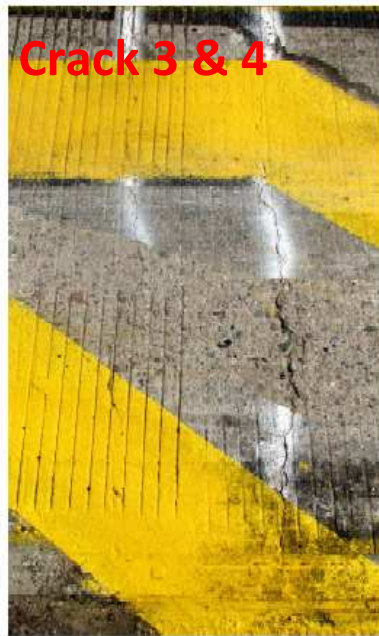
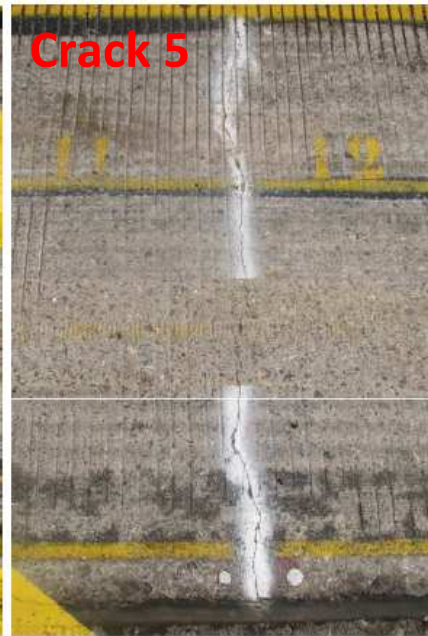
4.1 Visual Surface Evaluation

Spalling at Crack 4

Cracks 1,2,3 and 5 intact

No pumping of material

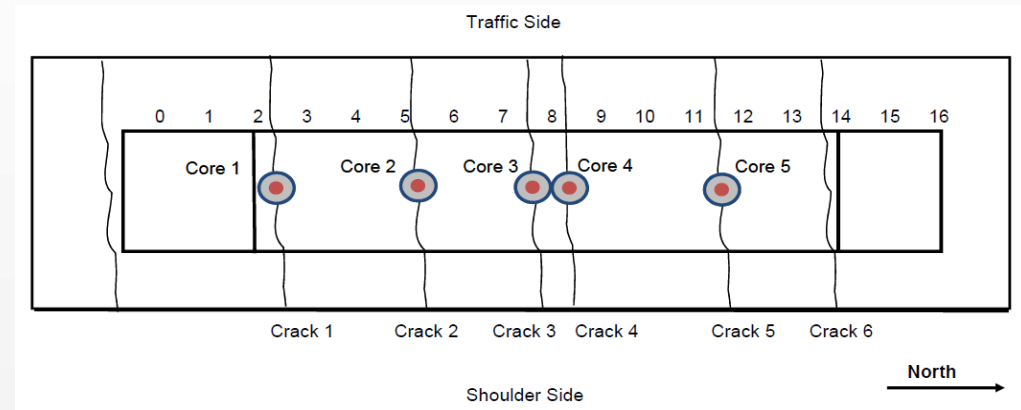
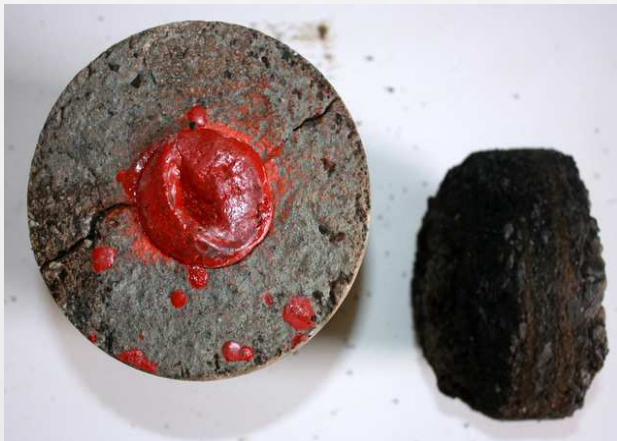
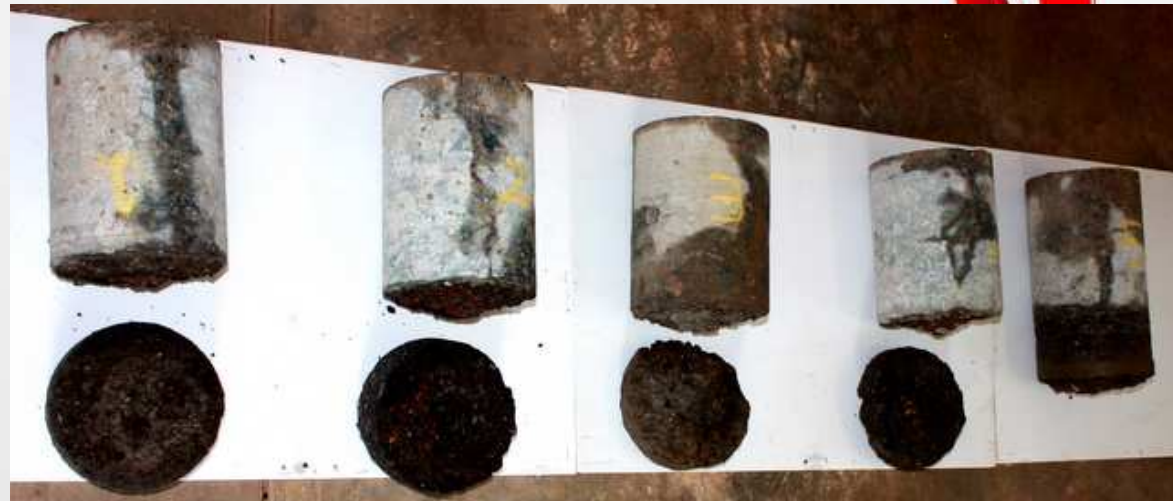
4.2 Diagnostic Investigation

Cores bisected the transverse cracks

- 50 mm core up to depth of 200 mm
- Filled with tinted epoxy
- 150 mm core up to 300 mm

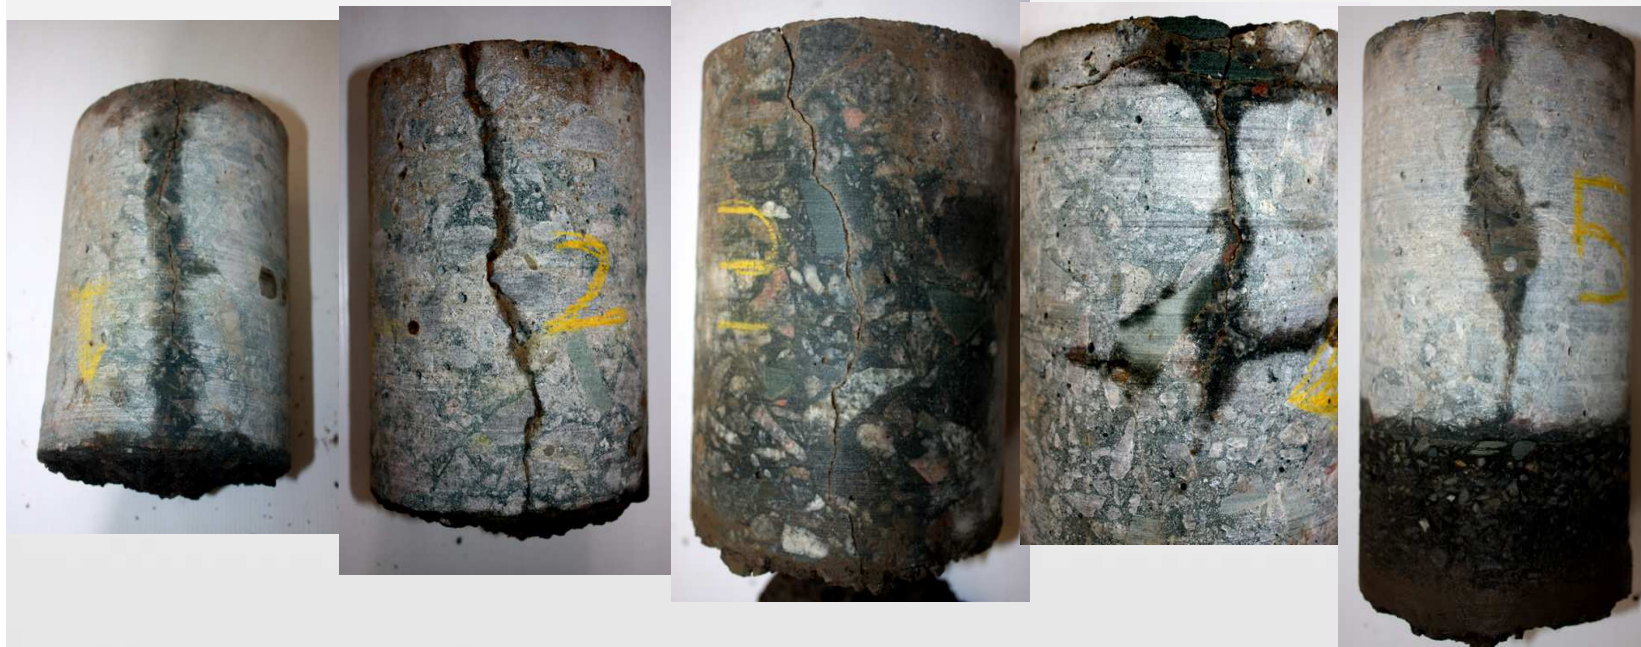
4.3 Diagnostic Evaluation: Crack Widths

Crack widths decrease with depth

Crack 3: greatest crack width

Crack 4: spalled crack

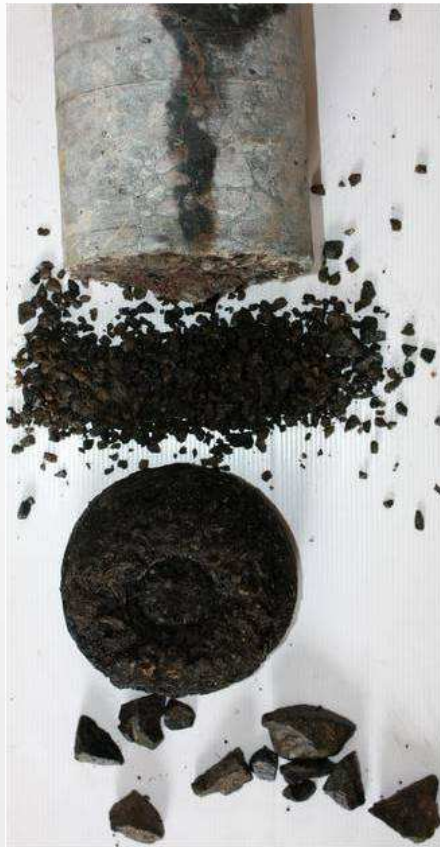
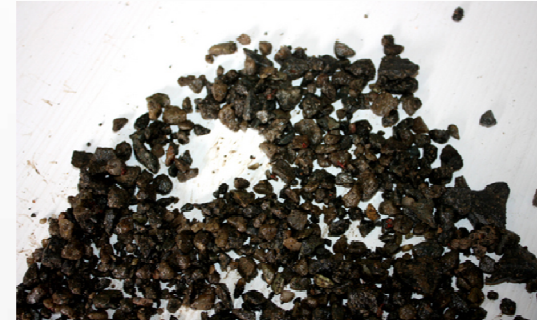
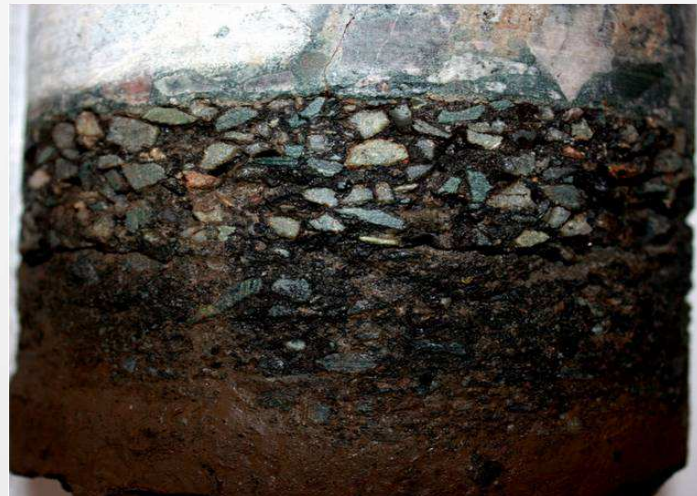
4.4 Diagnostic Evaluation: Interface

Deterioration of the CRC/HMA interface

- Stripping of the open-graded asphalt overlay
- Loss of fines, not visible at the surface

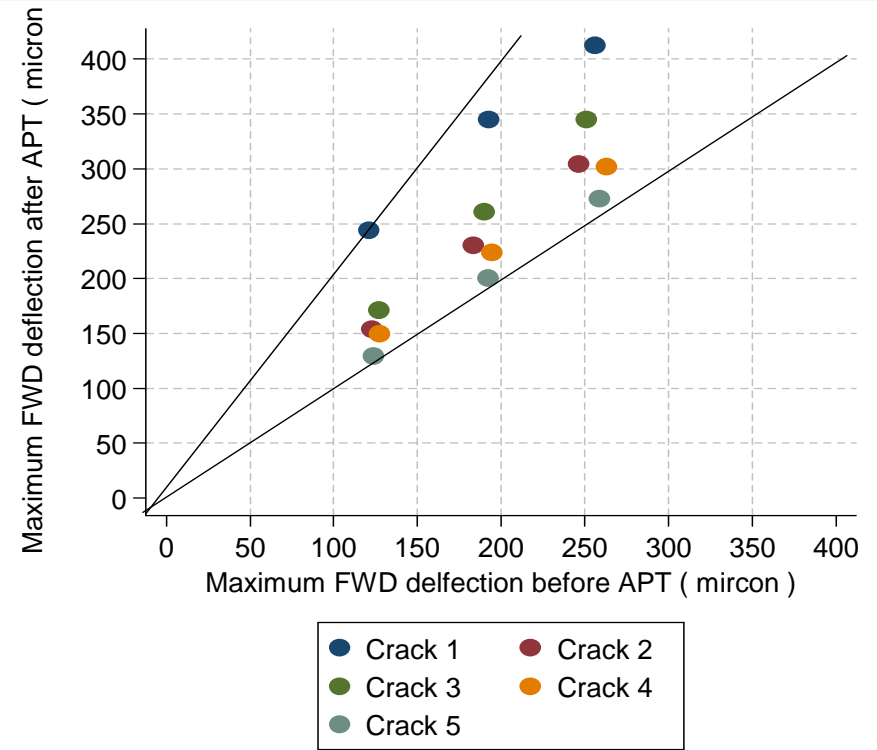
5.1 FWD Deflection

- FWD before and after APT
- Time Lapse between FWD after APT and HVS = 5 months
- Temperature and time of day comparable

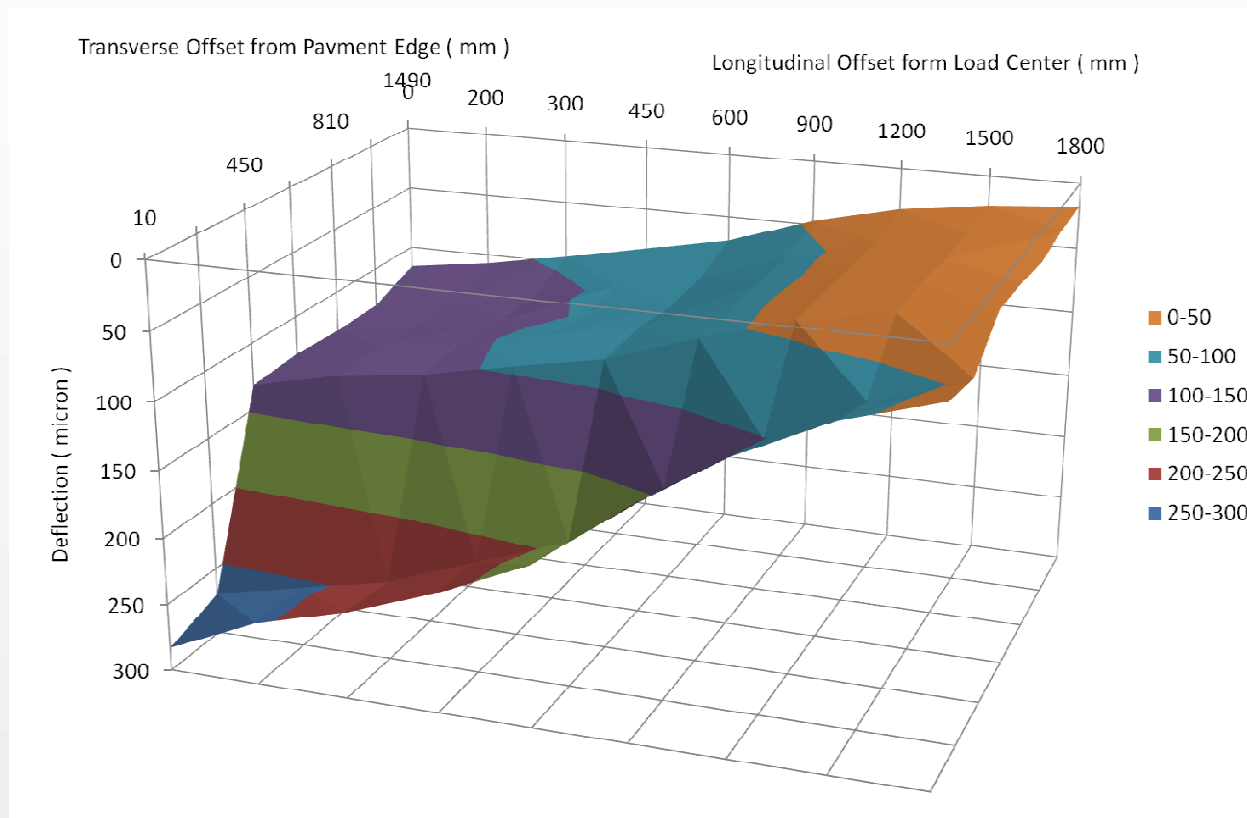
5.2 FWD: Edge Loading and Backcalculation

HVS = edge loading

FWD = internal loading

Modulus of subgrade reaction indicate test section condition:

- 20th percentile of N20/N21 before start of APT,
- 7th percentile after APT
