Roads Pavement forum 13-14 May 2009

Progress Report: Ultra Thin Reinforced Concrete Pavements: Field evaluation through accelerated pavement testing

Louw du Plessis

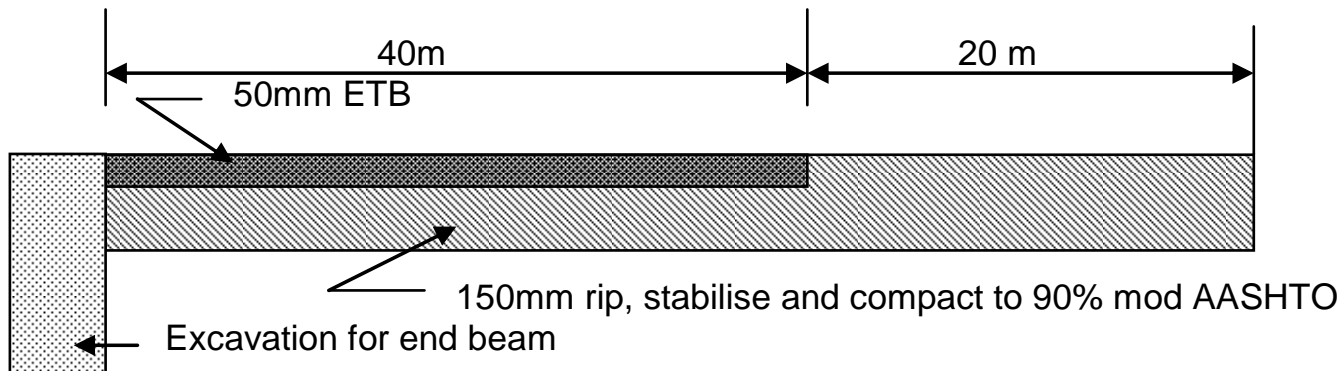
1. WEAK PAVEMENT

- Cut top 100mm to spoil
- Cut to line and level
- Rip insitu material 150mm deep, stabilise with 3% lime and compact to 90% Mod AASHTO at OMC
- Mill out 50mm of first 40 metres of lime stabilised base and construct 50mm ETB by labour and light plant as per Soshanguve specification
- Treat top of base with a 1:8 diluted emulsion broomed onto the surface.

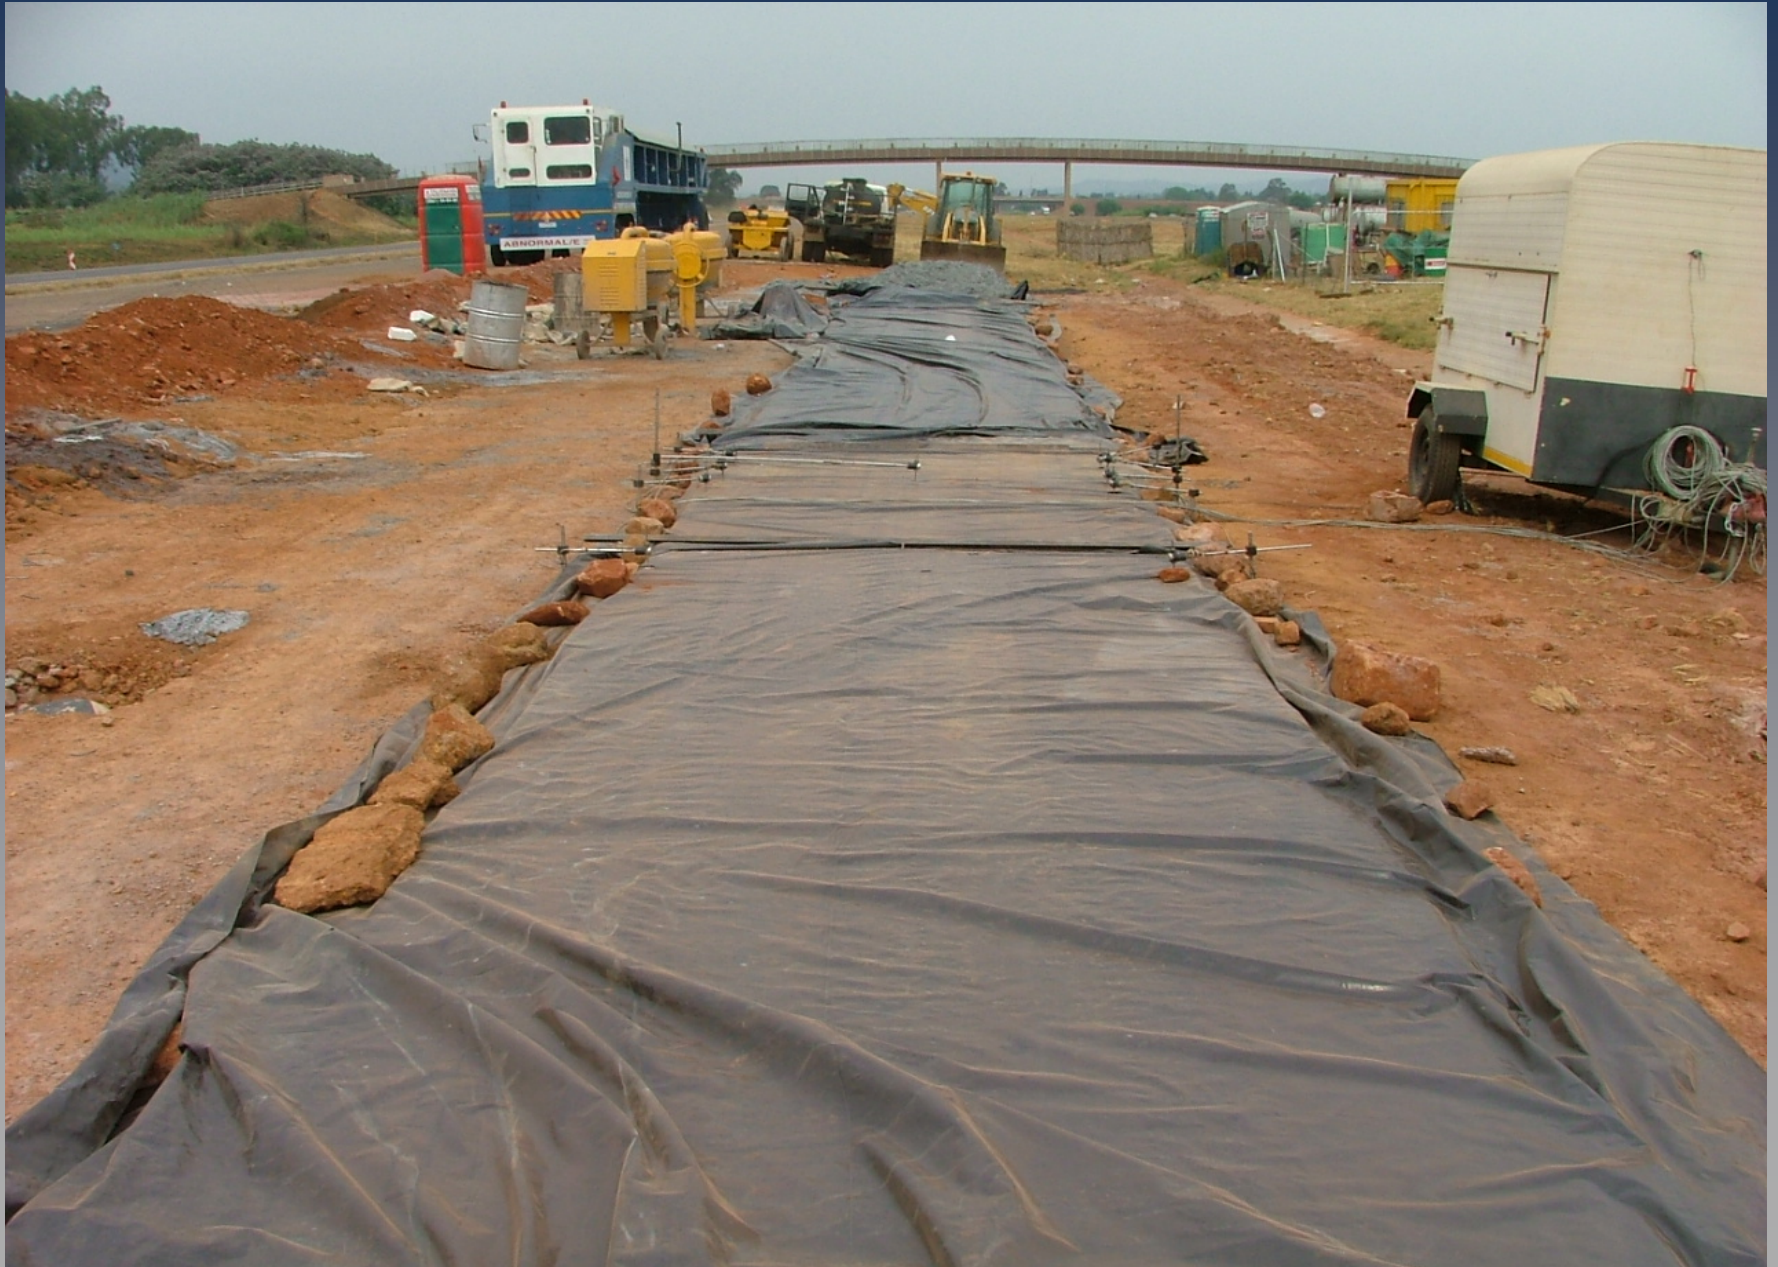
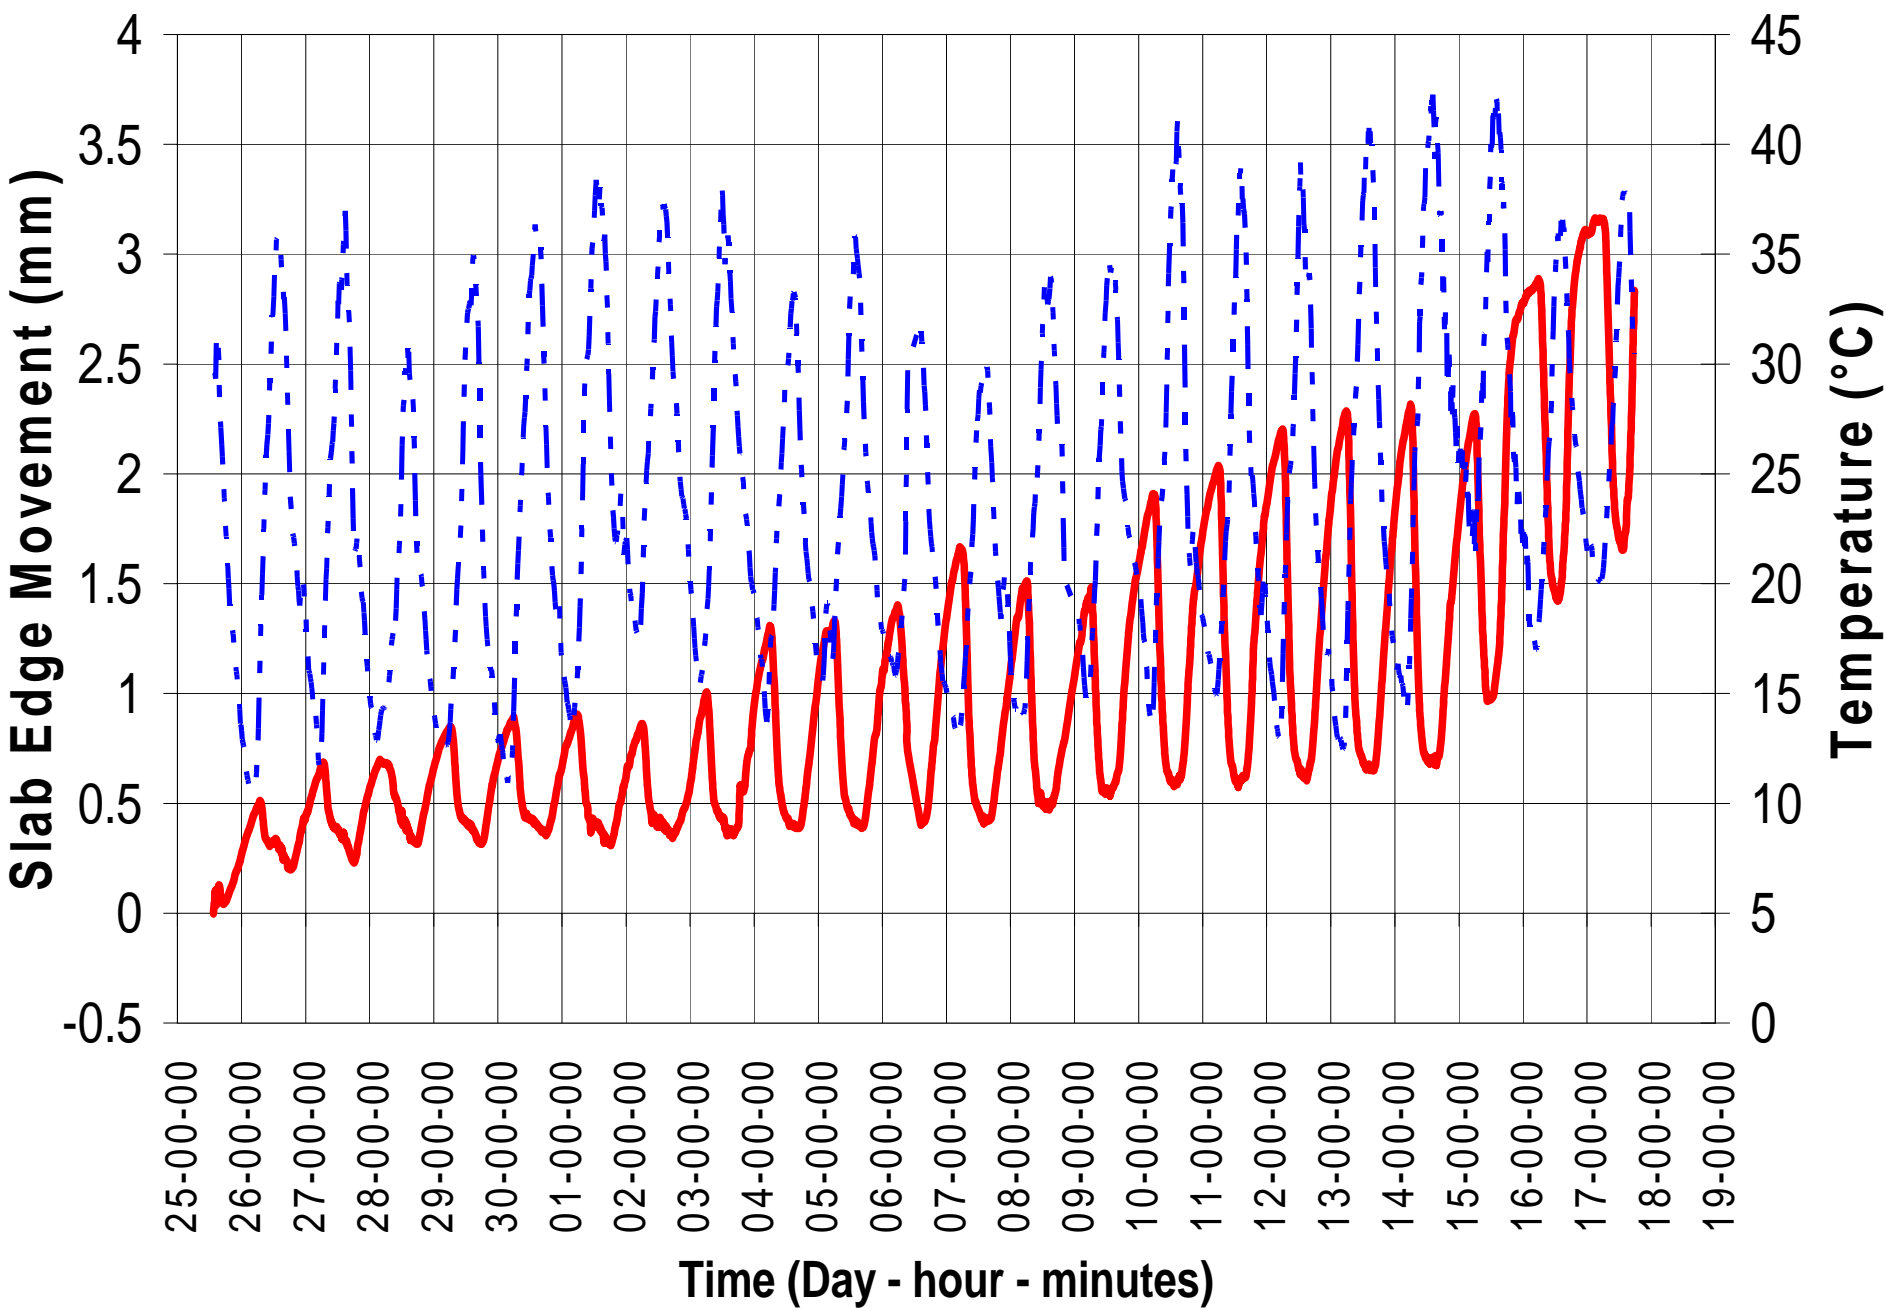
Environmental effects on slab curling and warping

Summary of slab edge movements due to environmental influences

Instrument	Permanent Warp (upward)	Daily Curl		Total daily elastic curling movement
	(mm)	up (mm)	down (mm)	(mm)
JDMD 10	2.30	0.80	0.70	1.50
Maximum surface temperature (Deg C)				42.40
Minimum surface temperature (Deg C)				10.50
Maximum positive temperature differential (top - bottom) (Deg C)				3.60
Maximum negative temperature differential (top - bottom) (Deg C)				-3.40
<p>The diagram illustrates the slab edge movements. It shows a cross-section of a slab with a vertical line on the left representing the edge. Three curves are plotted: a blue curve (top surface), a black curve (bottom surface), and a red curve (neutral axis). The blue curve shows a maximum upward movement of 2.30 mm at the edge, which decreases to zero at a distance of 3.1 m. The black curve shows a maximum downward movement of 1.60 mm at the edge, which also decreases to zero at 3.1 m. The red curve shows a maximum downward movement of 0.80 mm at the edge, which decreases to zero at 3.1 m. The total daily elastic curling movement is 1.50 mm. The diagram also shows the maximum positive temperature differential of 3.60 Deg C and the maximum negative temperature differential of -3.40 Deg C.</p>

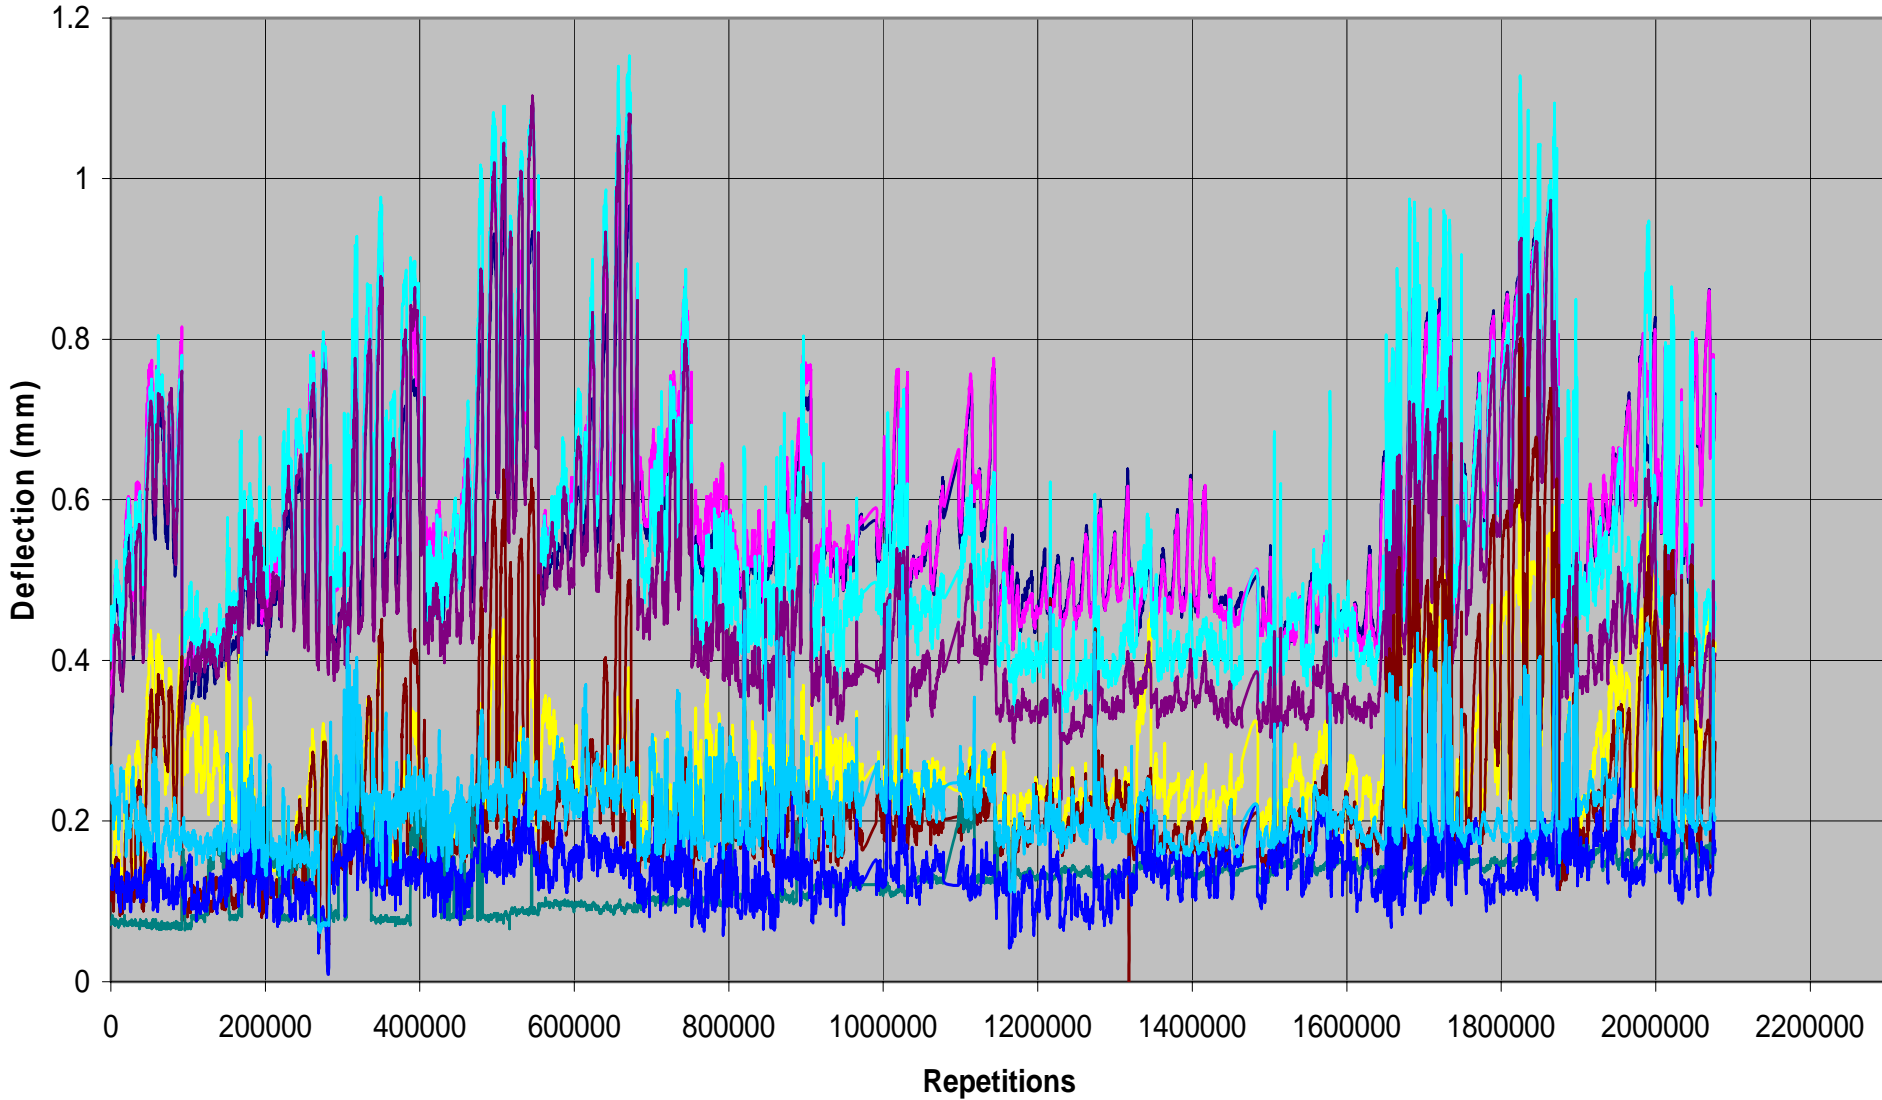
DEFLECTIONS OF JDMD'S SECTION 457A5 (cracked)

Weak Concrete Section

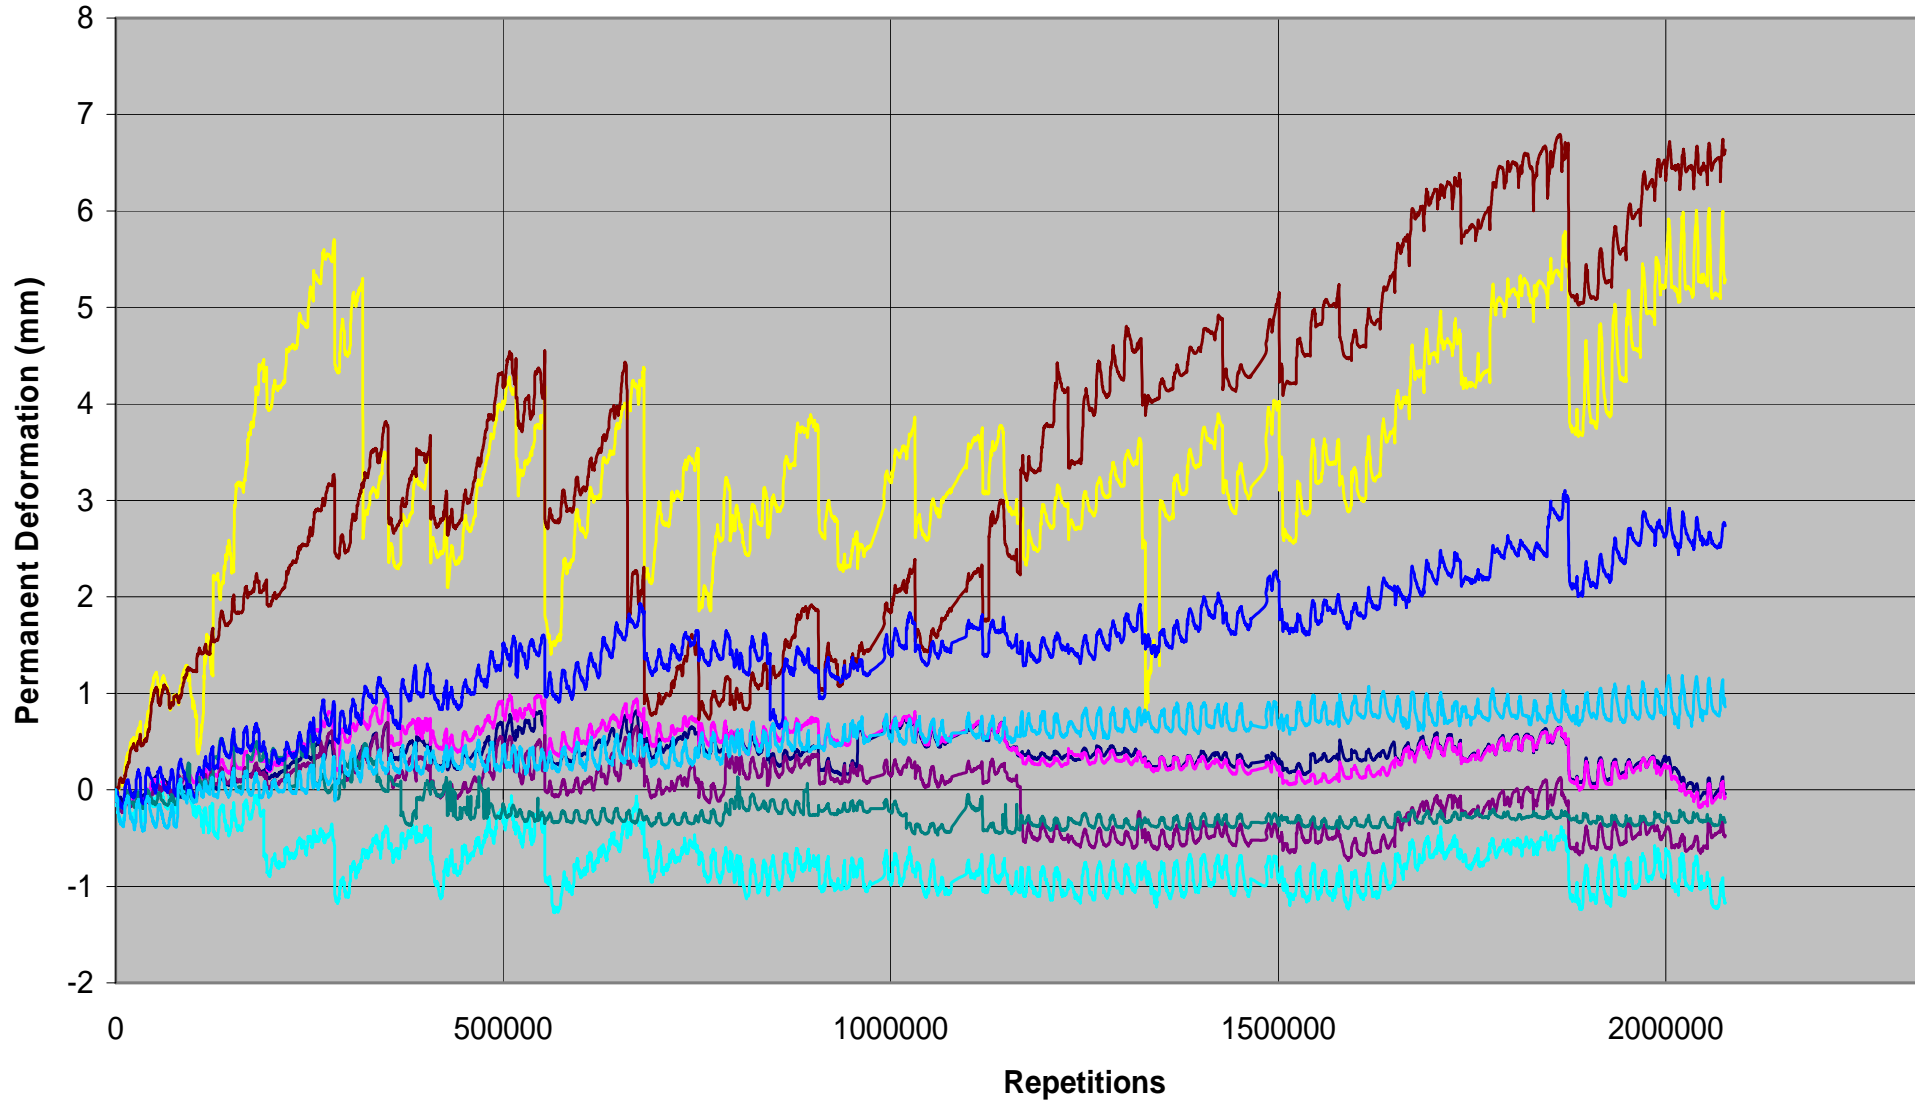
PERMANENT DEFORMATION OF JDMD'S SECTION 457A5 (crack)

Weak Concrete Section

Failure: 2 346 920 Reps (3rd water Cycle)

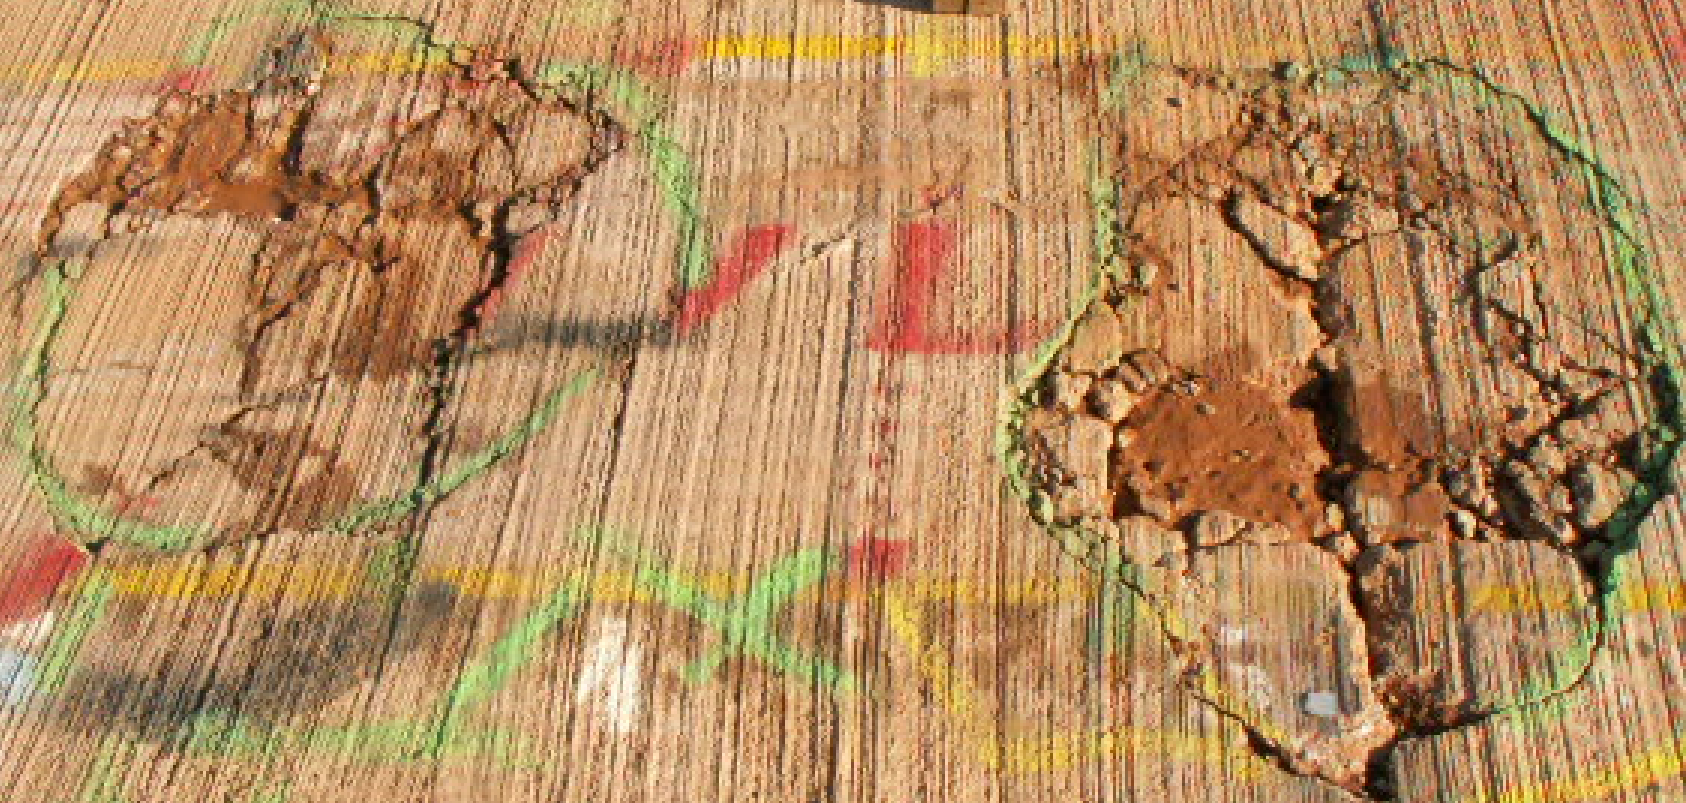
SEC : 407A5
REPS : 2346920
DATE : 16-04-2009
TIME : 10:00
LOAD : 40KN
POINT : End of 3rd cycle
STATUS : Failed (Fract)

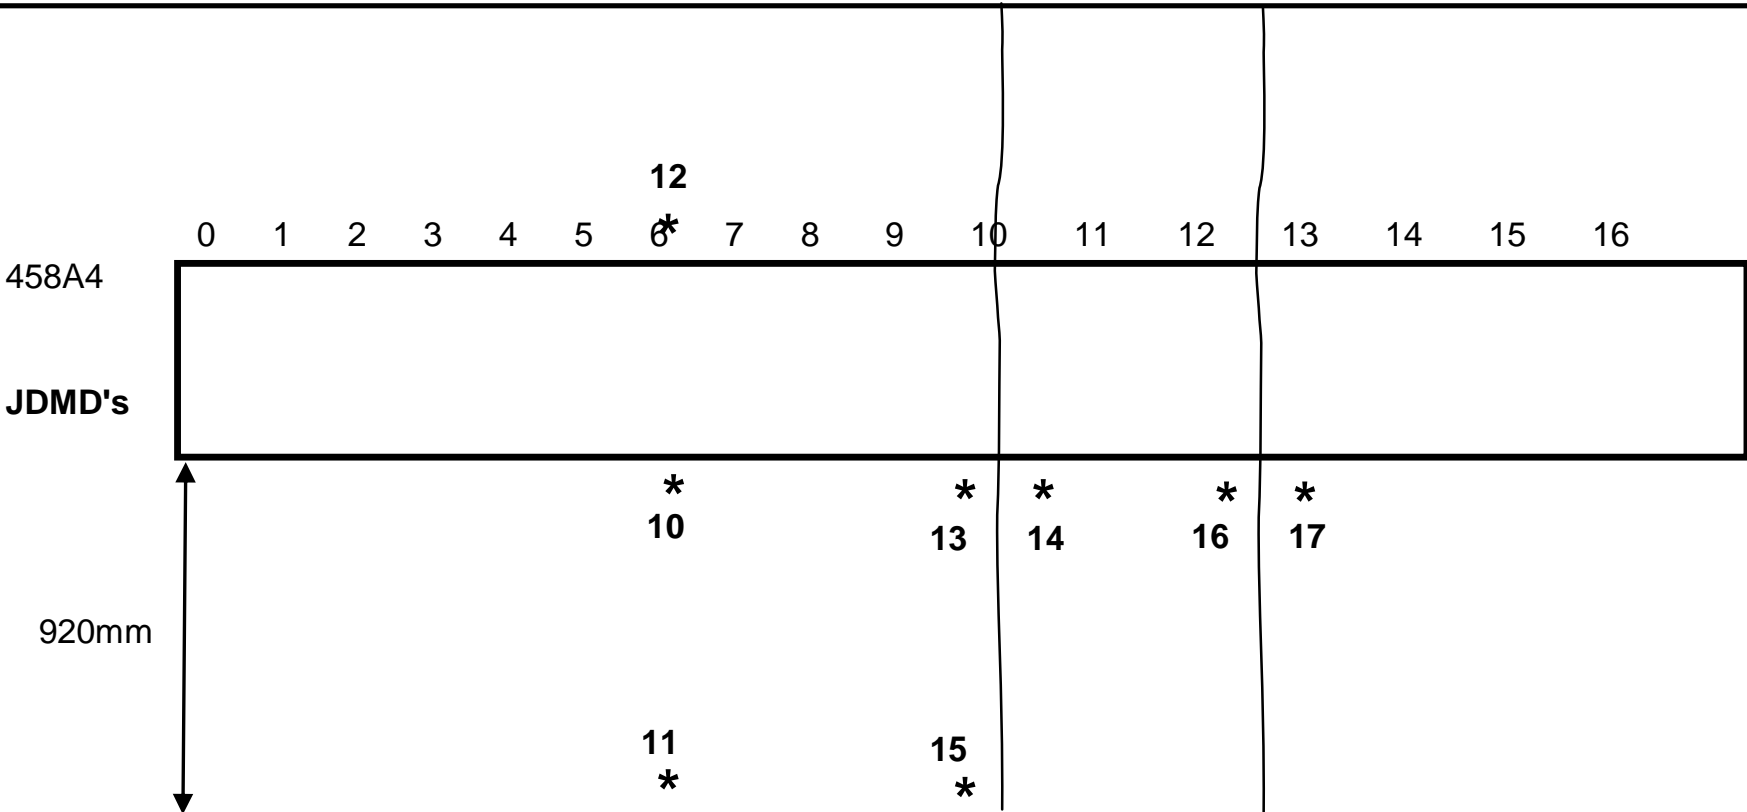
458A4

458A4: Centre slab loading Strong base (no ETB), water from 1.150m reps

- Section failed after 1 243 100 reps
- 1 149 700 dry, 93 400 reps wet
- Starting date: 31 Oct 08, end 13 Feb 09 (104 days)
- Ave slab thickness: 59mm

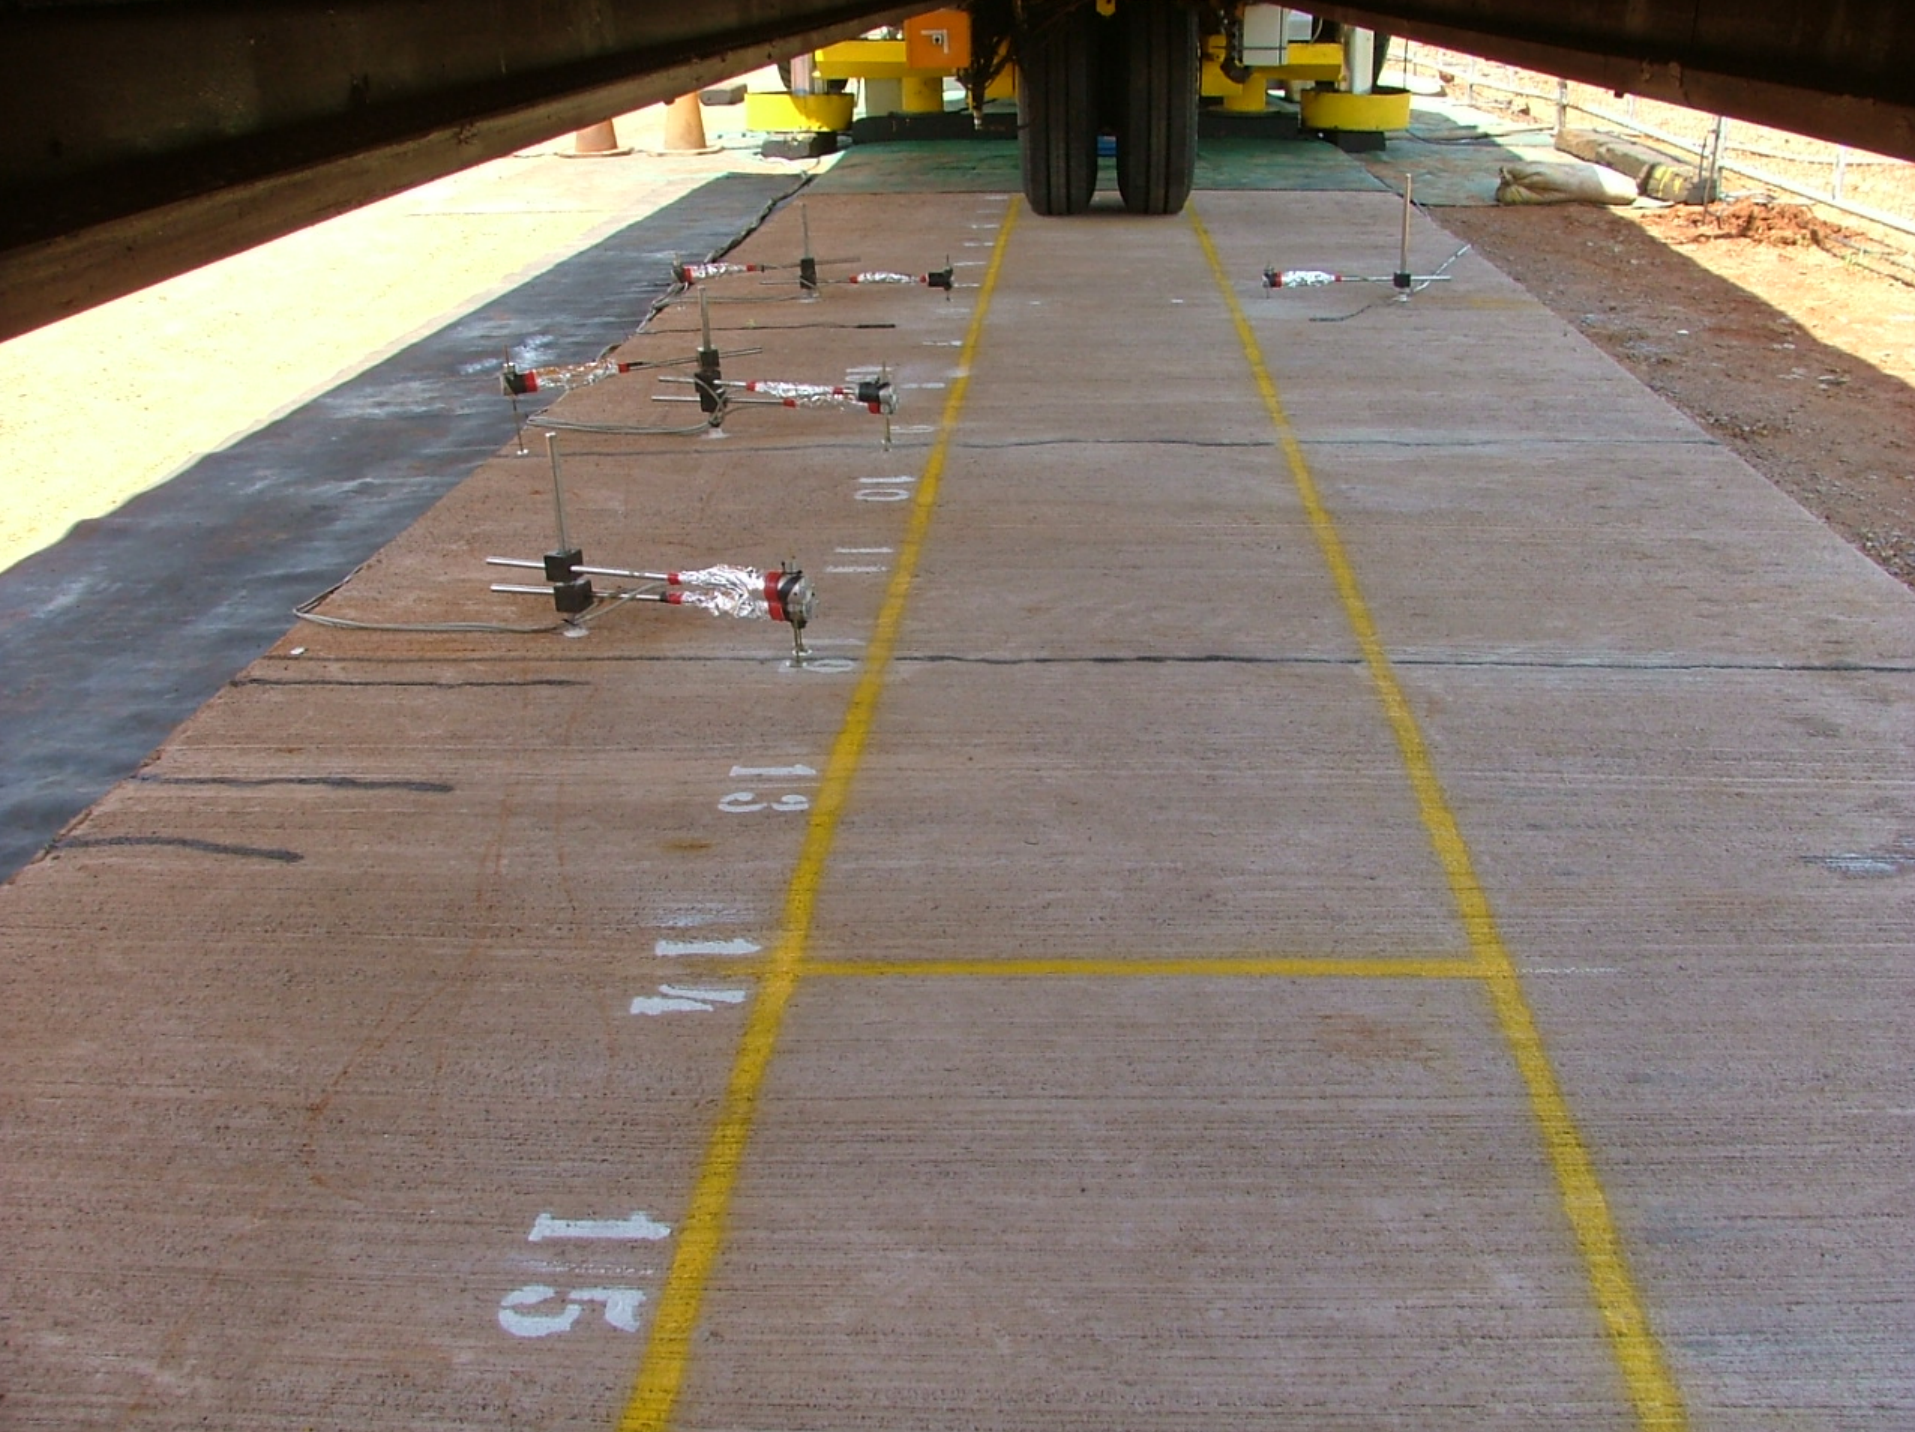
Watering cycle started after 1 149 700 reps

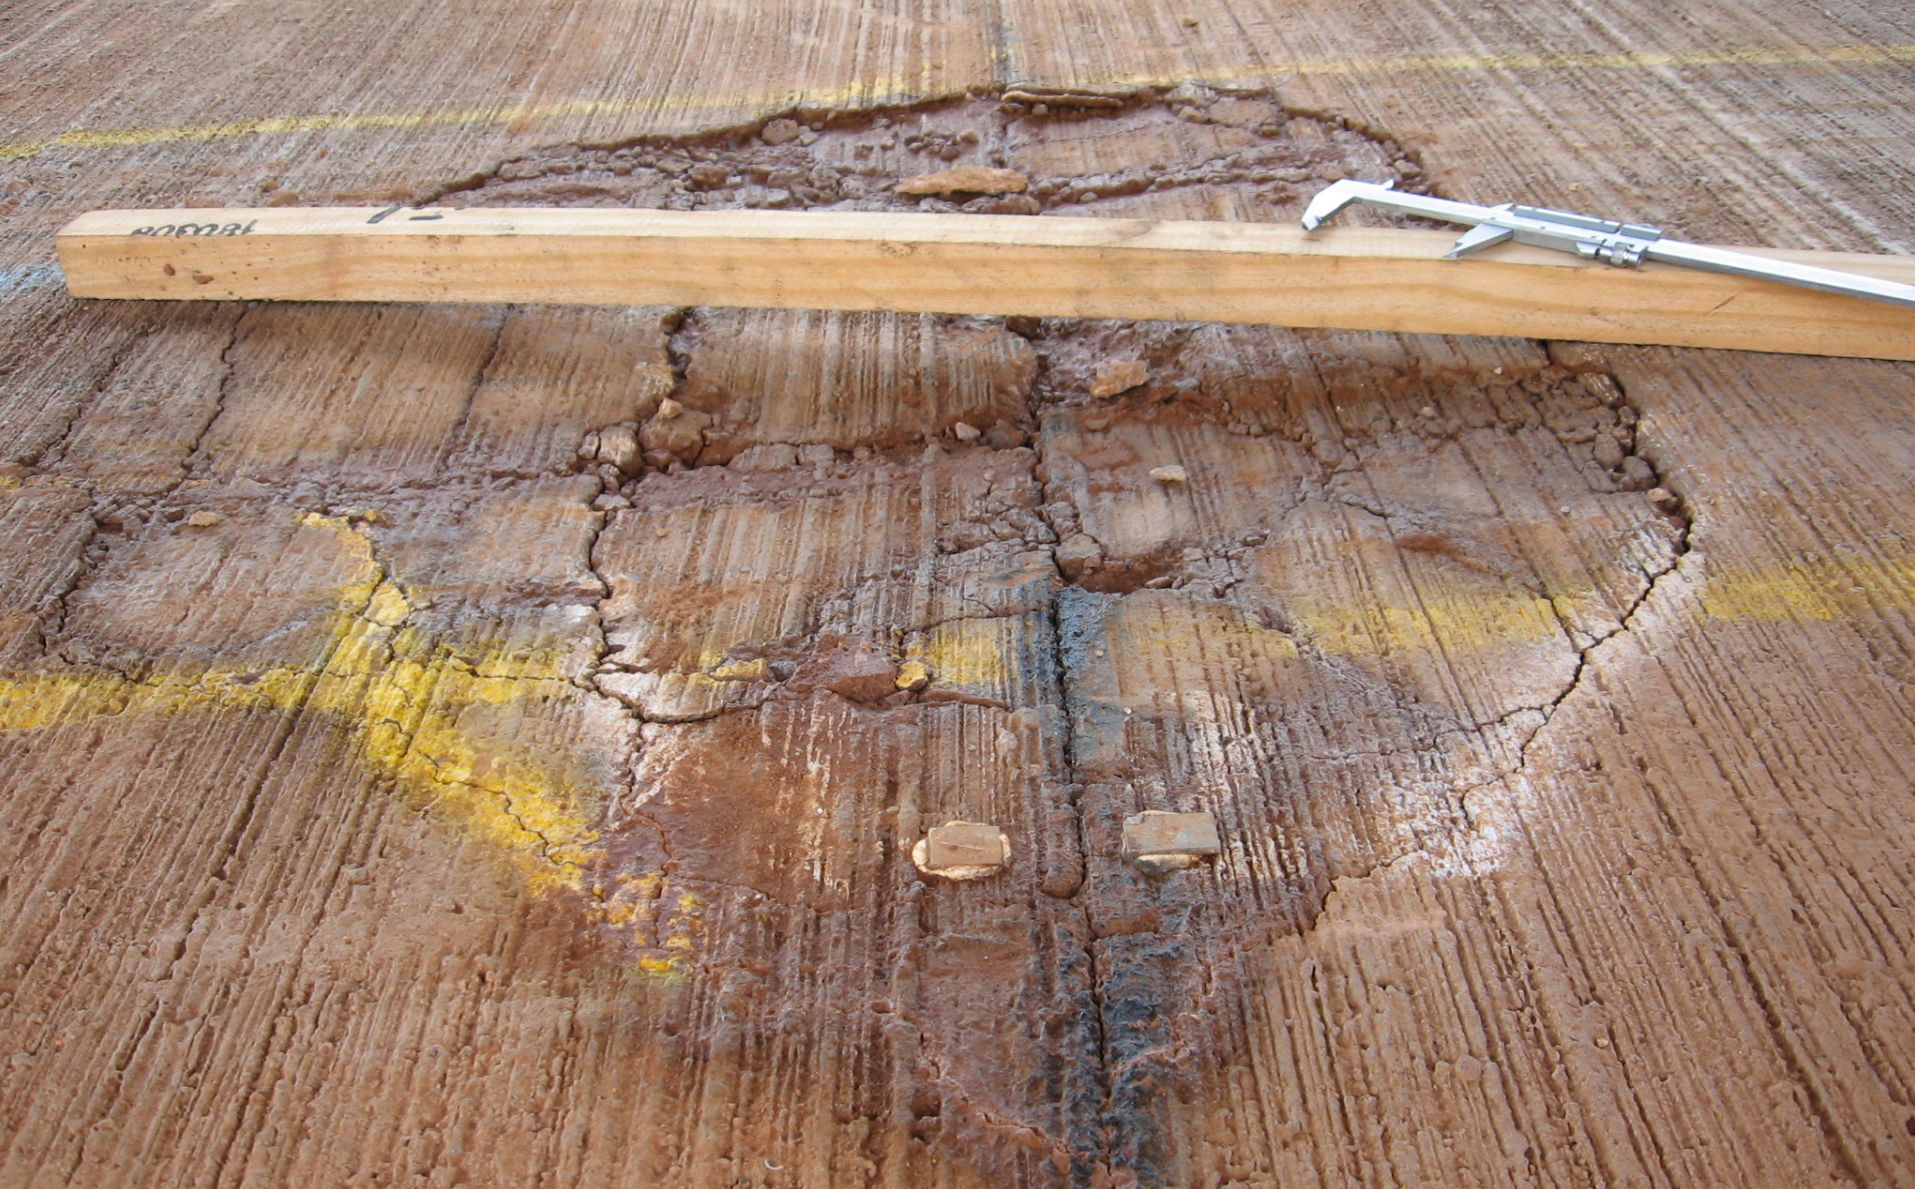
Section failed after 1 242 700 Reps

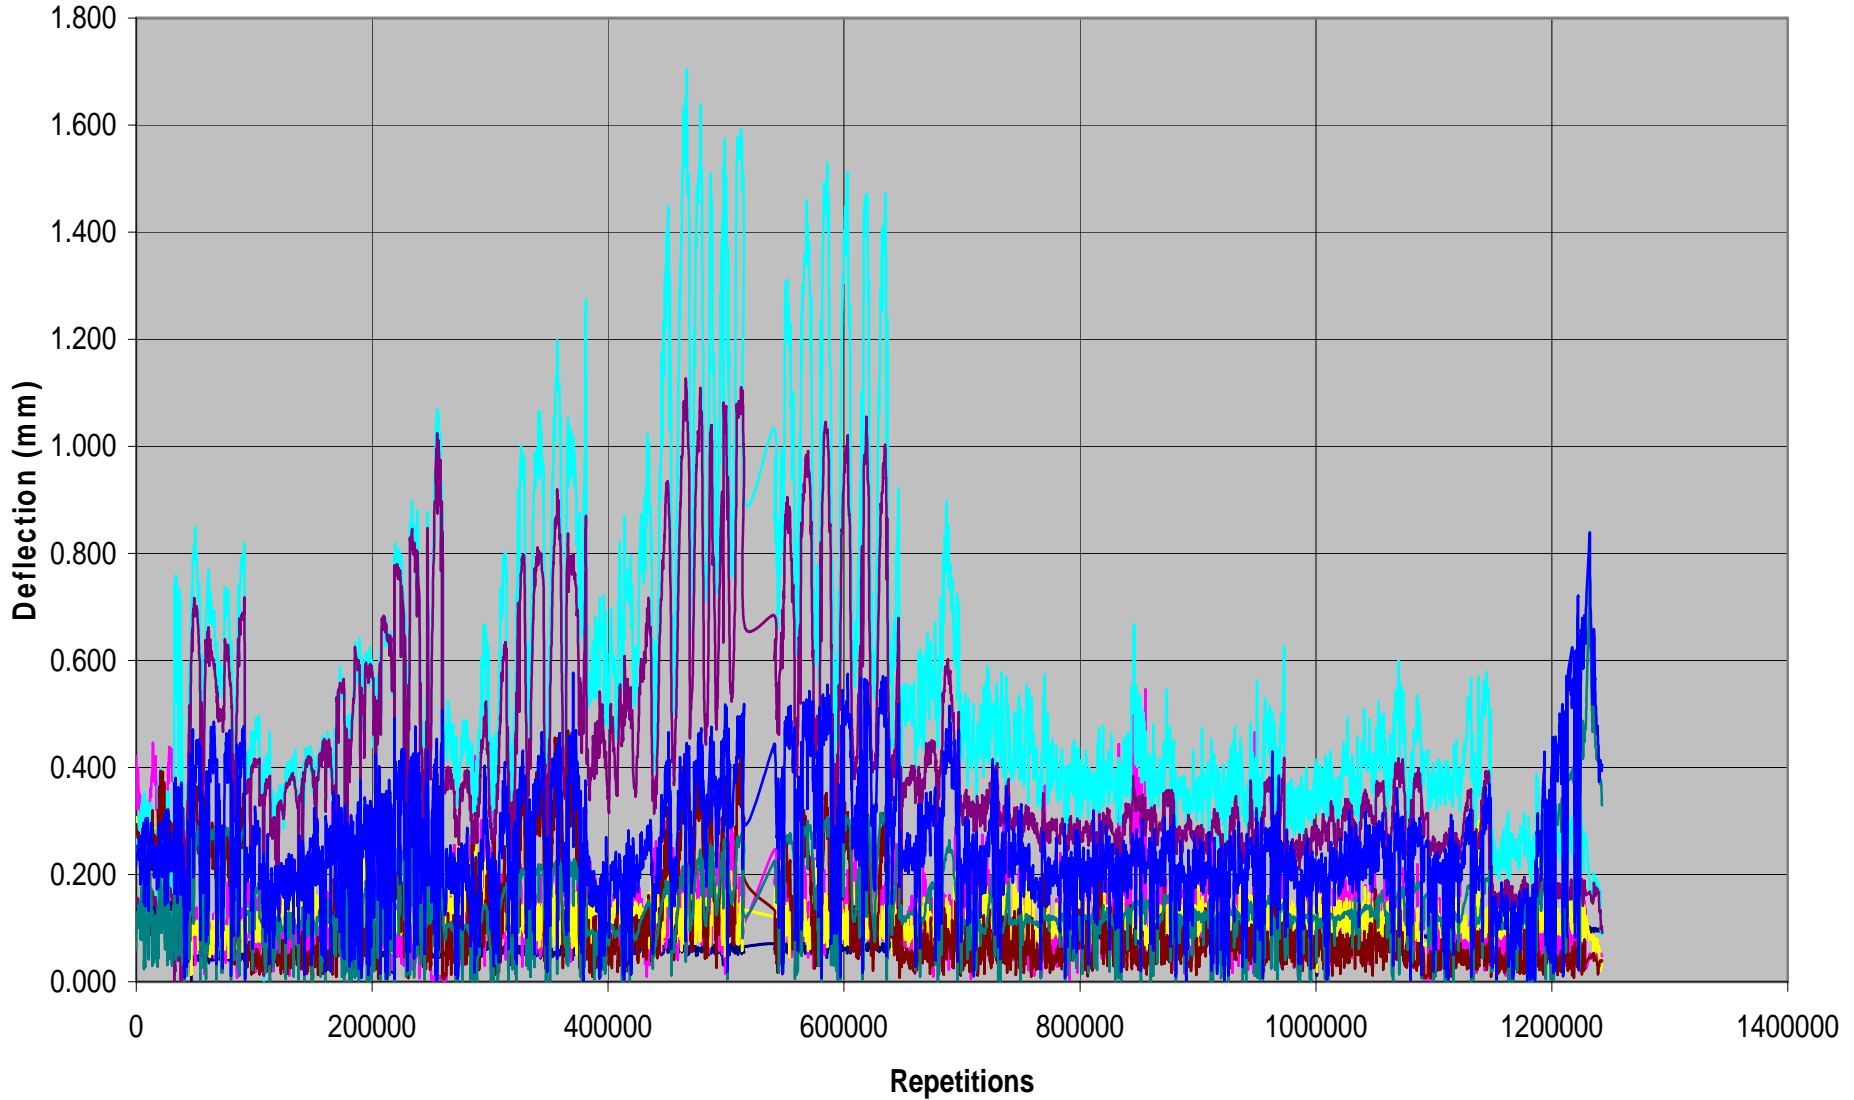
DEFLECTIONS OF JDMD'S SECTION 458A4 (cracked)

Strong Base Concrete Section

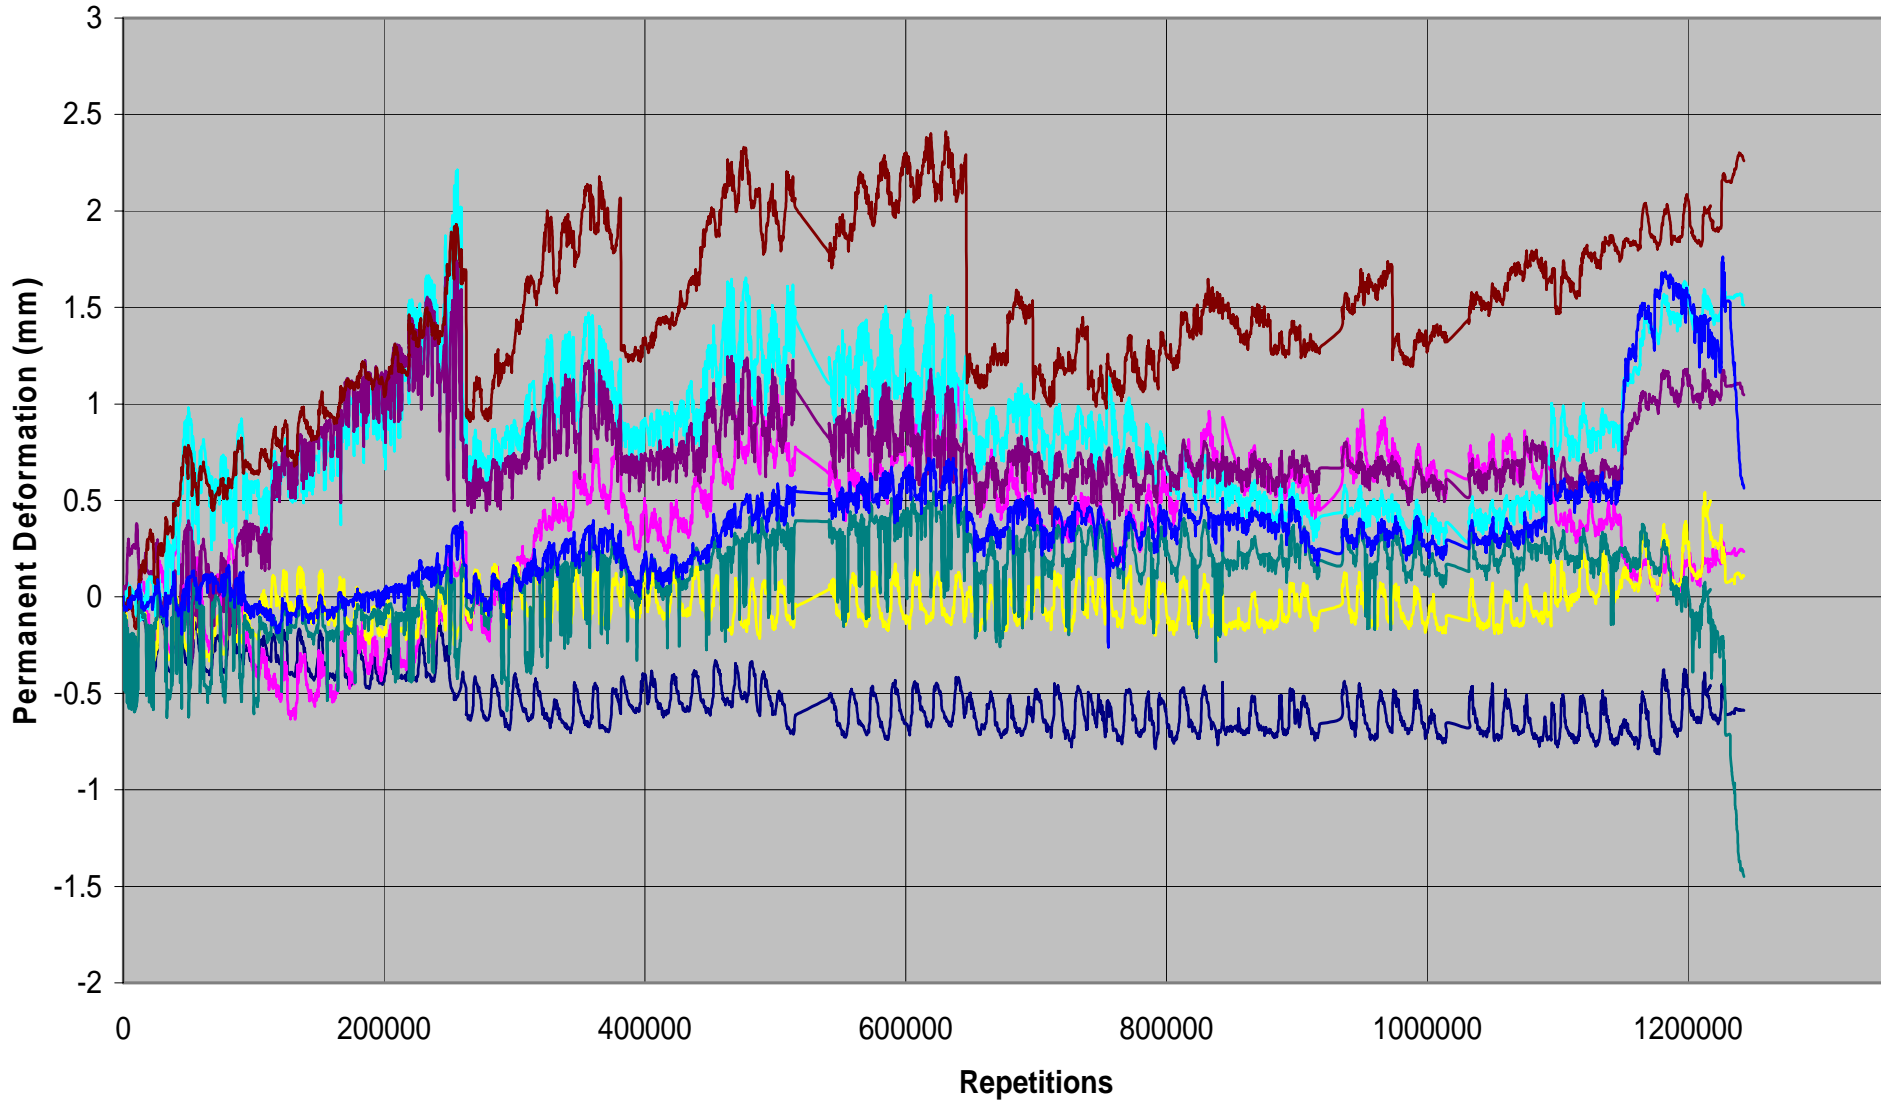
PERMANENT DEFORMATION OF JDMD's SECTION 458A4 (crack)

Strong Base Concrete Section
