Roads Pavement forum 13-14 May 2009

Progress Report: Ultra Thin Reinforced Concrete Pavements: Field evaluation through accelerated pavement testing

Louw du Plessis

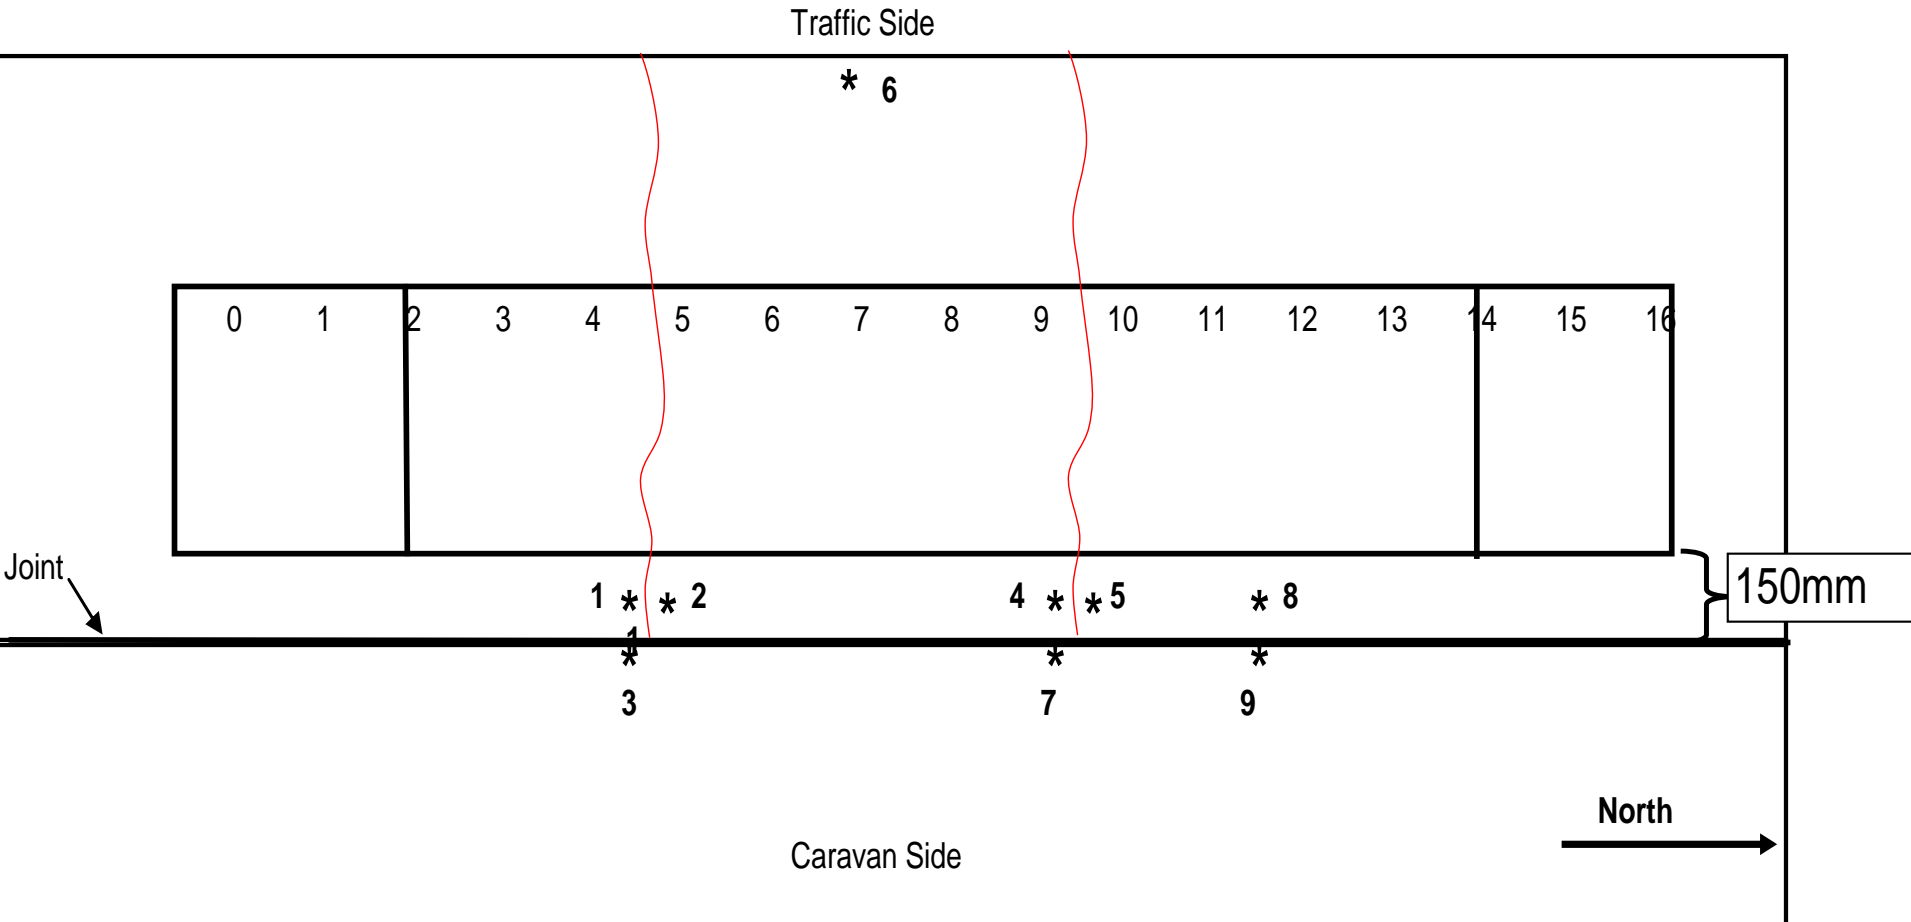
LAYOUT OF JDMD's FOR SECTION 459A4

459A4: Edge loading “tied” shoulder (strong base, with 50mm ETB)

- Section failed after 237 567 reps
- 200 000 dry, 37 567 reps wet (fail in its 1st wet cycle)
- Starting date: 20 Feb 09, end 11 March 09, 18 Days
- Ave slab thickness: 68mm

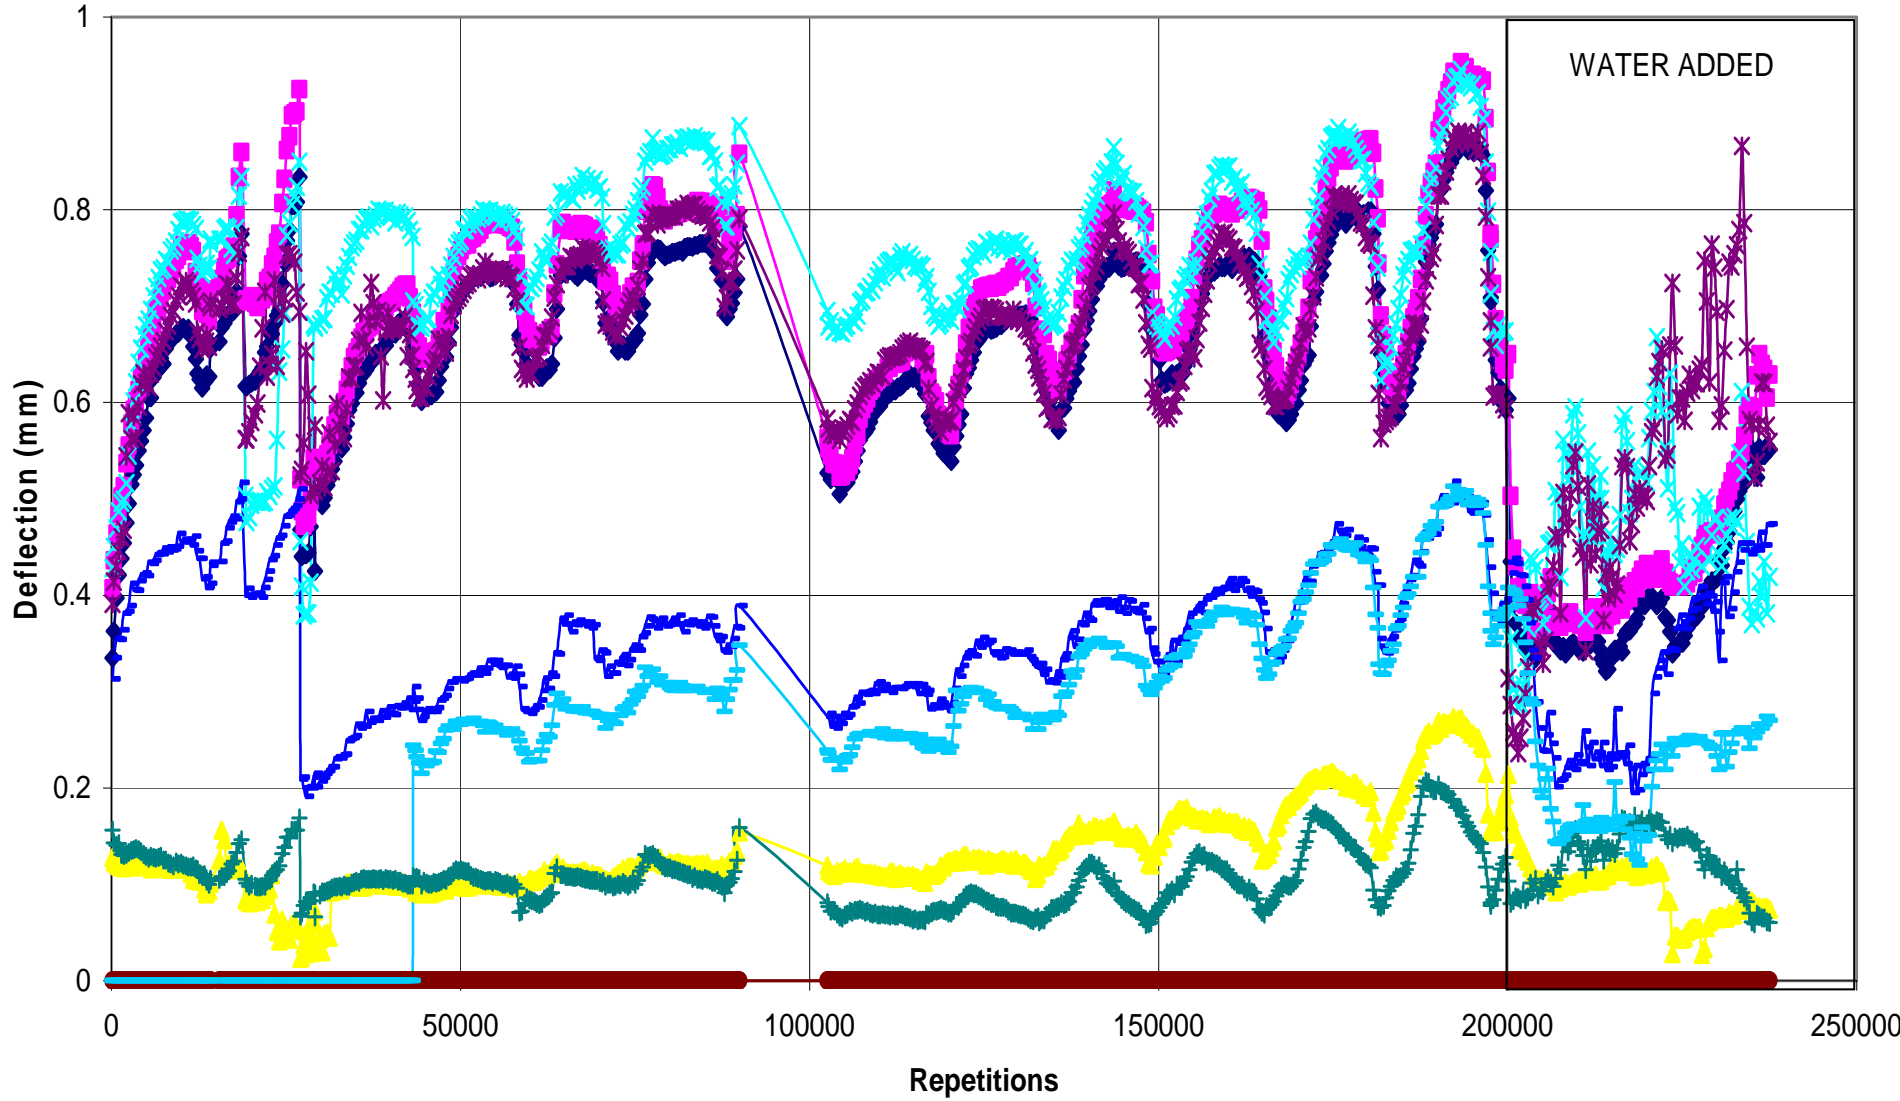
DEFLECTIONS OF JDMD'S SECTION 459A4 (cracked)

Joint with Steel

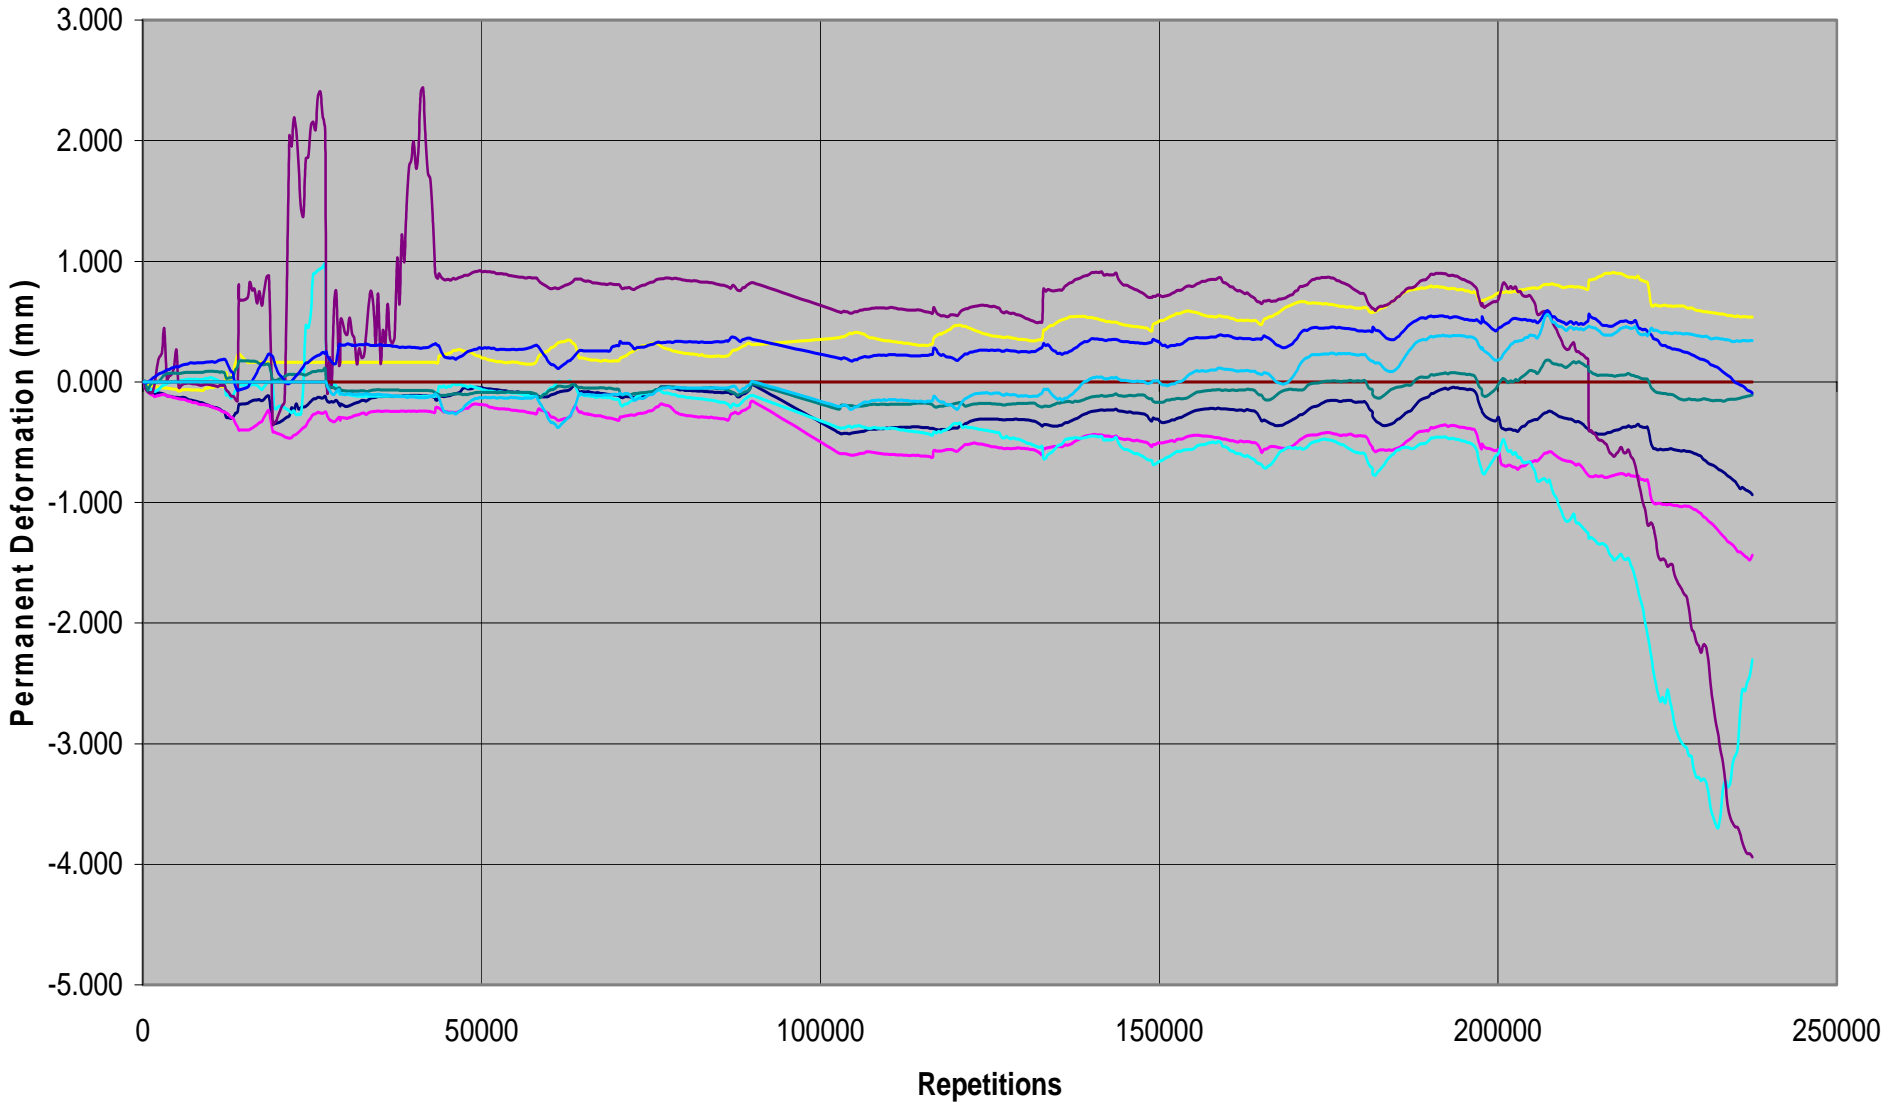
PERMANENT DEFORMATION OF JDMD'S SECTION 459A4 (crack)

Joint with Steel

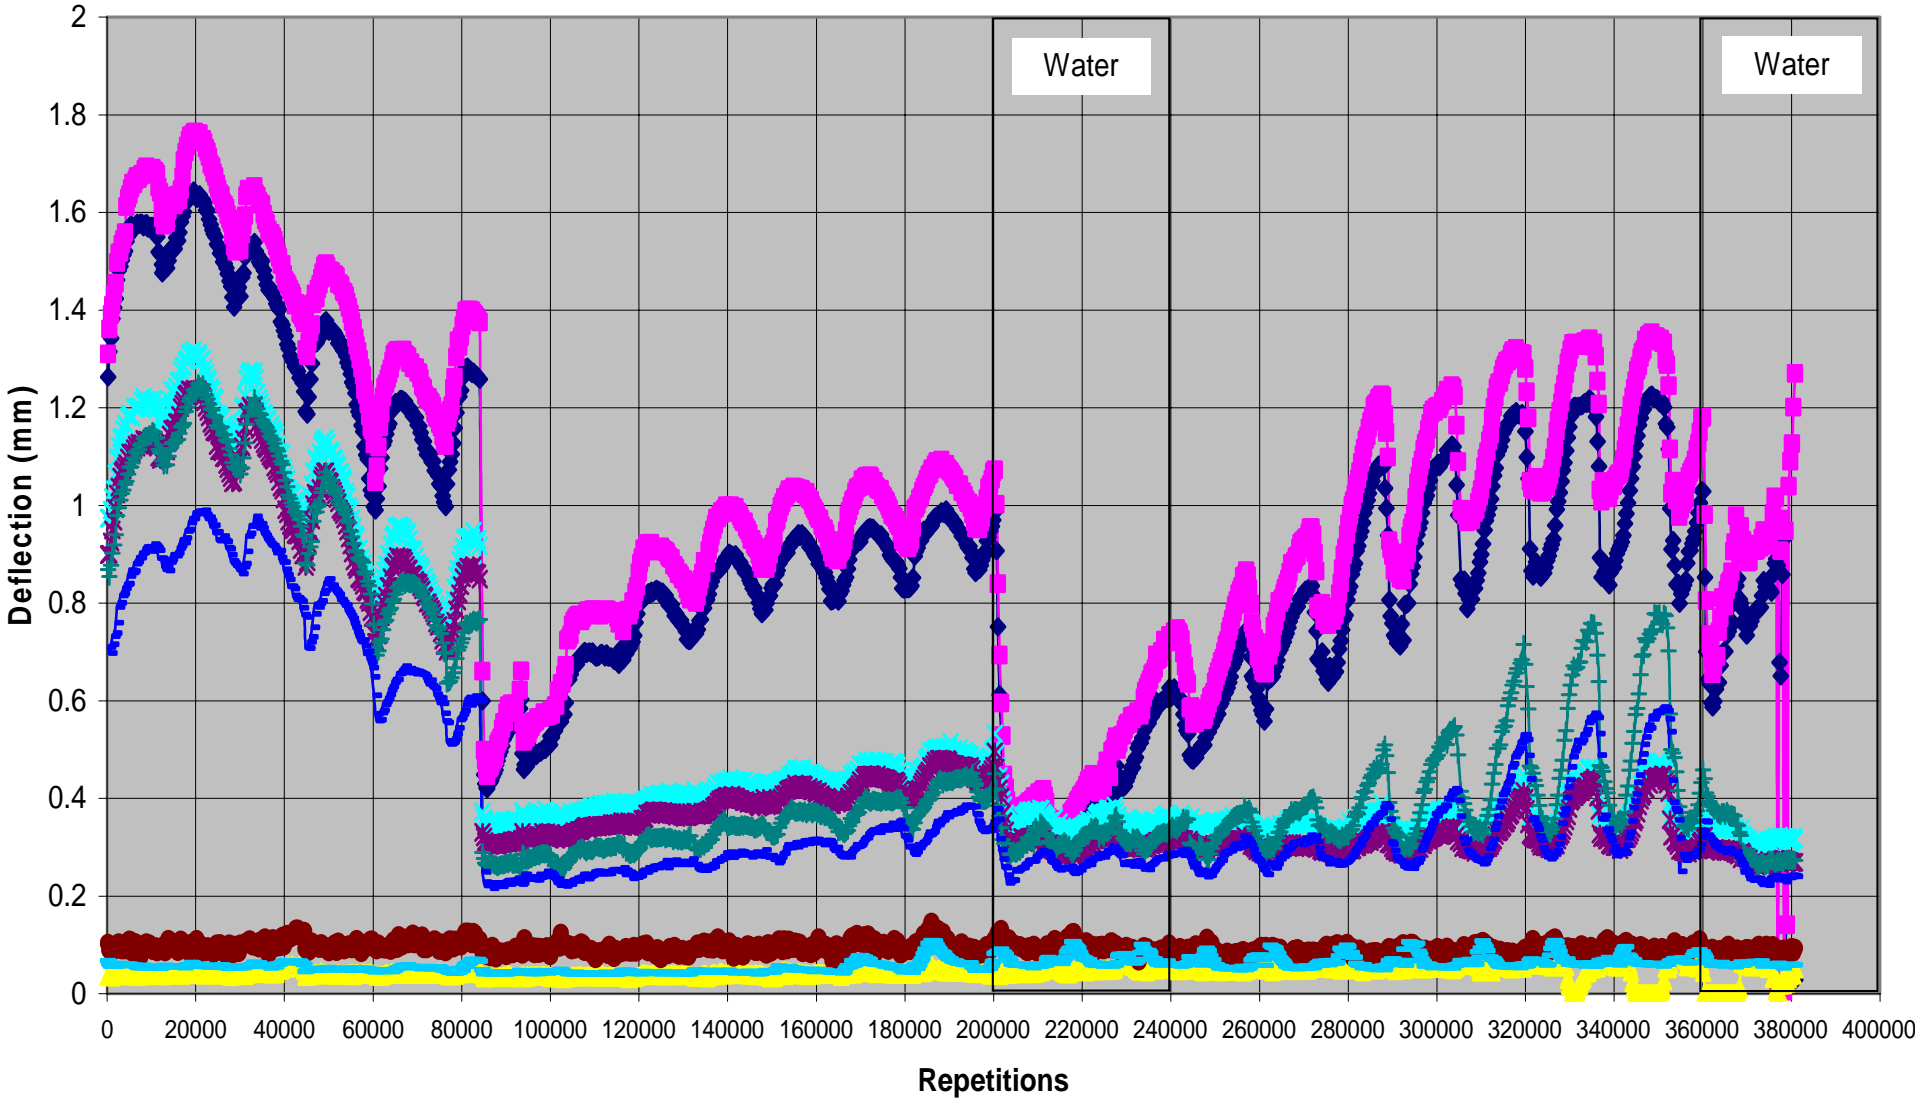
DEFLECTIONS OF JDMD's SECTION 460A4 (cracked)

- Section failed after 381 048 reps
- 200 000 dry, 40 000 wet, 120 000 dry, 21 048 wet (fail)
- Starting date: 12 march 09, end 8 April 09 (28 days)
- Ave slab thickness: 65mm

Joint with NO Steel

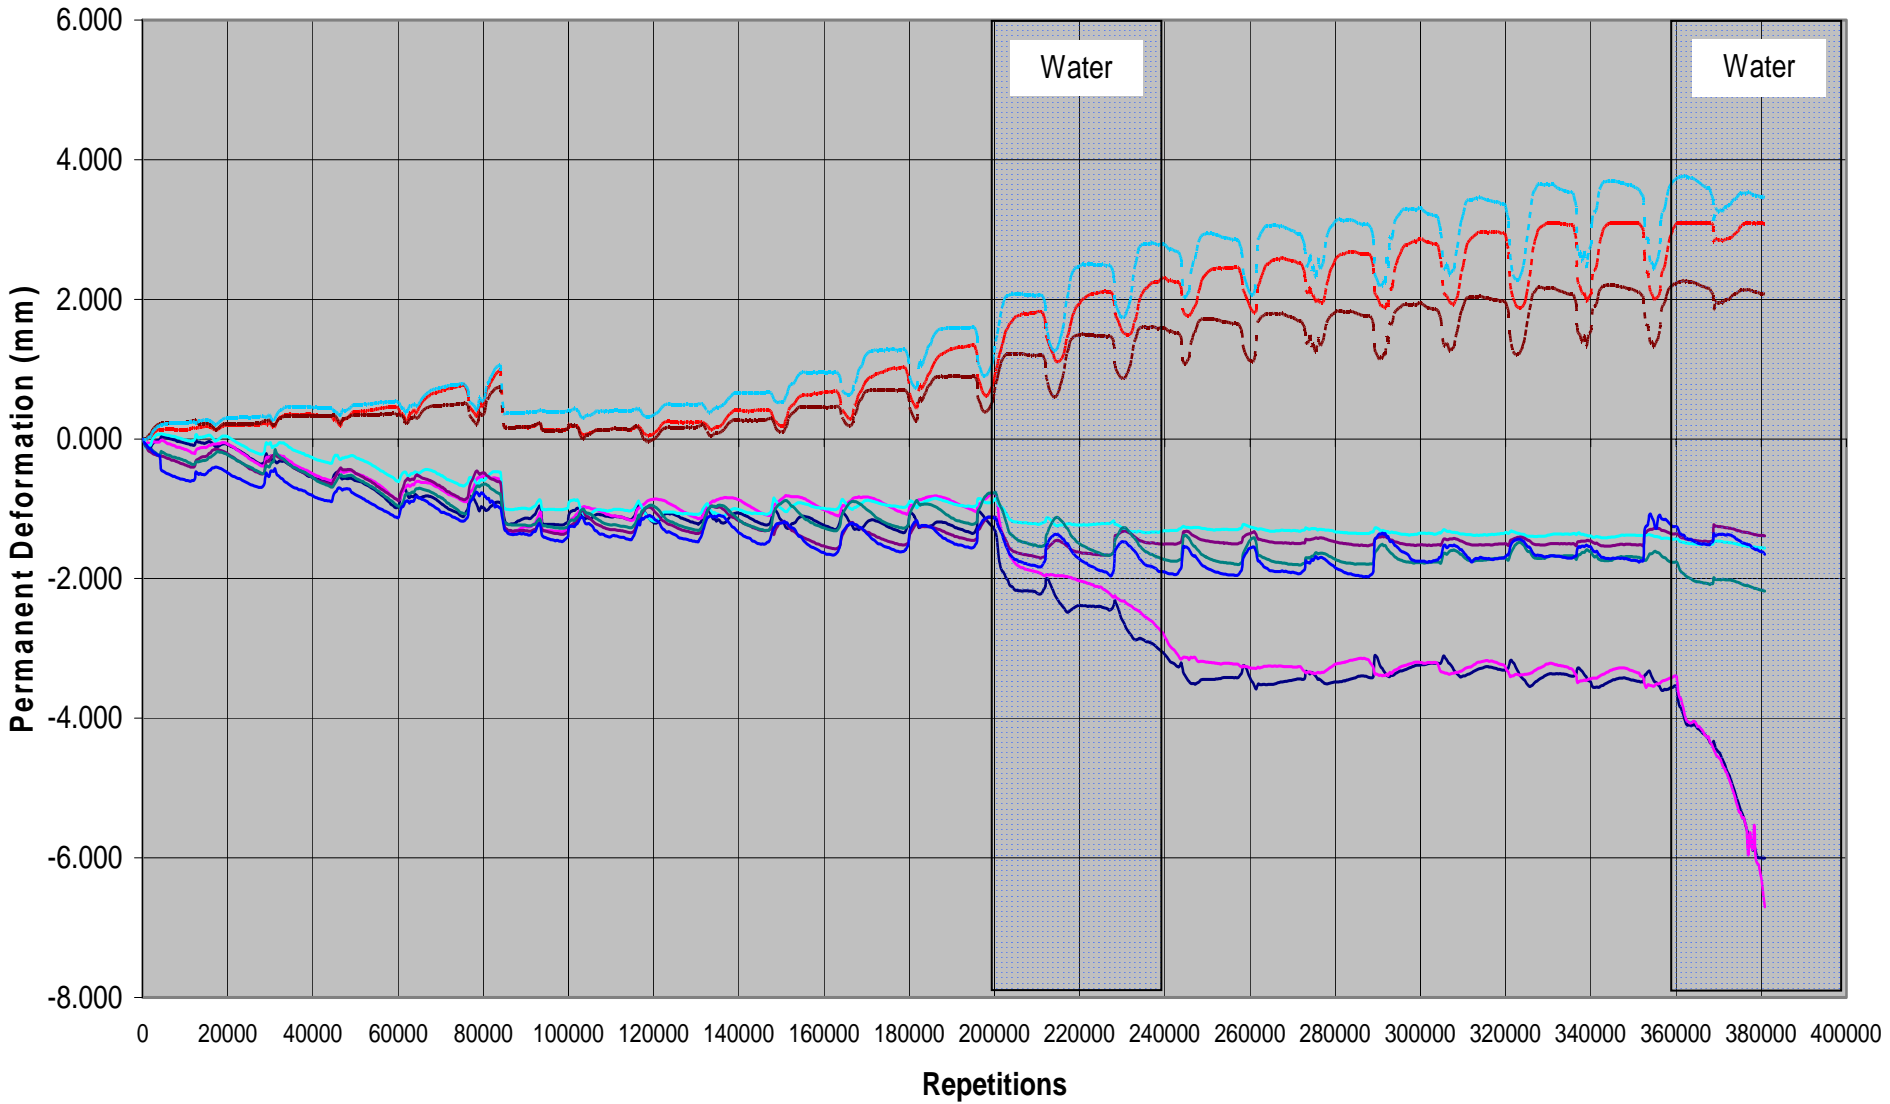
PERMANENT DEFORMATION OF JDMD's SECTION 460A4 (crack)

Joint with NO Steel

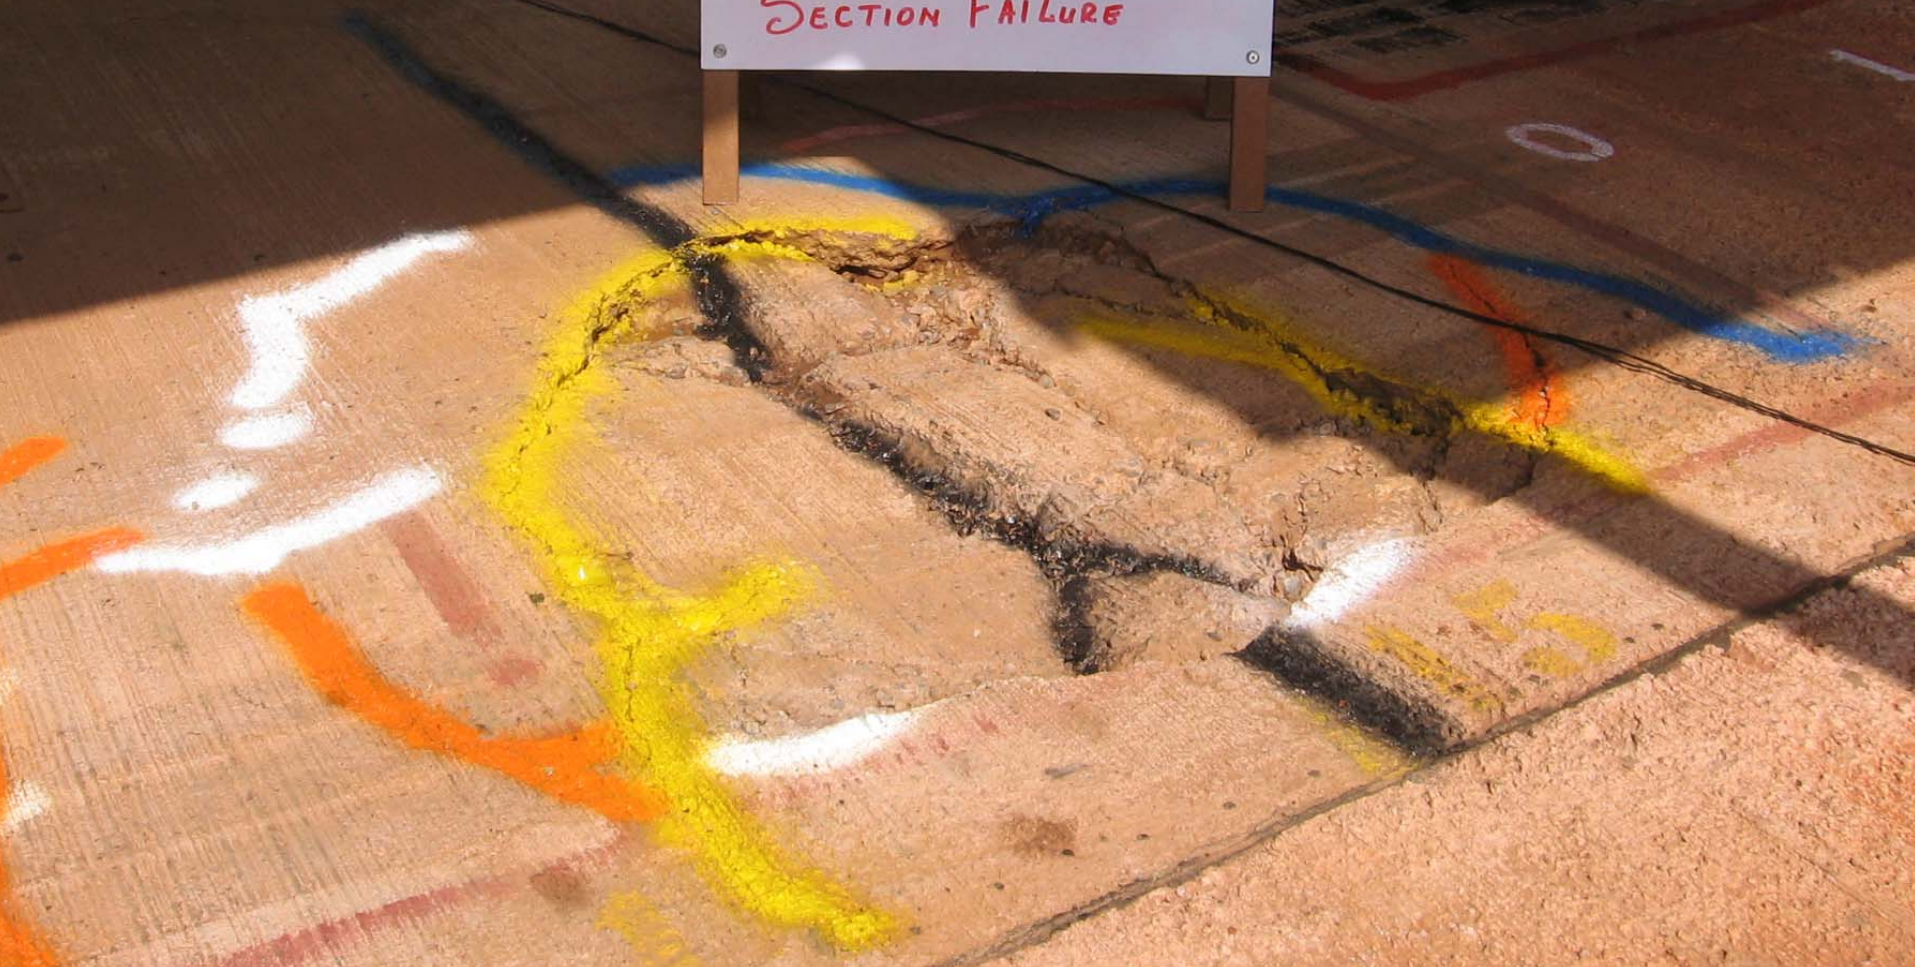
SECTION FAILURE

HVS 04
SECTION: 460A4
DATE : 8-4-09
N : 381048
CRACKS : YES
WET/DRY : DRY (WET)
POINTS : (1-8) (13-16)
TIME : 09H50
LOAD : 40 KN
POINT : ORANGE

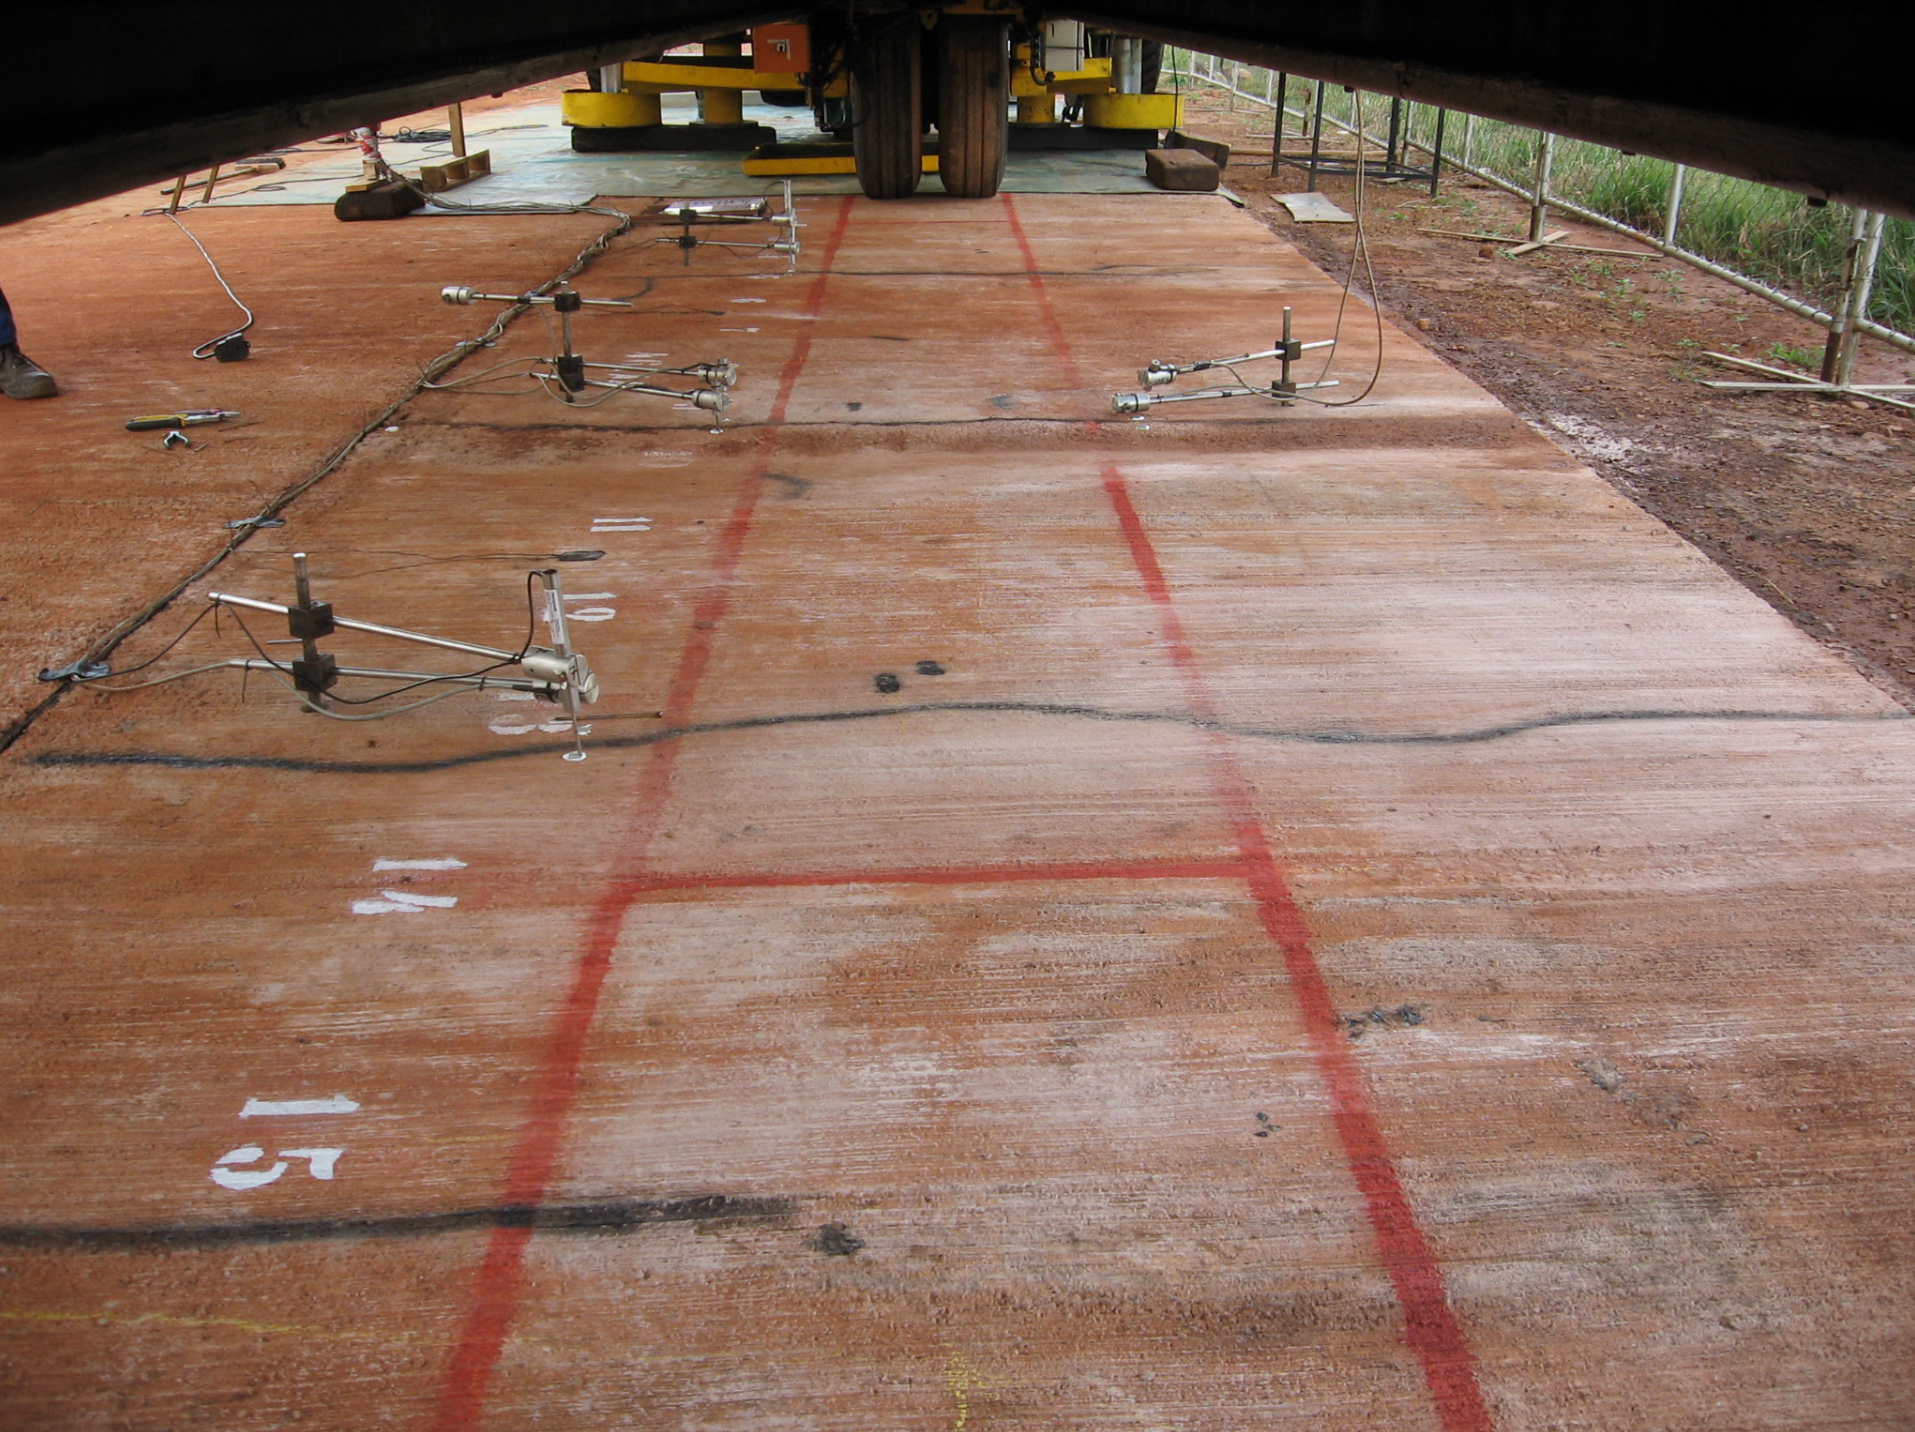
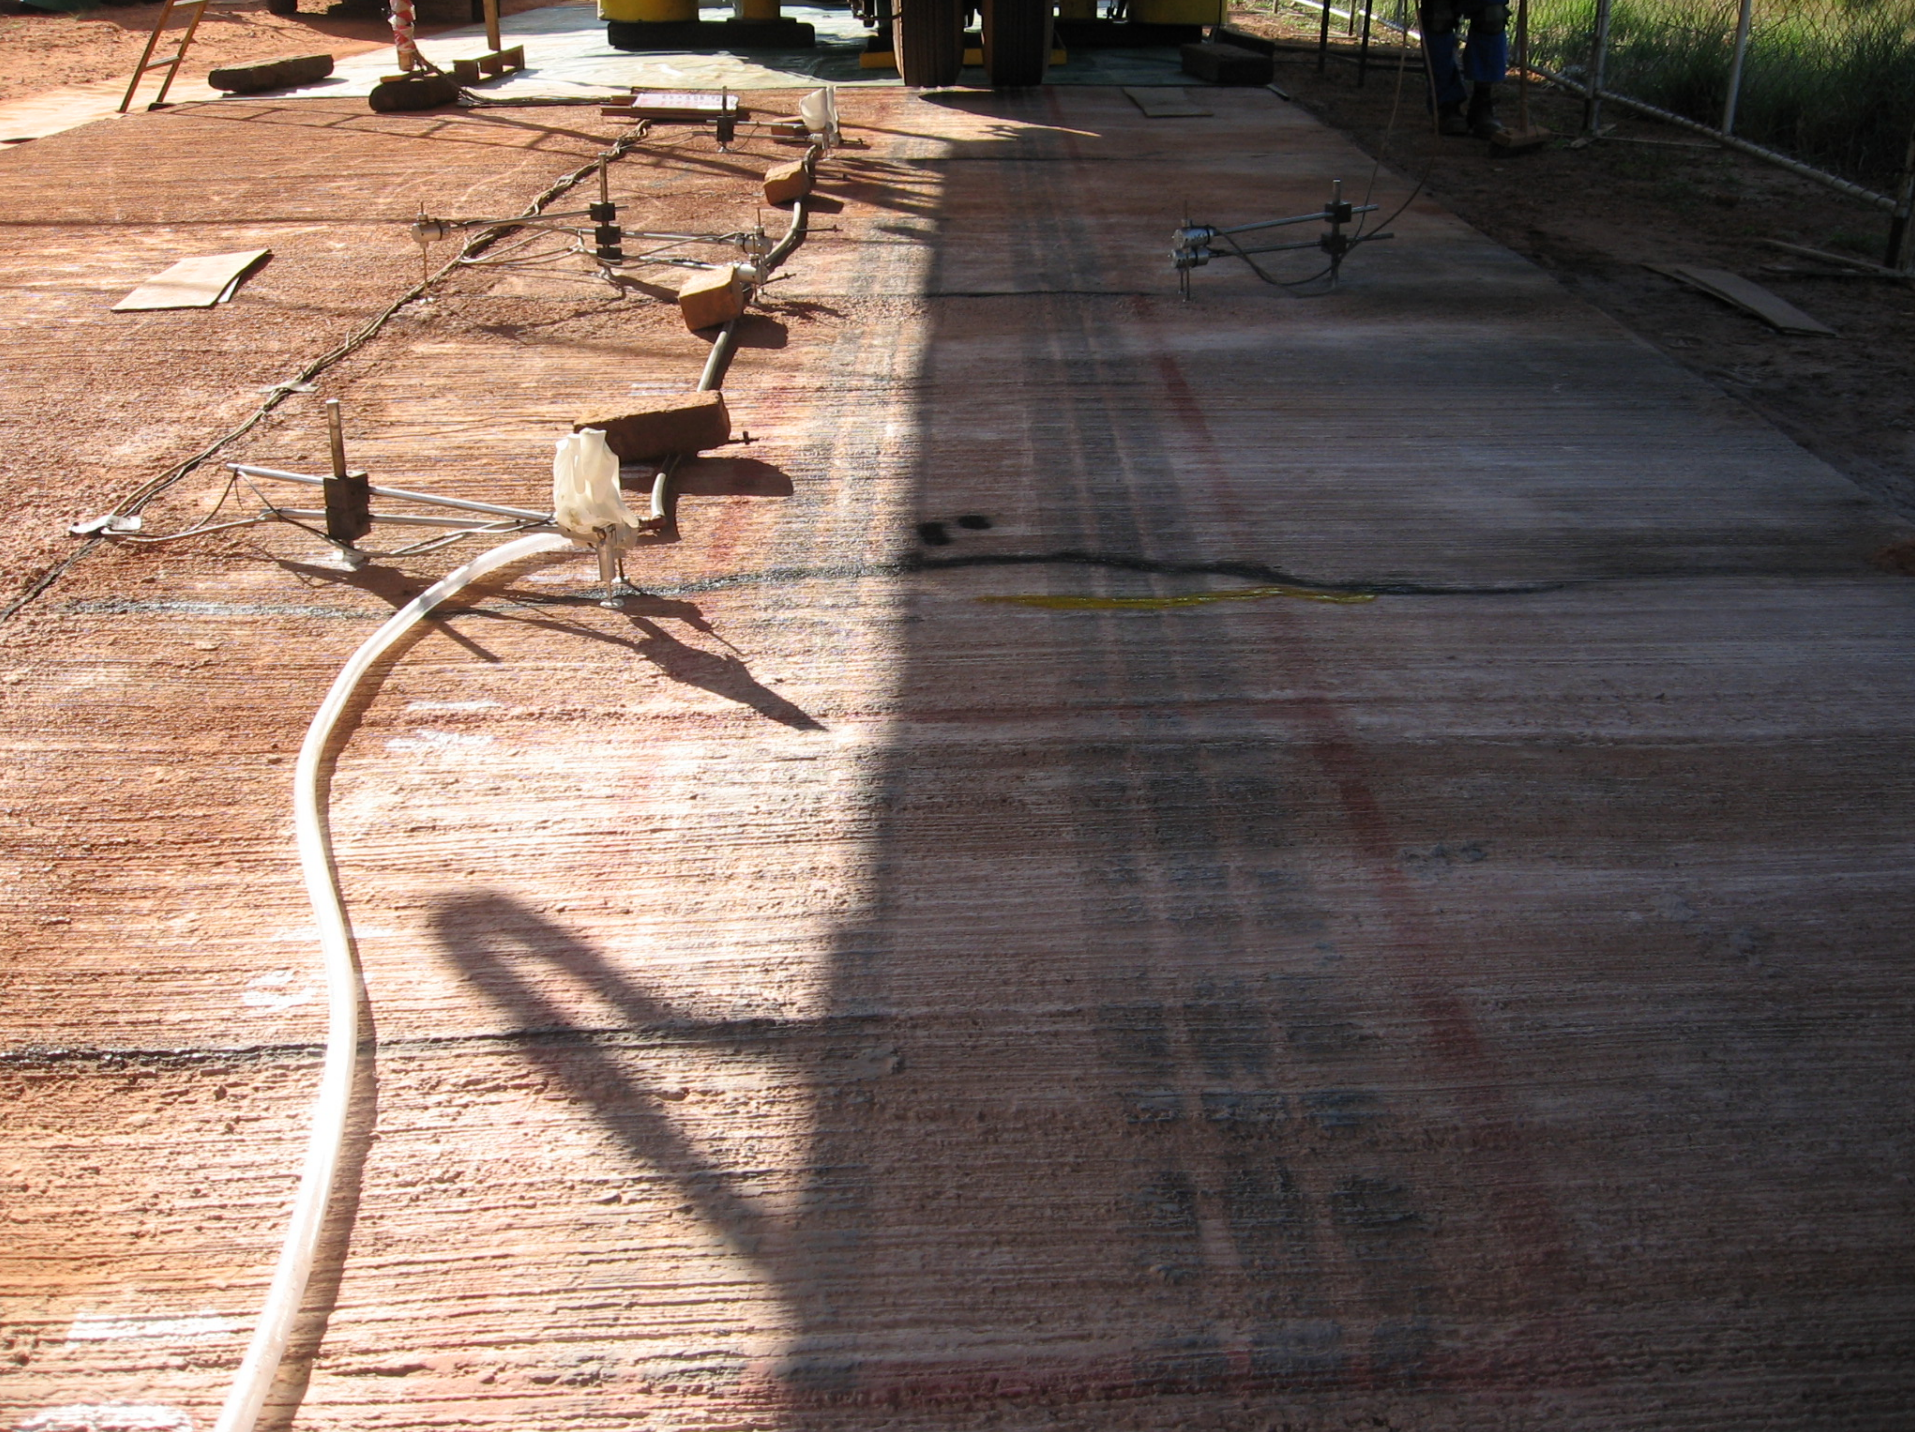
461A4: Centre loading “Day joint” test (strong base, 50mm ETB)

- Starting date: 9 April 09
- Failed after 365 972 reps (Friday 11 May)
- Failed 6 000 reps into its 2nd watering cycle
- 33 days of testing
