# SEAL AGEING AND EFFECTS

## RPF MAY 2014

# Empirical modelling

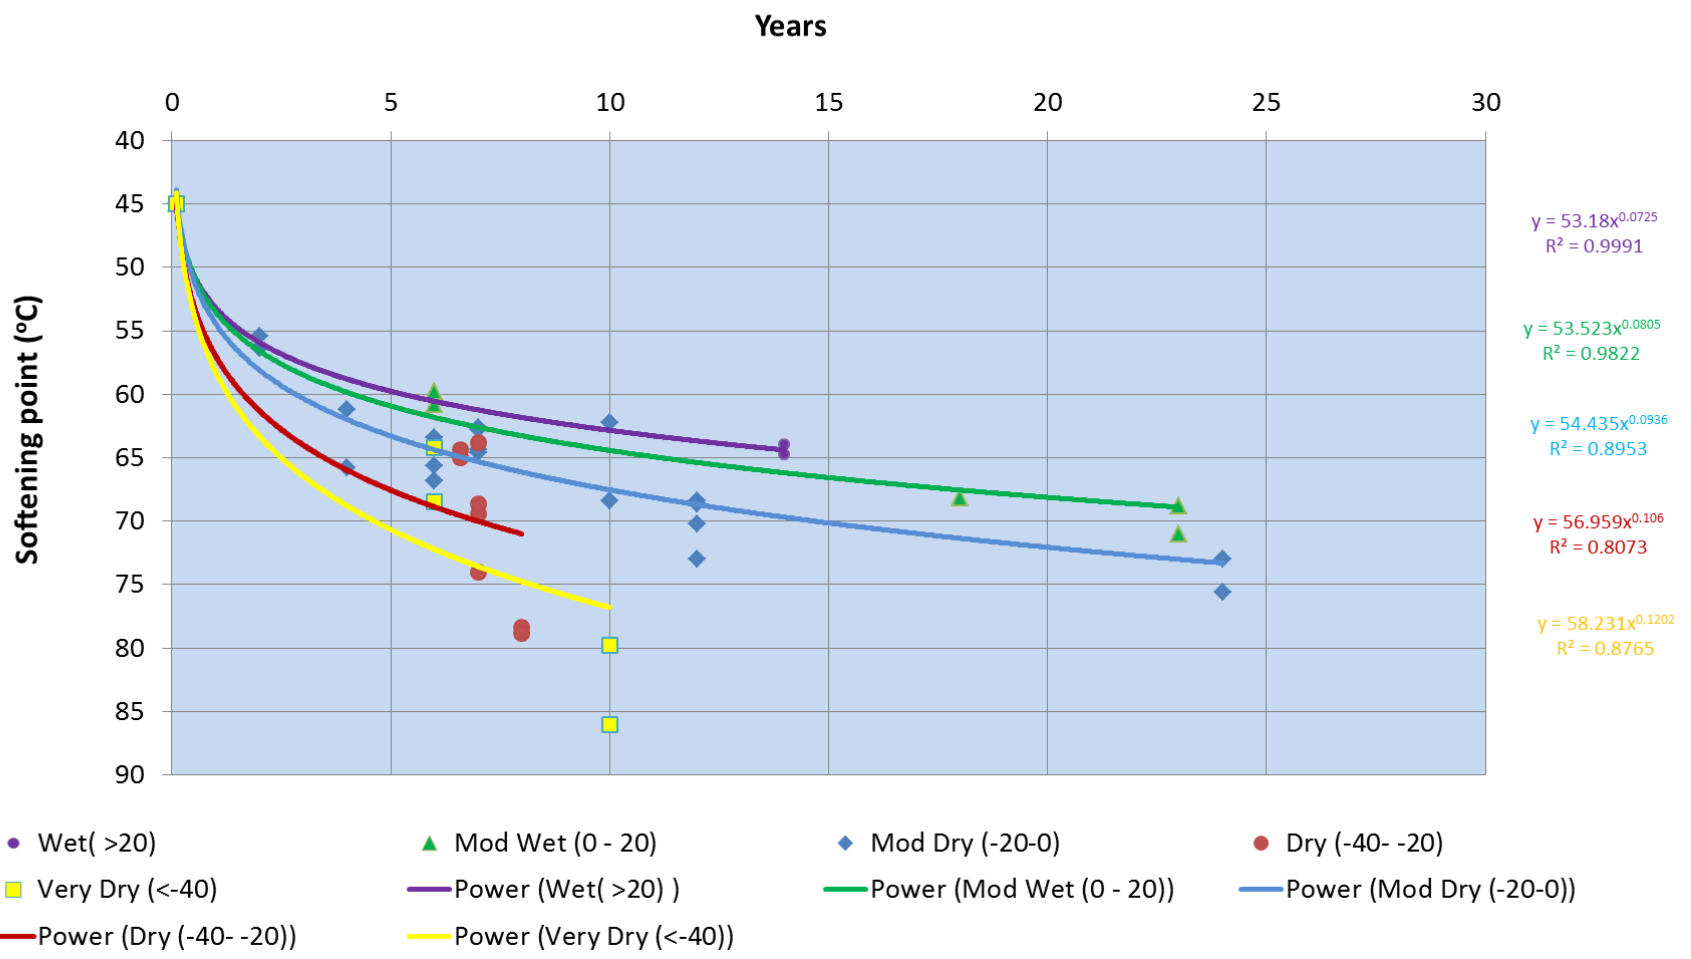
# Hardening: Double seals

## Binder hardening (Double & Split Seals)

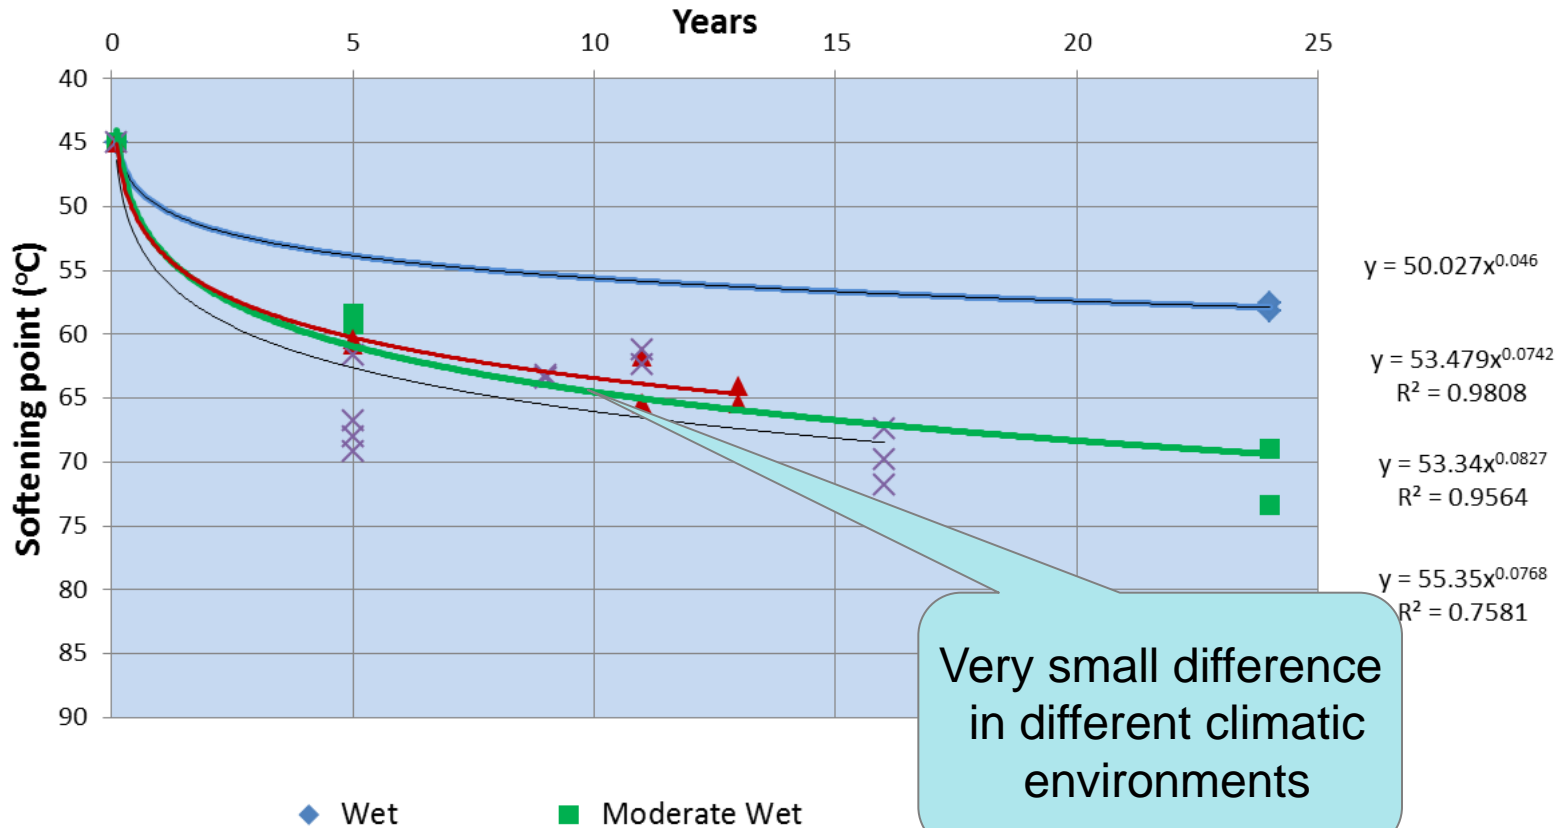
## Binder hardening (Cape Seals)

Very small difference  
in different climatic  
environments

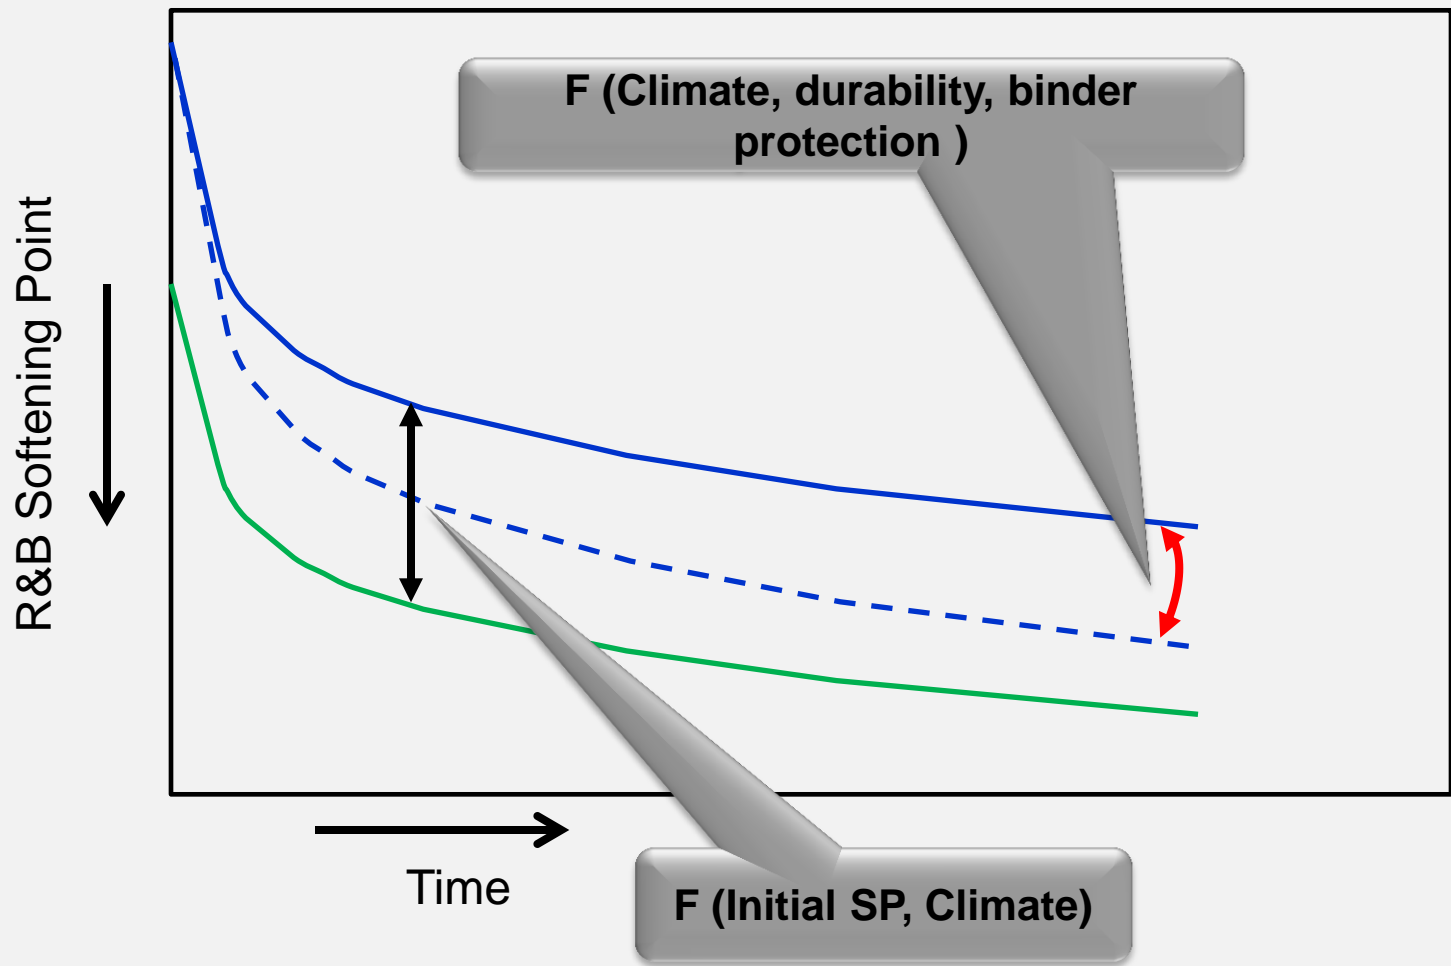
# Binder hardening Conclusions

$$F(t) = 1 - e^{-\left(\frac{t}{\alpha}\right)^\beta}$$

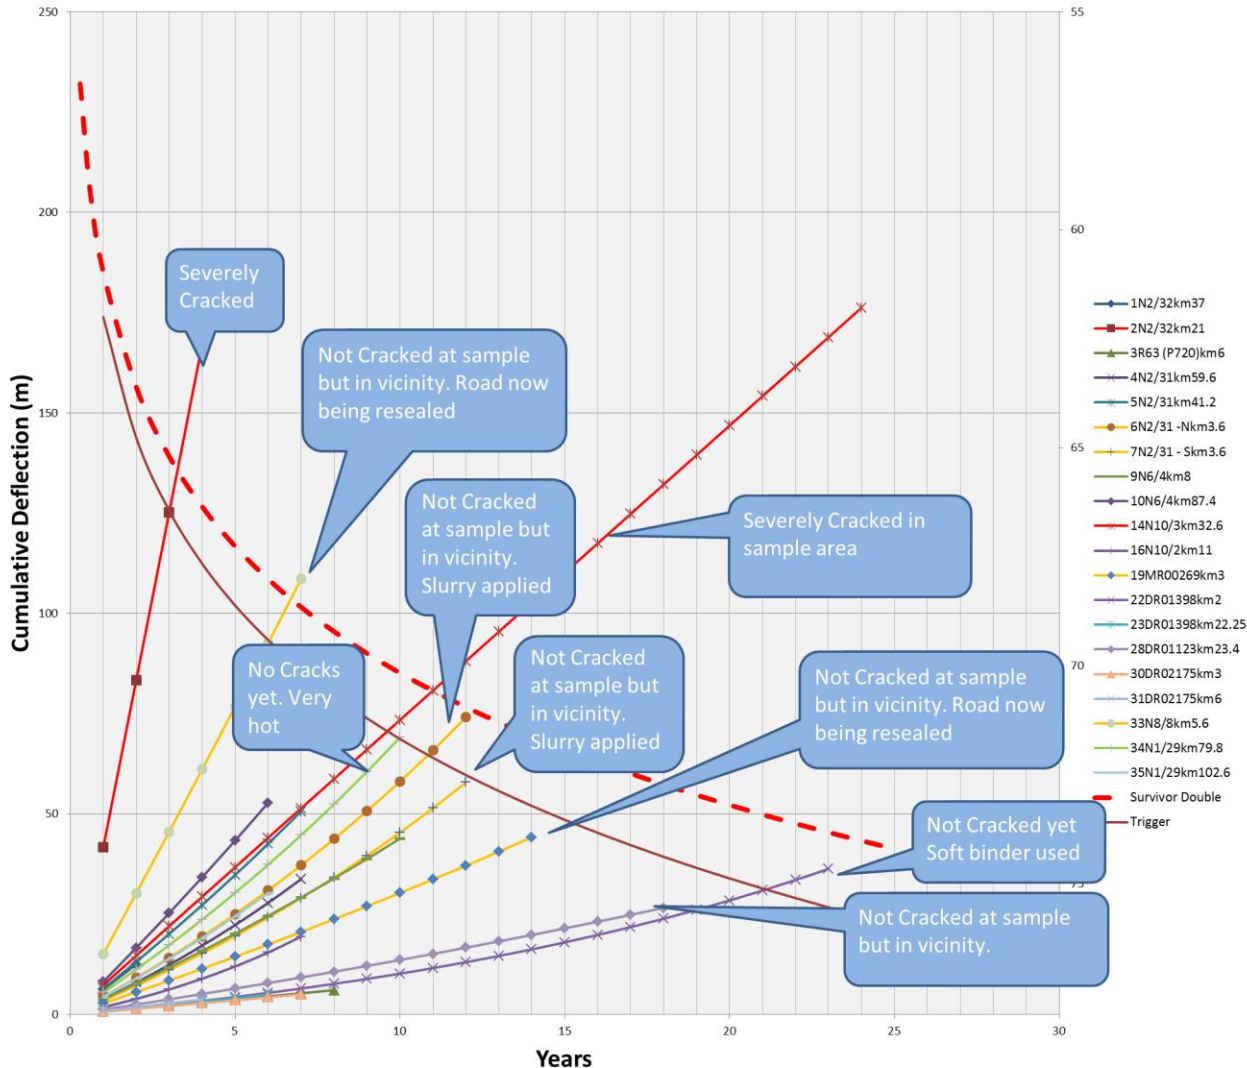
Cumulative deflection to failure (Double seals)

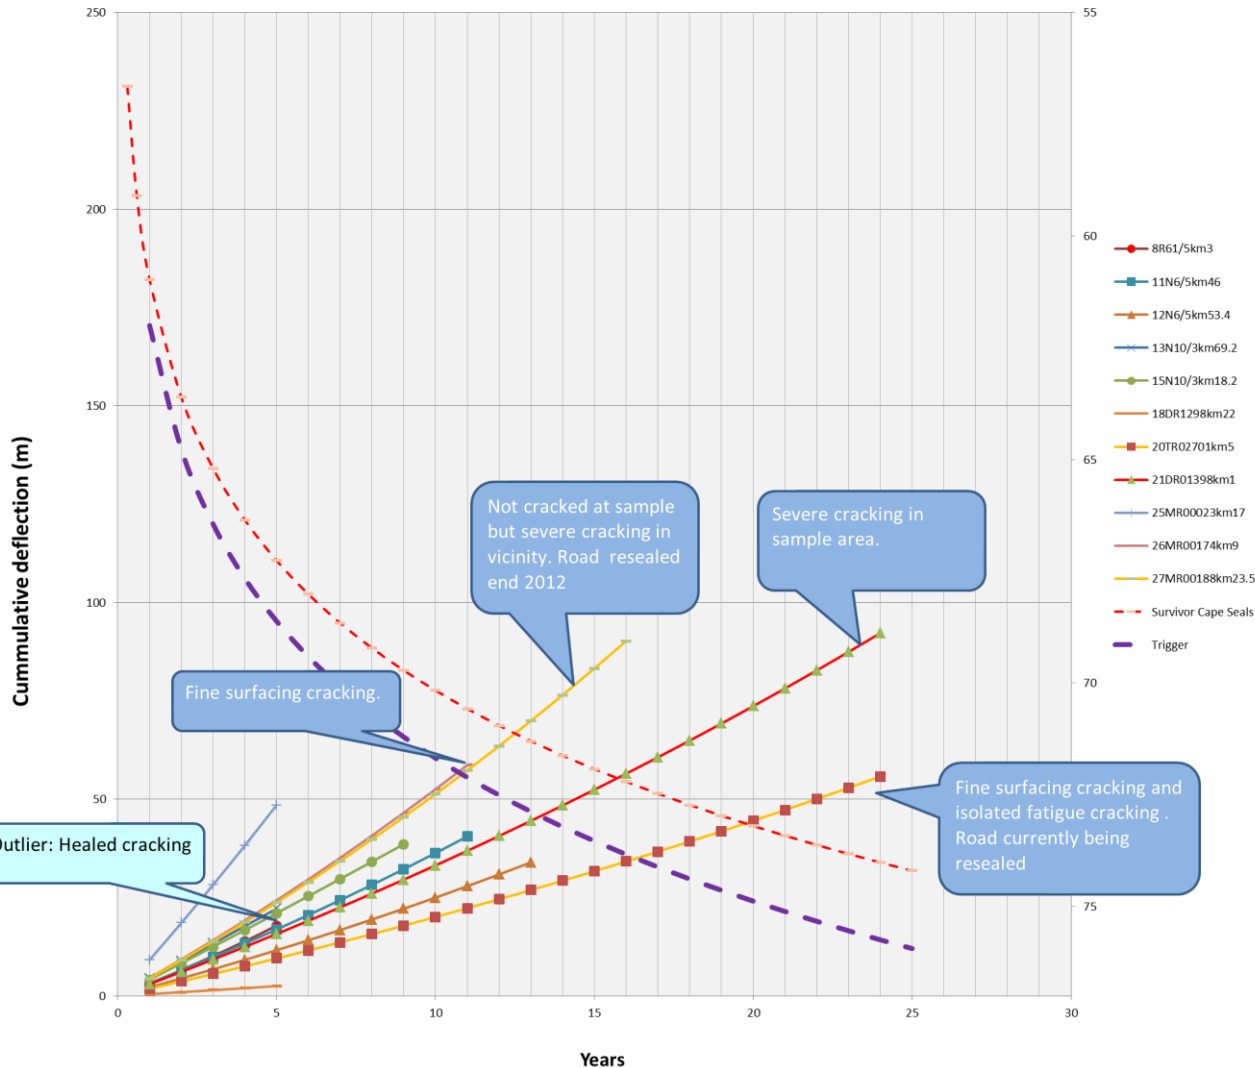
Cumulative deflection to failure (Cape Seals)

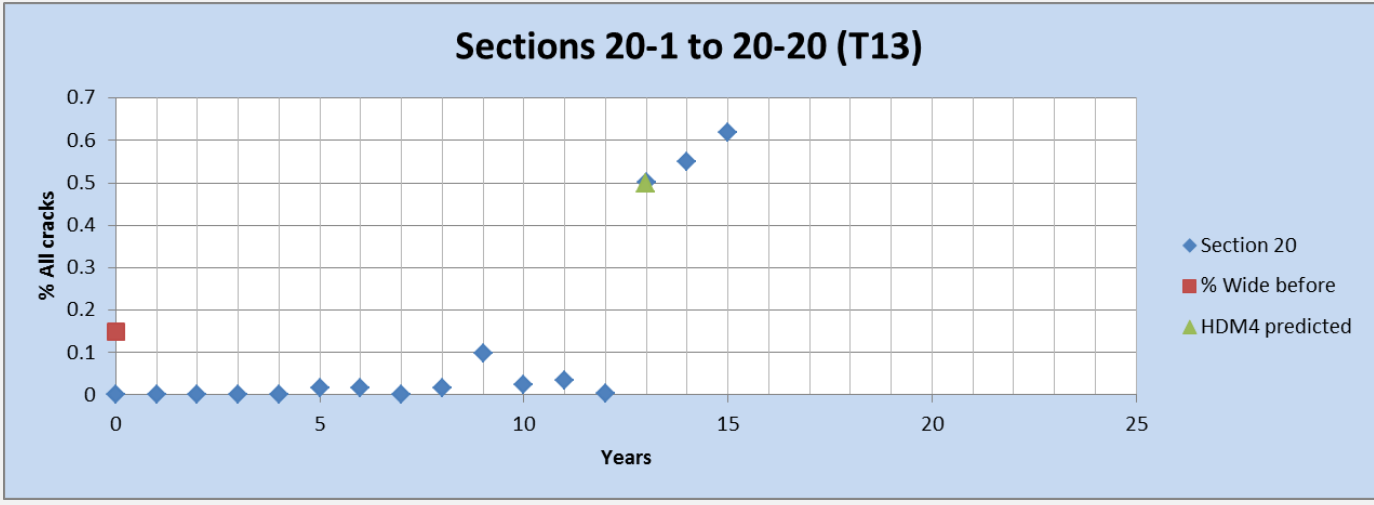
# Example: T13 Predicted vs Measured

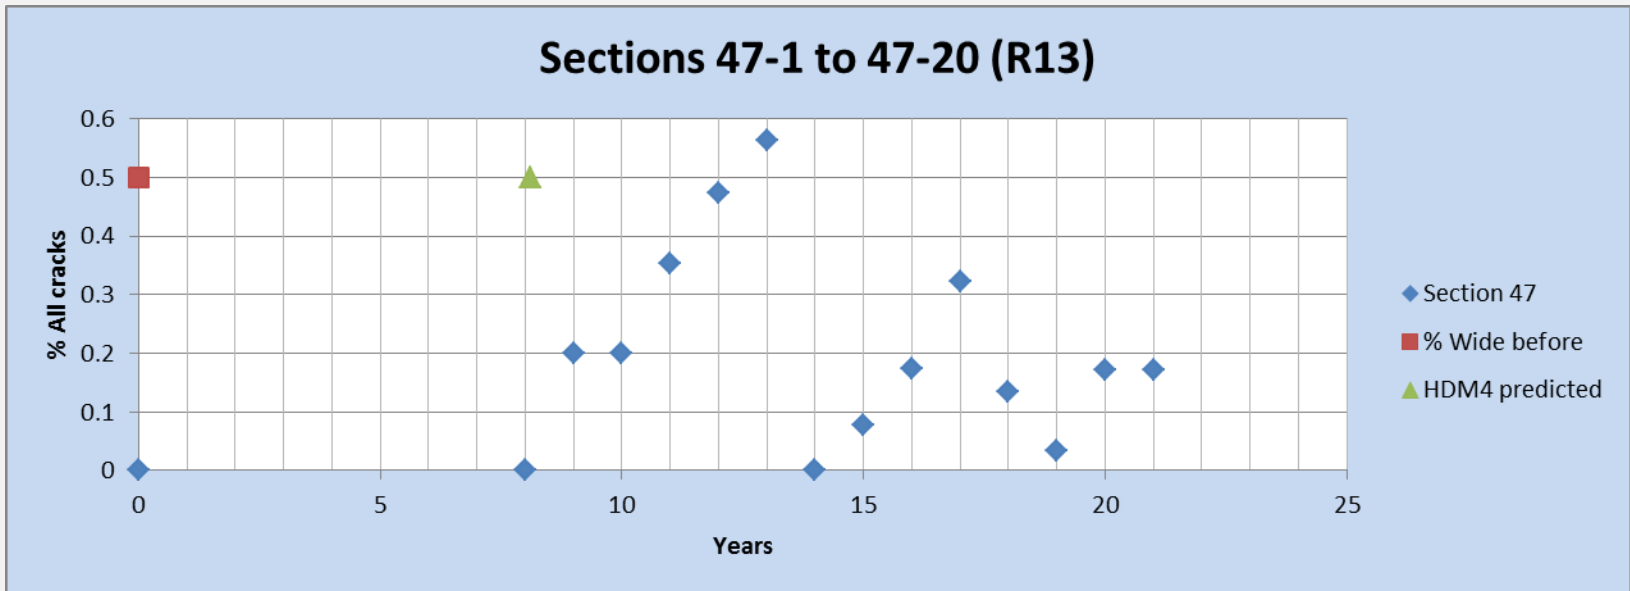
# Example: R13
