N1/1 UTCRCP PERFORMANCE

(RPF November 2011)

G VAN ZYL

Background

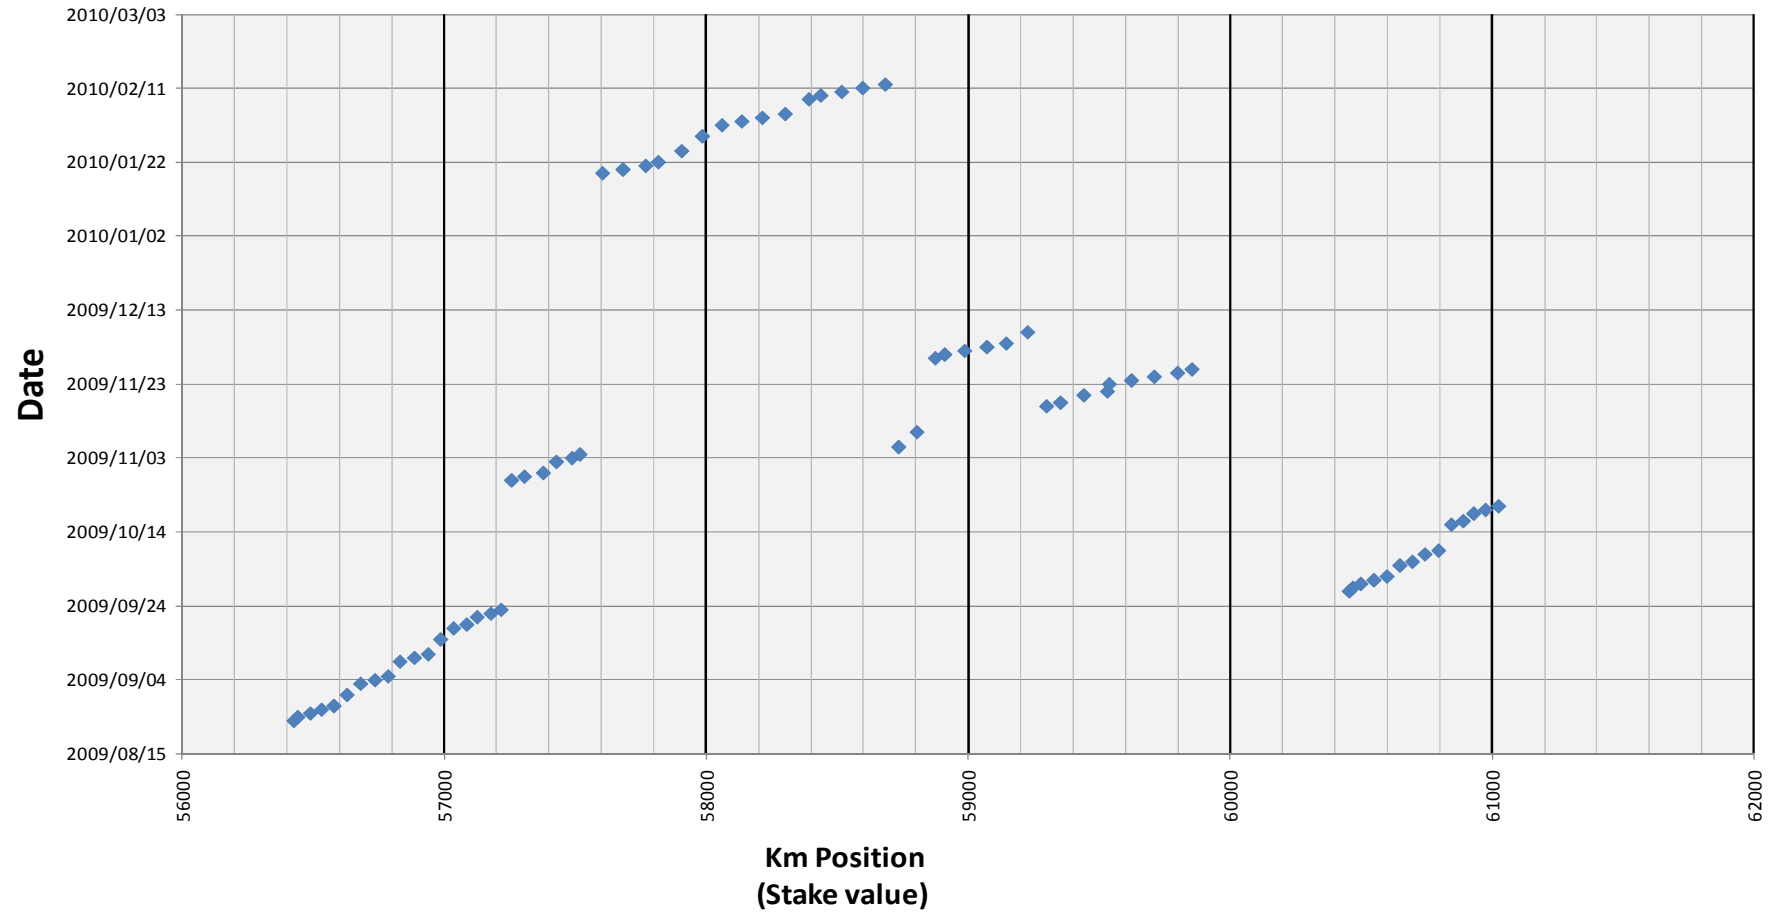
Construction sequence

N1/1 UTCRCP Sequence of Construction

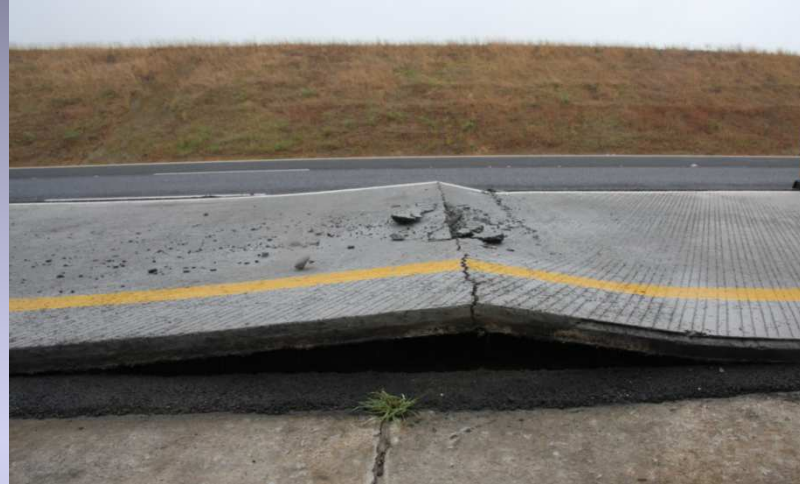
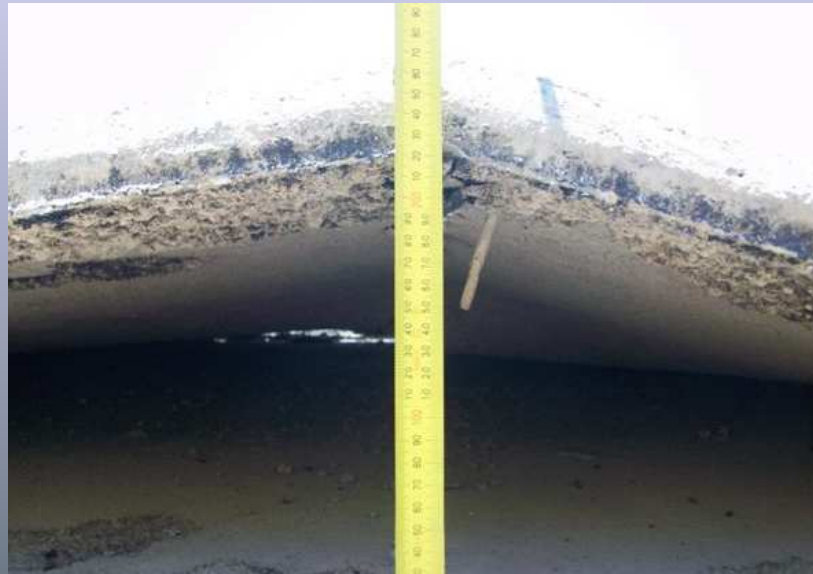
- 21/12/2010

Main Defect: Buckling

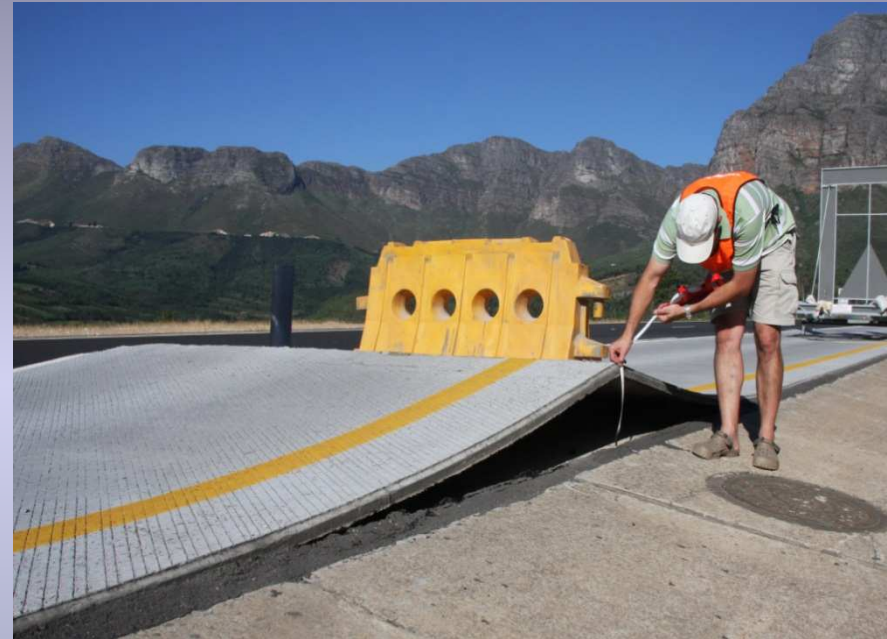
- 7/1/2011

Buckling

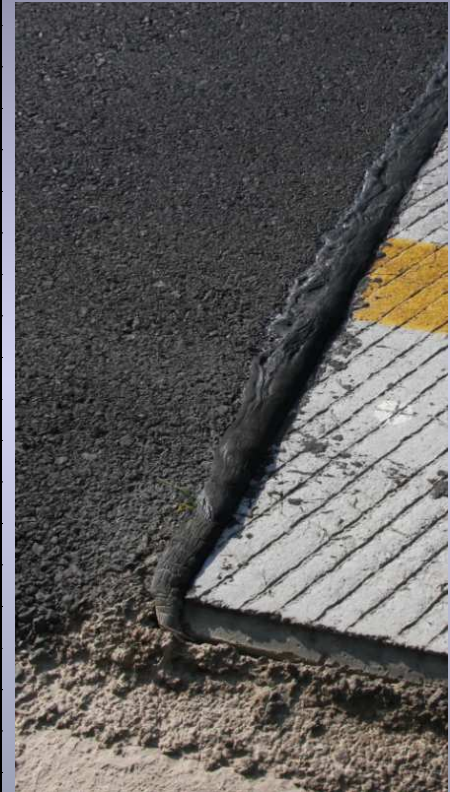
Temperature/ Expansion

km 59.051						
Time:	Surface Temperature:	Surface Temperature:	Surface Temperature:	Relative Movement:	Relative Movement:	Relative Movement:
	Concrete North	Concrete South	WC	North (mm)	South (mm)	Overall (mm)
08:00	22.1	21.9	27.3	20	25	45
09:00	25.8	24.9	29.3	19	23	42
10:00	35.3	33.6	42	17	21	38
11:00	39.6	36.1	45.8	13	15	28
12:00	45.9	44.8	50.4	7	10	17
13:00	48.5	48.5	55.2	3	2	5
14:00	54.6	55.8	62.6	0	0	0
15:00	53.3	51.3	60	0	0	0
16:00	52.3	50.1	55.9	0	1	1
17:00	44.8	44.4	49.8	1	2	3
18:00	42.4	42.1	47.5	5	7	12
19:00	34.7	34.4	37.5	8	9	17
20:00	29.9	29.6	33.1	11	12	23
22:00	24.4	23.3	27.7	15	18	33
00:00	22.3	21.6	26.8	16	22	38
02:00	18.5	17.6	23.6	18	23	41
04:00	17.8	17.5	22.7	20	26	46
06:00	15.8	15.6	20.6	20	26	46
08:00	23.3	22.5	30	19	24	43
			Distance from closest Int beam	249m	13m

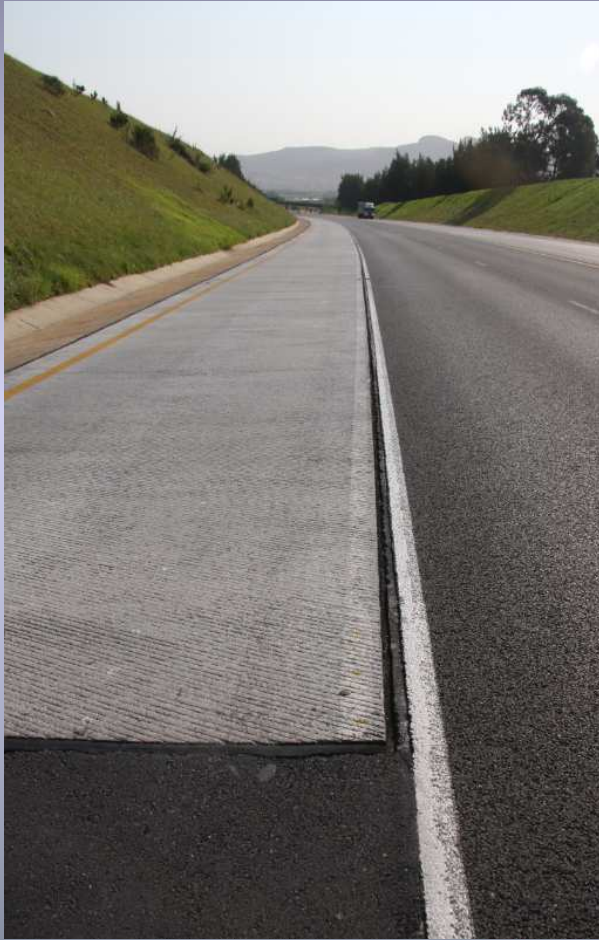
Creeping on curve

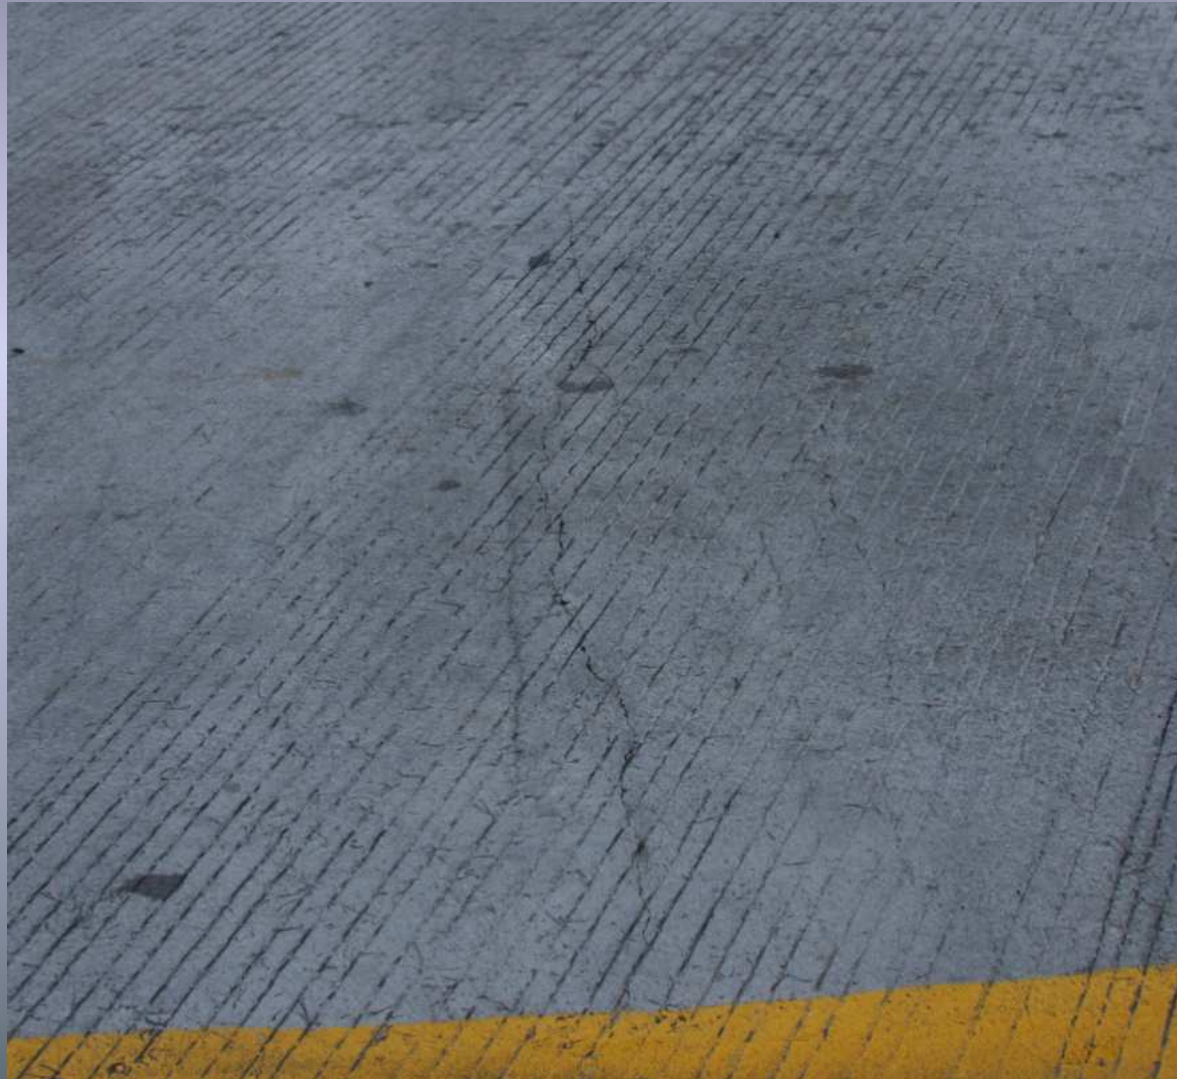
Transverse Cracking

- Random pattern (not mesh related)

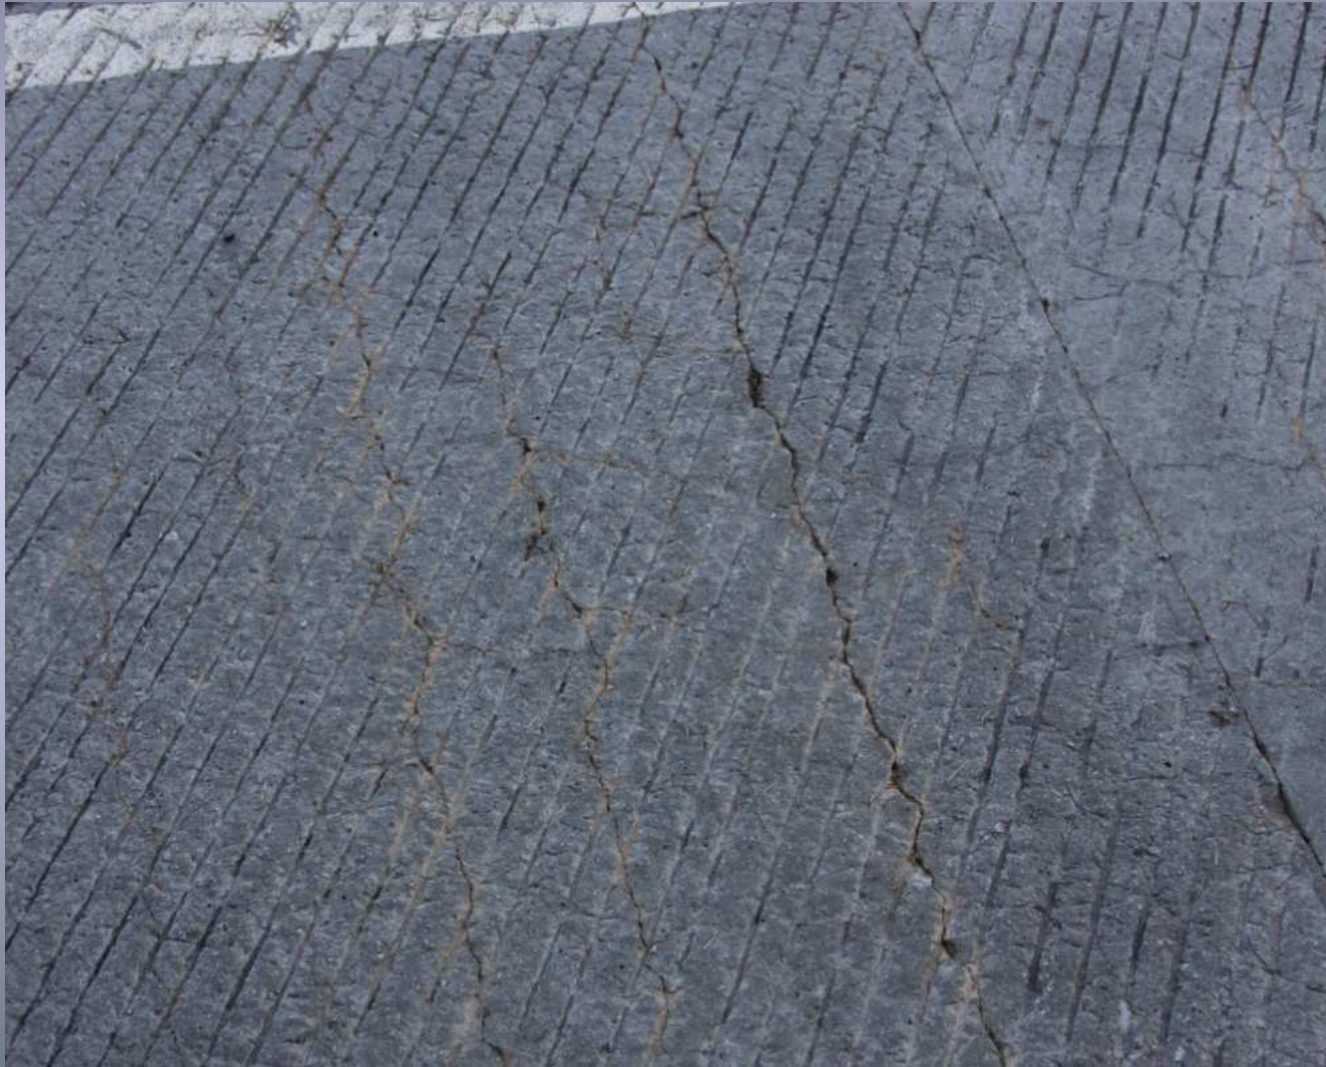
Transverse Mesh Cracking

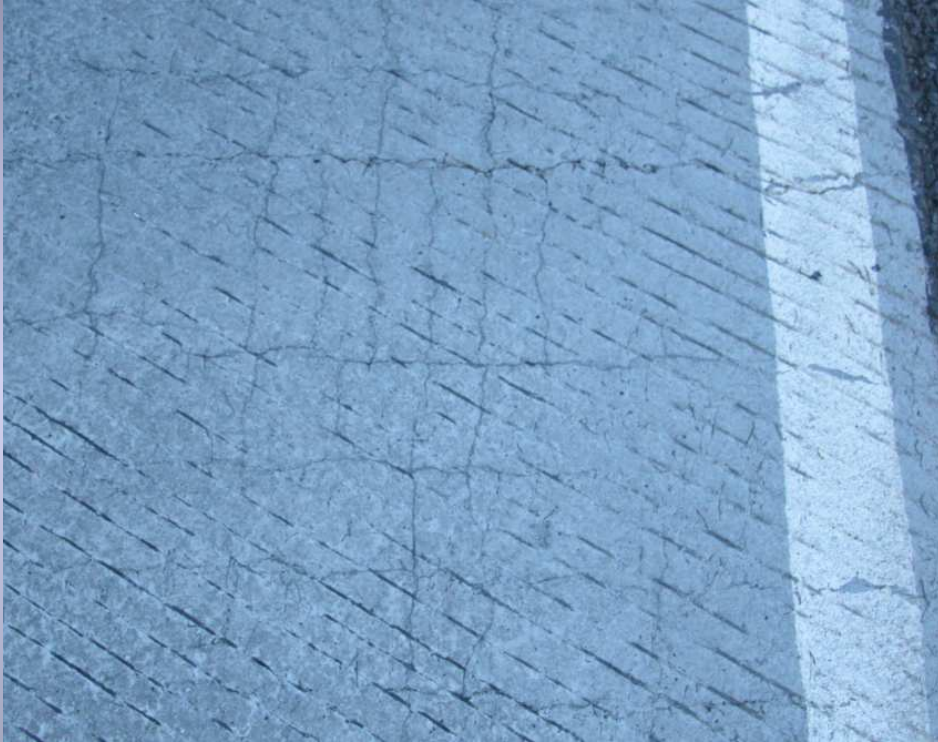
Block Mesh cracking

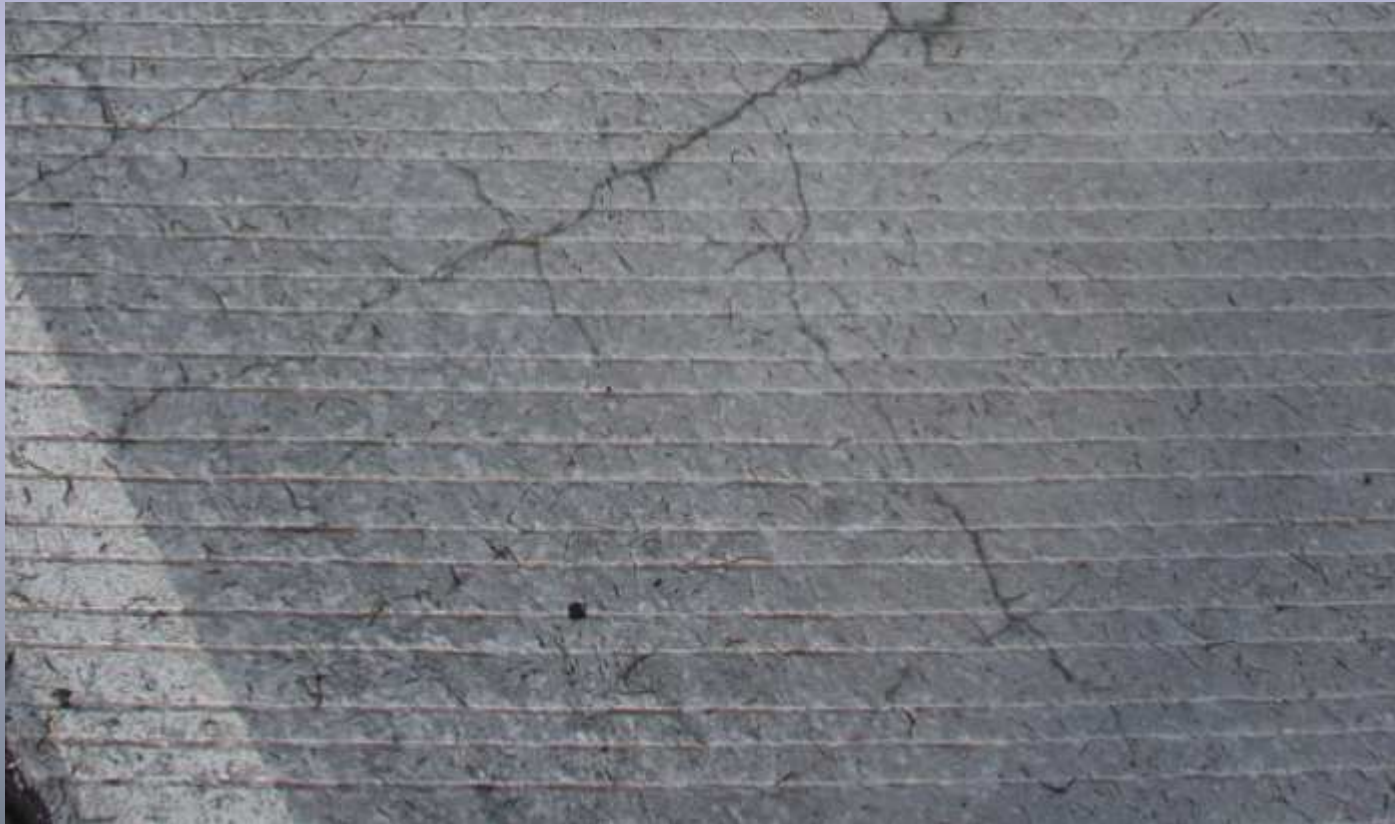
Longitudinal cracking

- **Not mesh related**

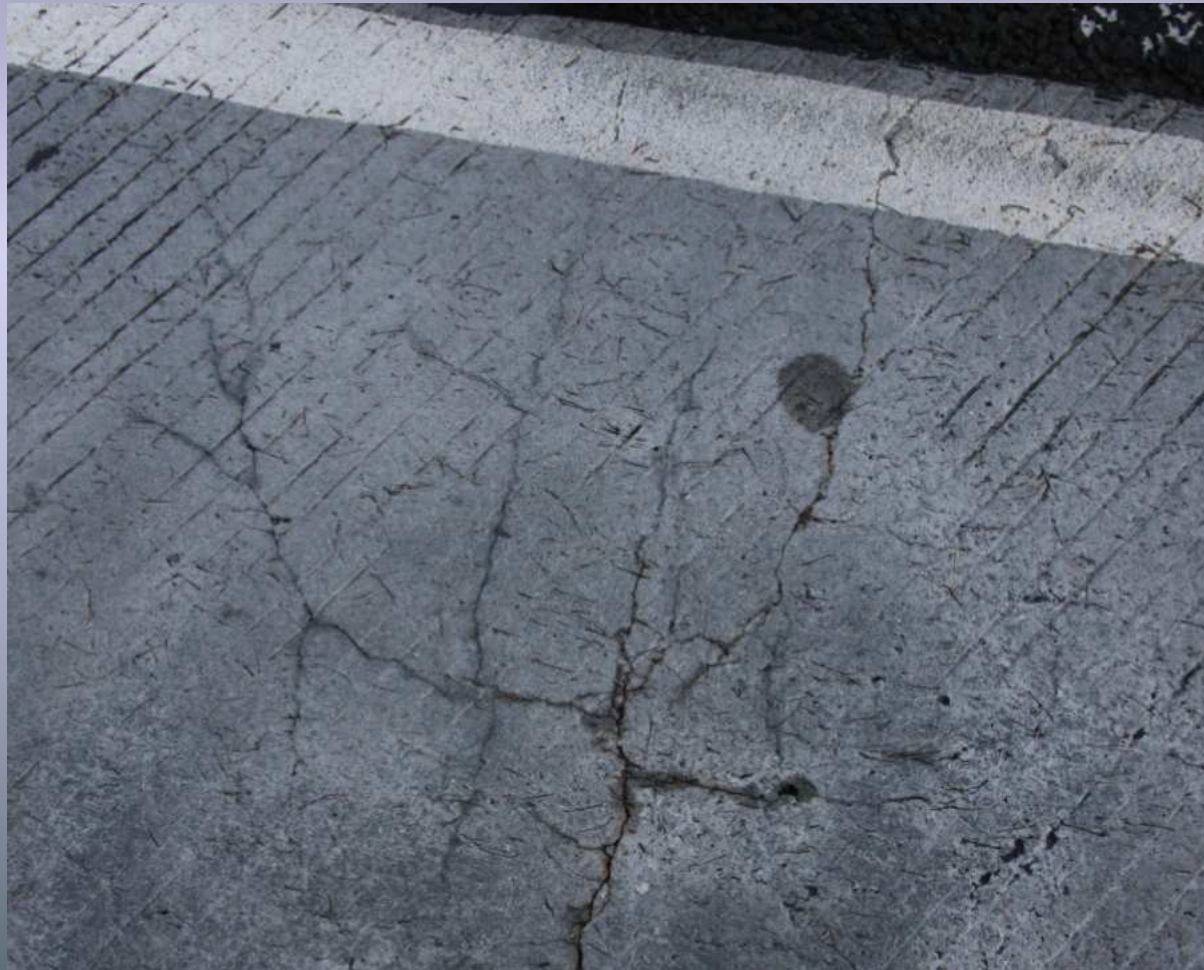
Crocodile cracking

- Irregular block pattern (not mesh related)

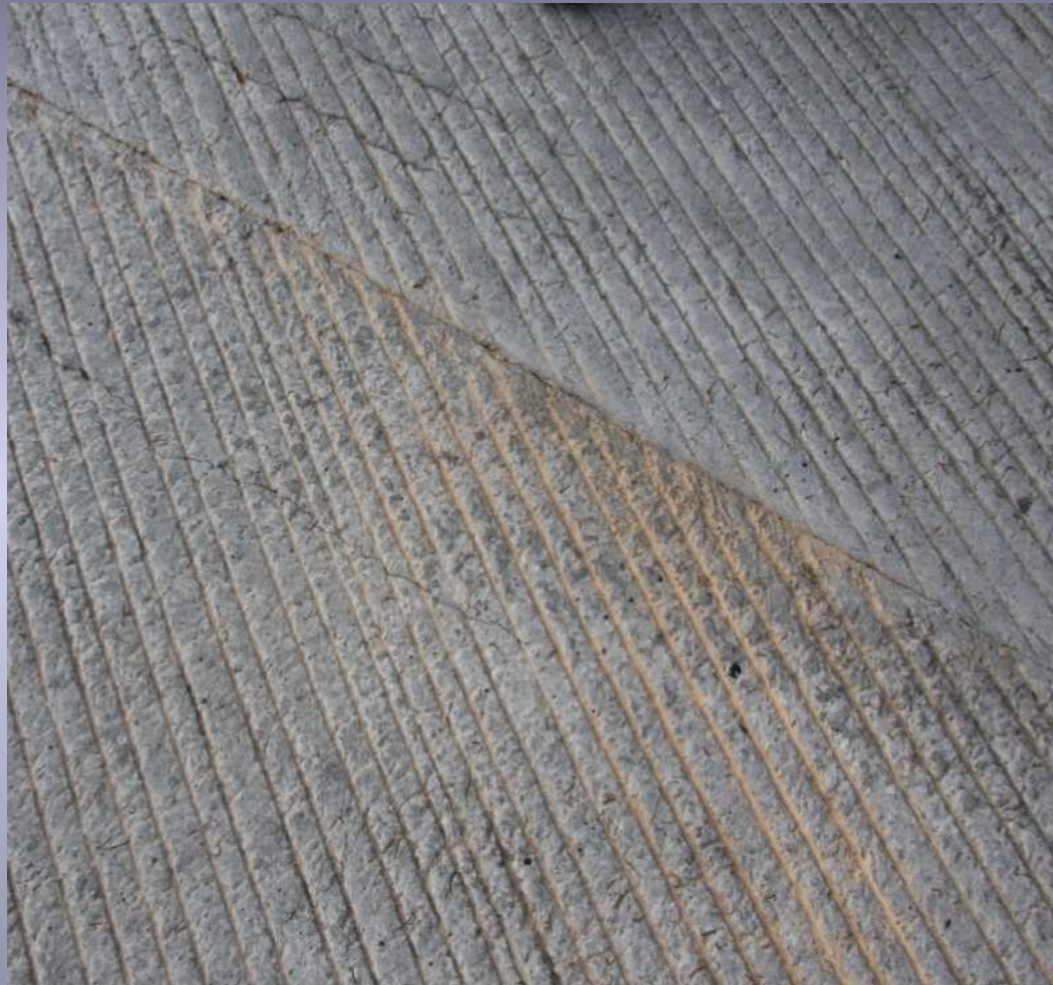
Pumping of Fines

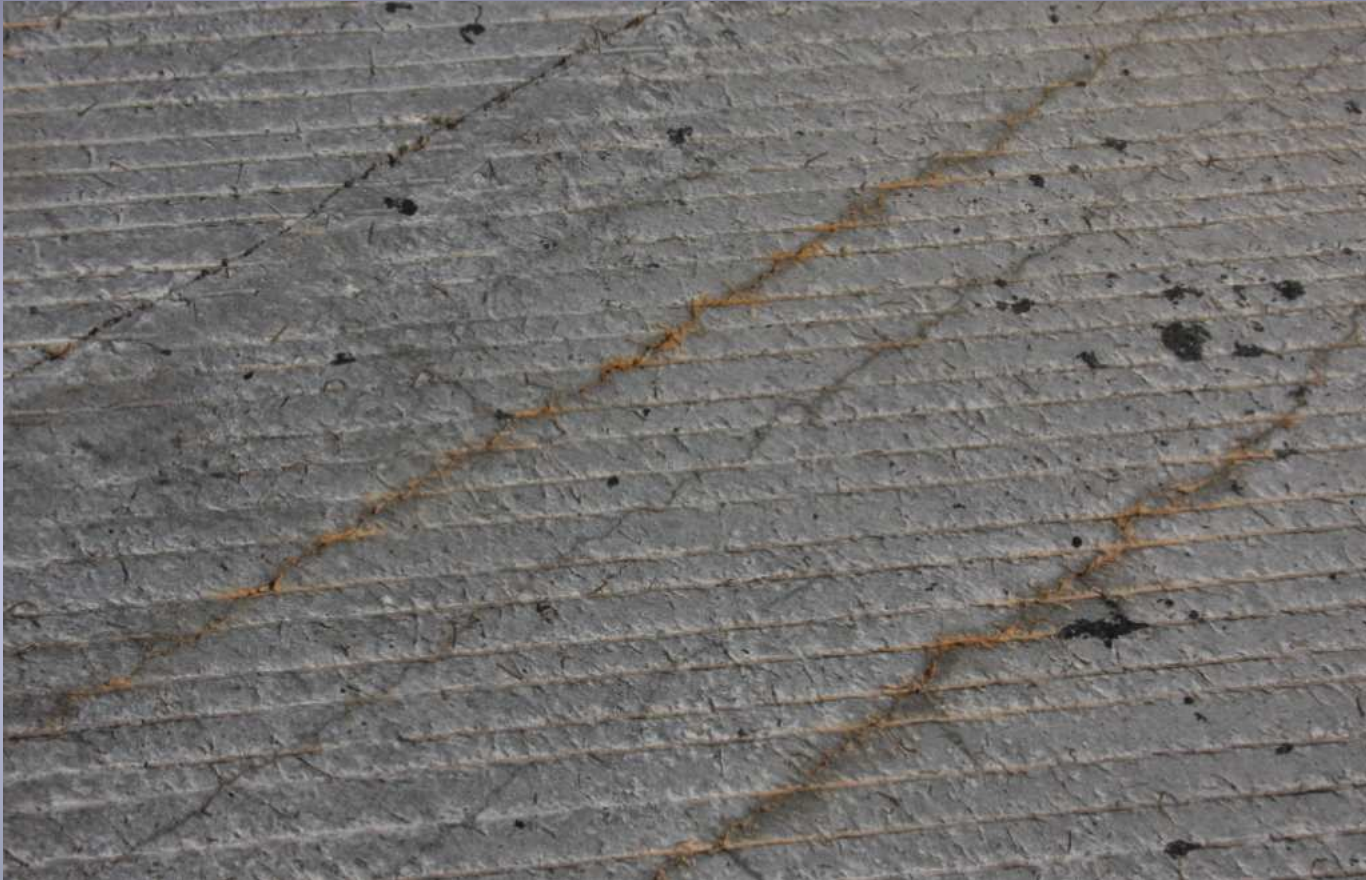
Rust

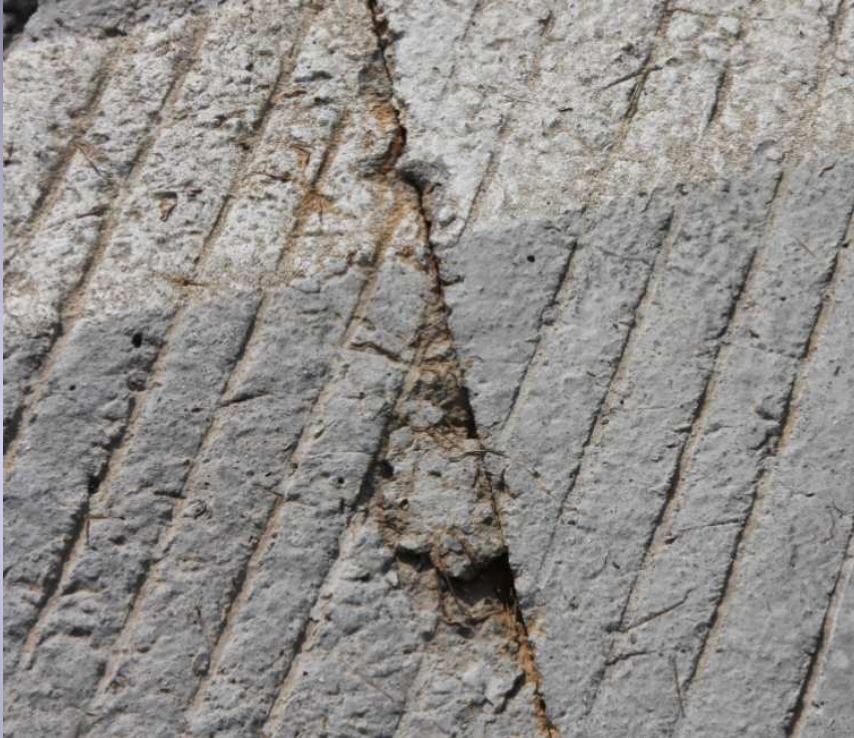
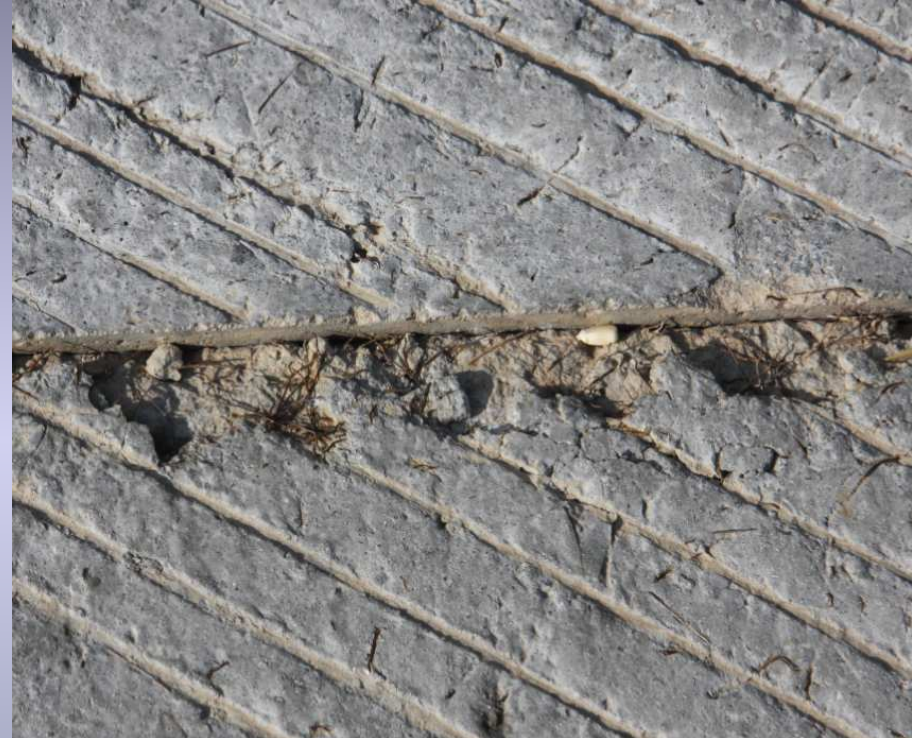
Transverse Joint Spalling

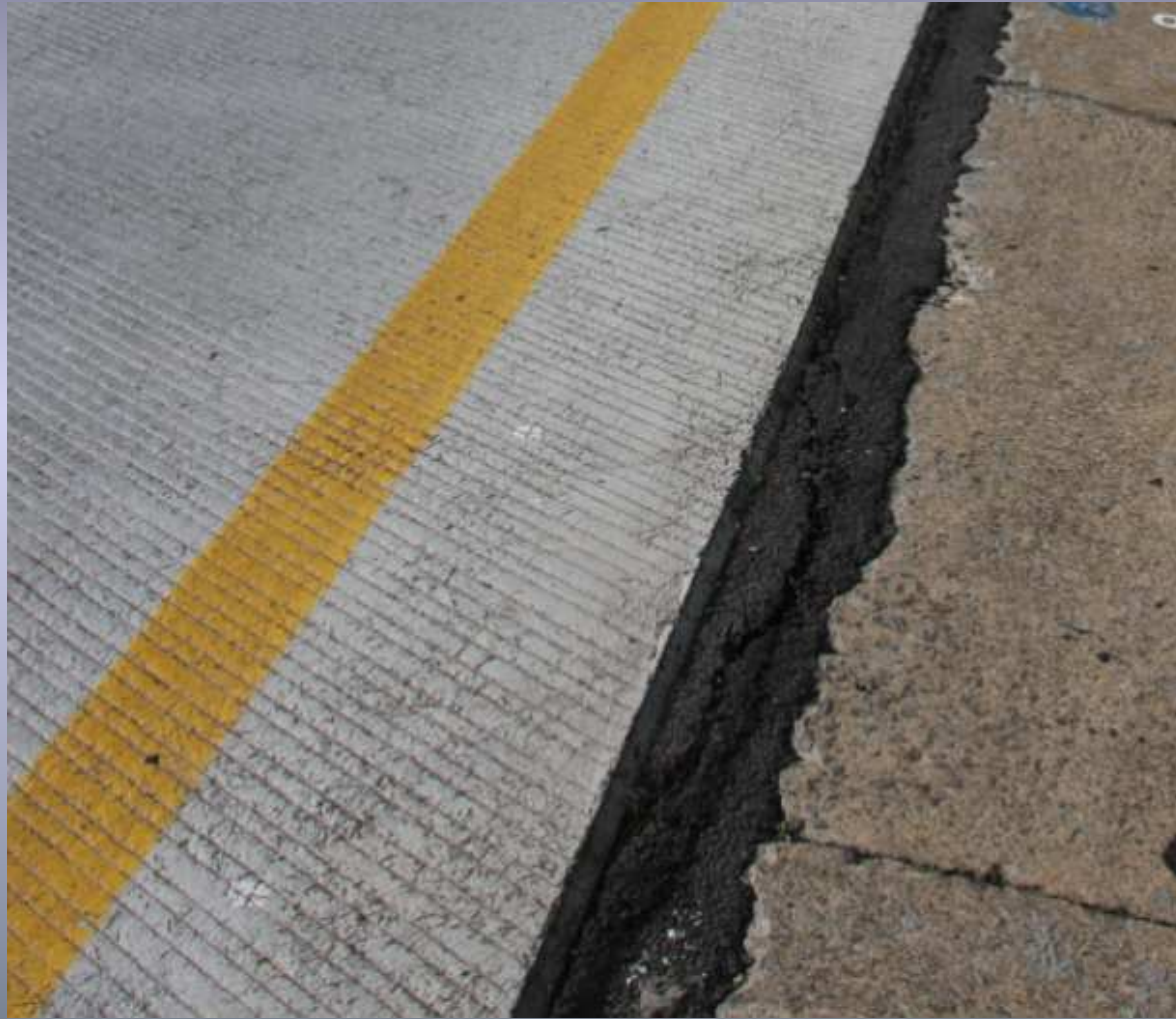
Longitudinal joint

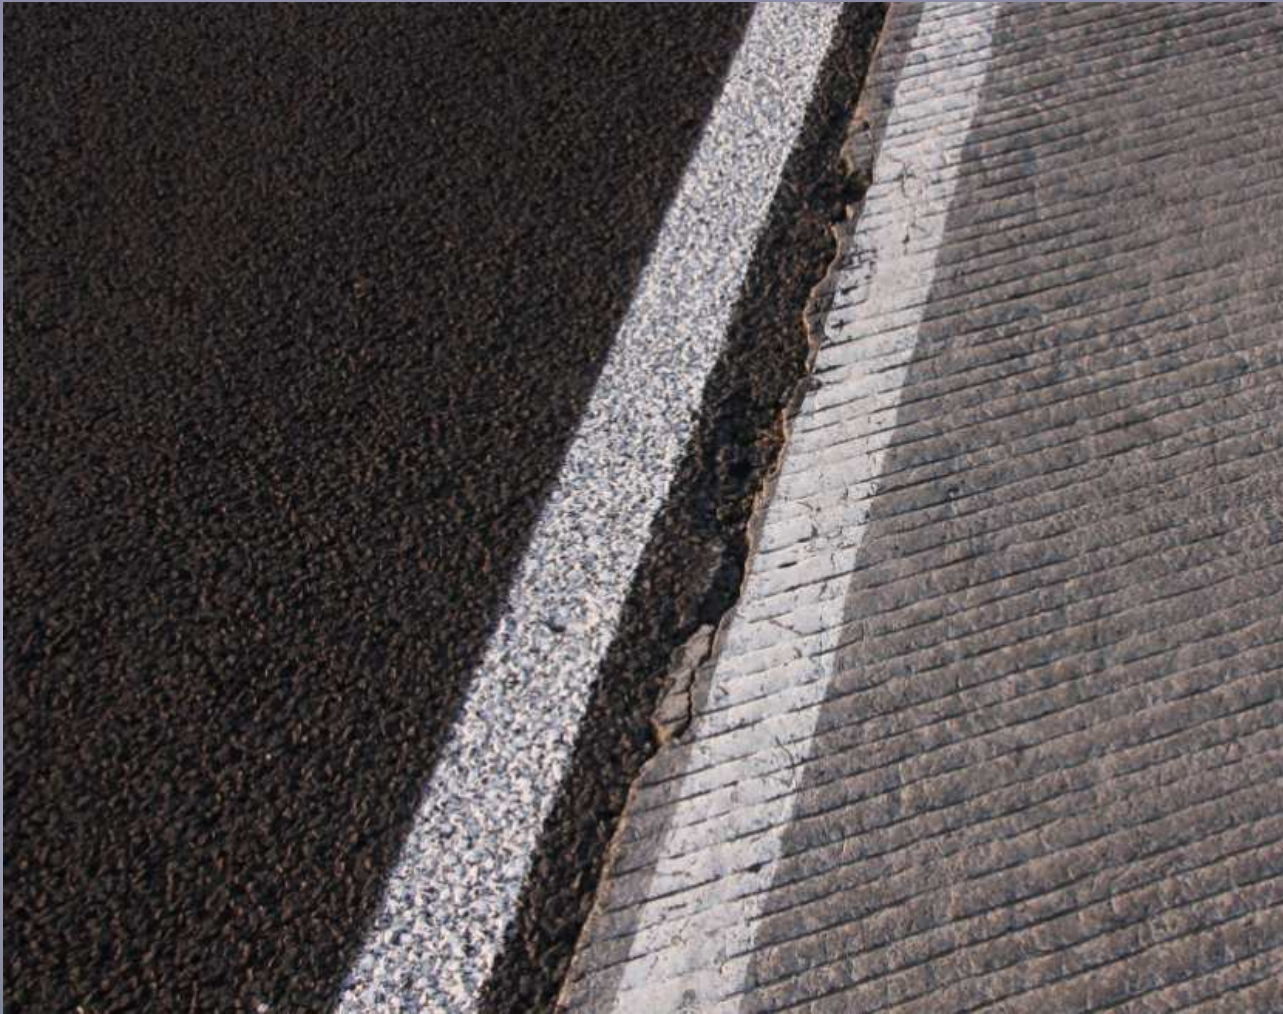
Edge breaks

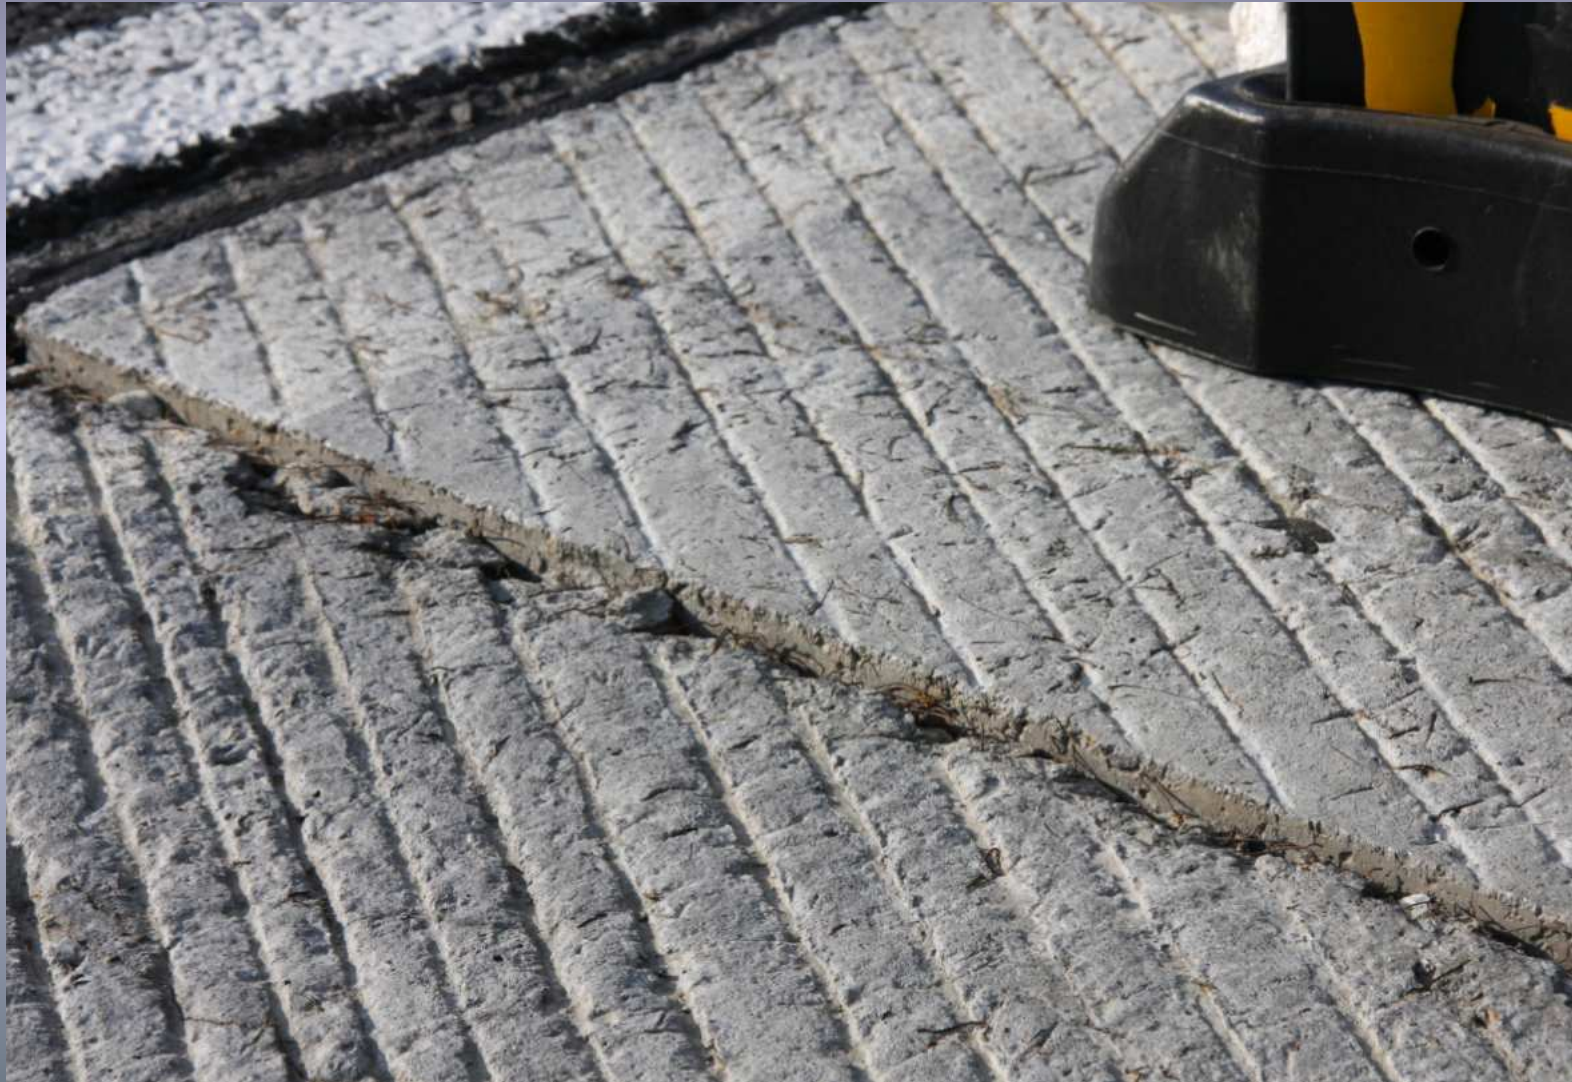
Step

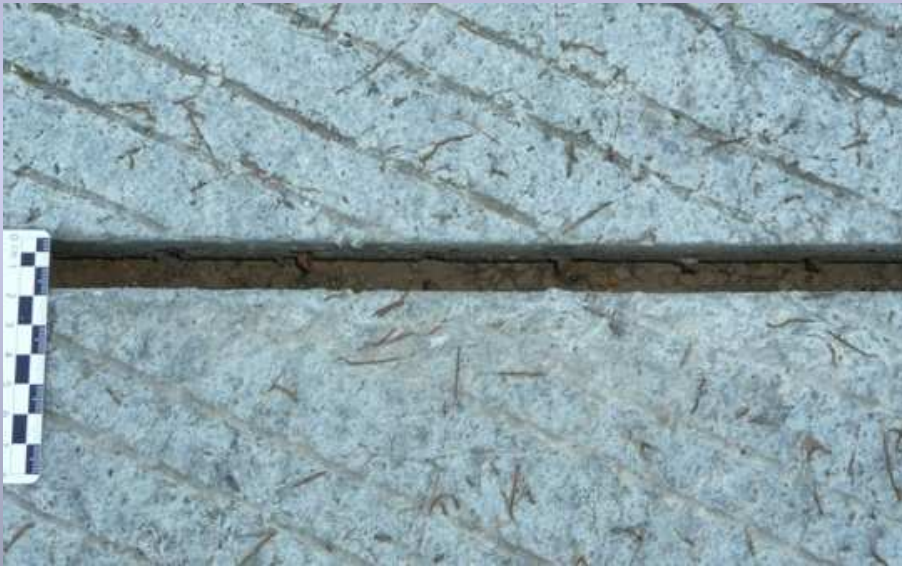
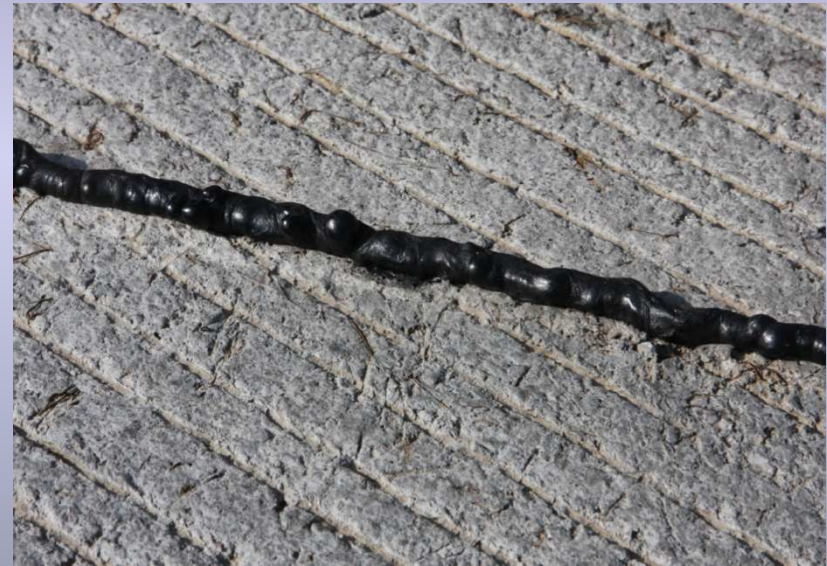
Transverse Joint
