Jointed Concrete Pavement Restoration using **Ultra Thin Continuously Reinforced Concrete** on Airport Aprons

*OR Tambo International Airport (ORTIA)
Performance of UTCRCP Experimental Sections*

34th Road Pavement Forum (CSIR)

14 November 2017

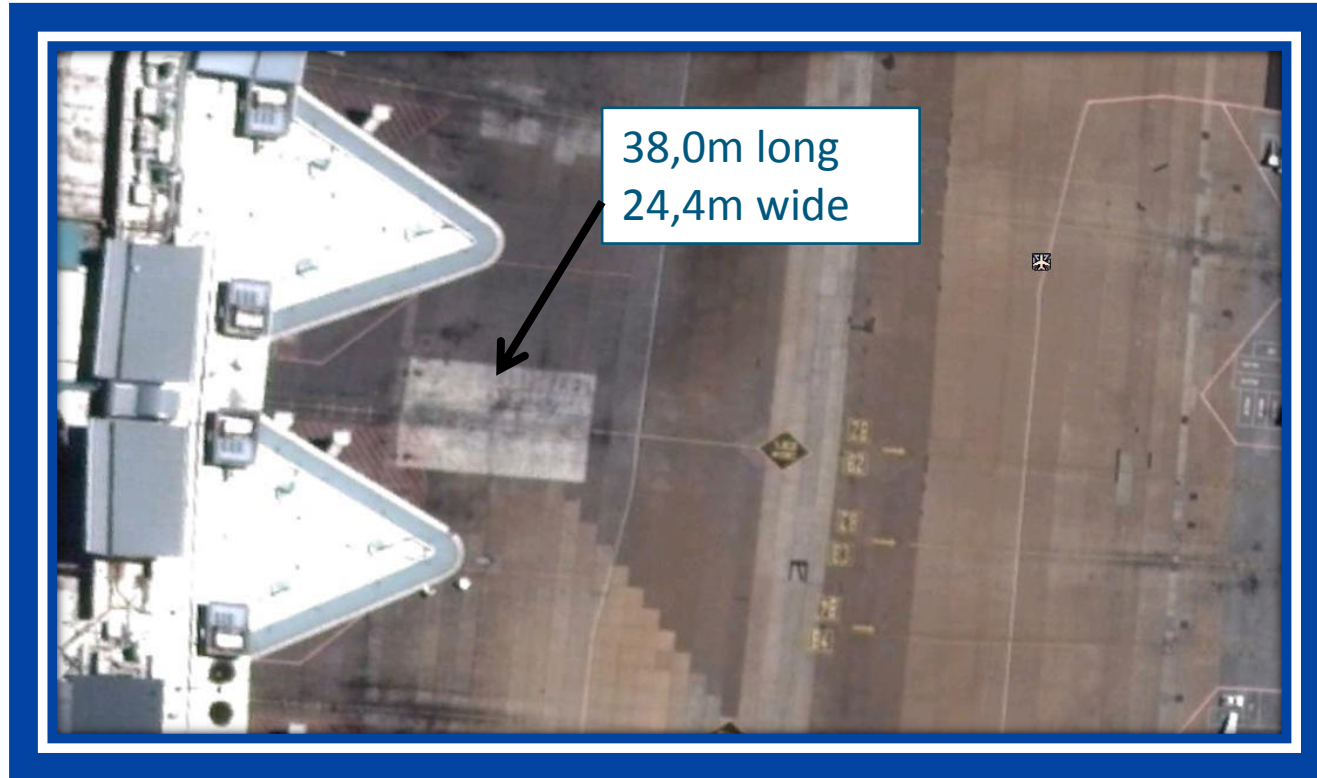
UTCRCPC Layout @ ORTIA – Stand A6. Constructed in May 2010

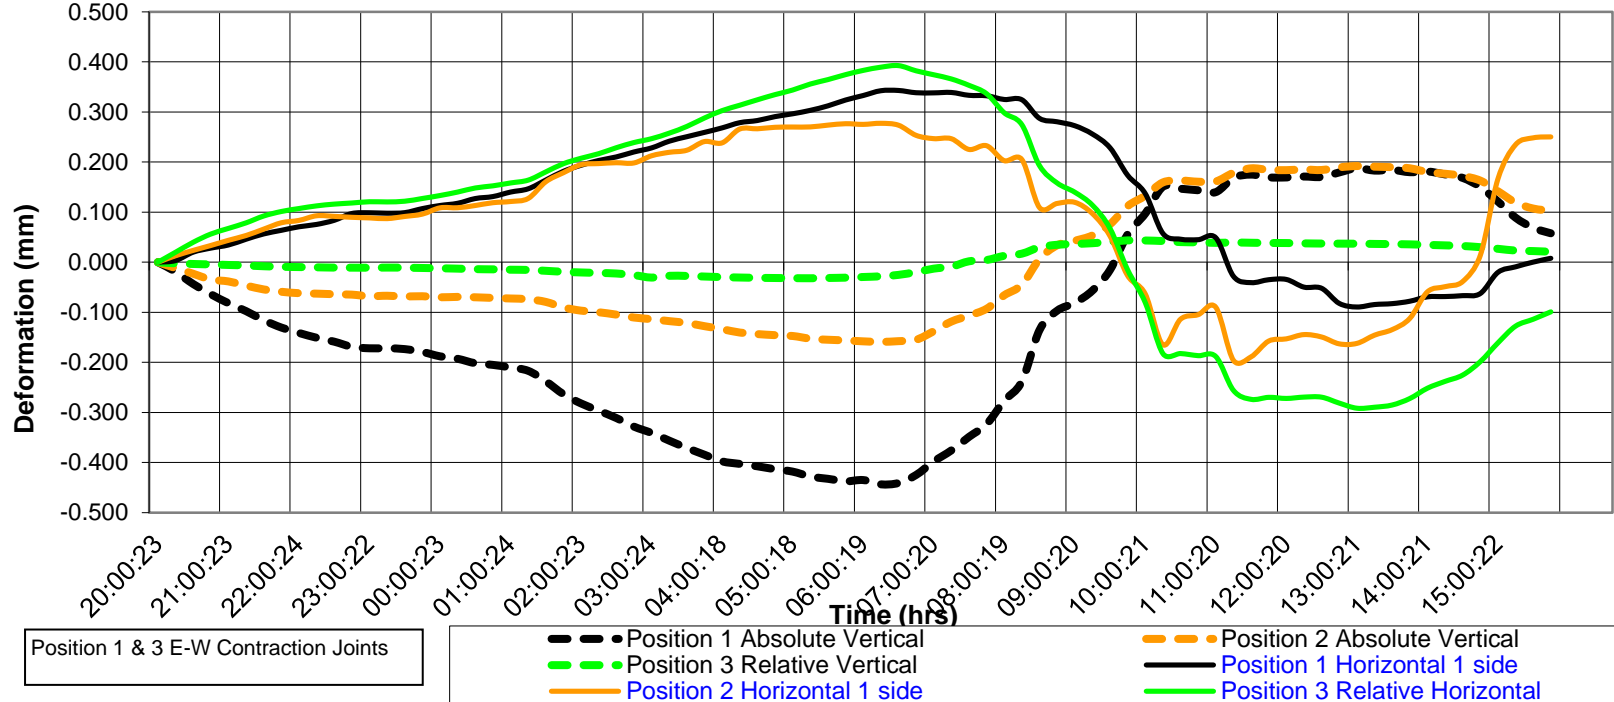
Environmental Measurements at OR Tambo Parking Bay A6 North

Note :- Test started after a shower of rain

Test run from 4 March 2010 @ 20H00 to 5 March 2010 @ 16H00

- Stand A6 – summary of temperature related joint movement - mm

<i>Max Contraction of Concrete</i>	0.393	during night
<i>Max Expansion of Concrete</i>	0.292	during day
<i>Total Horizontal Movement of Concrete</i>	0.684

<i>Upward Movement of Concrete</i>	0.192	during day
<i>Downward Movement of Concrete</i>	0.444	during night
<i>Total Vertical Movement of Concrete</i>	0.636

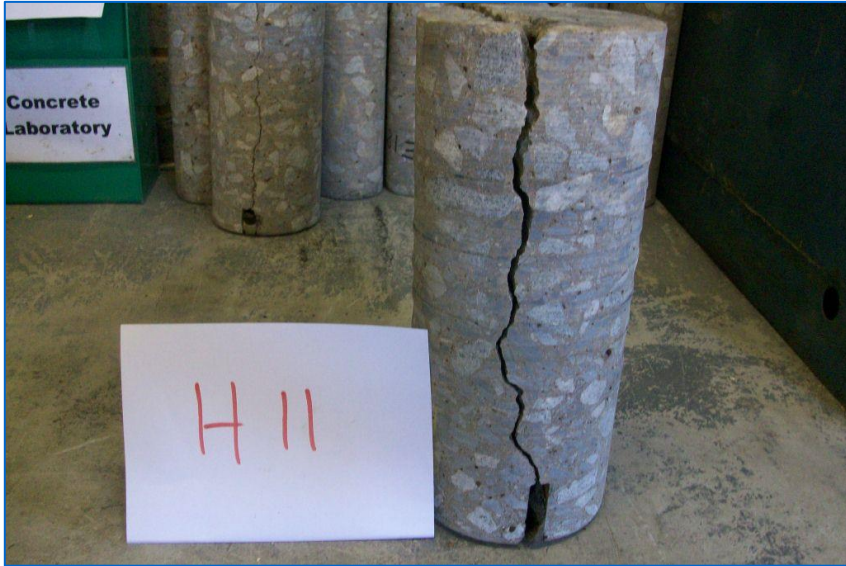
Sawn contraction joint

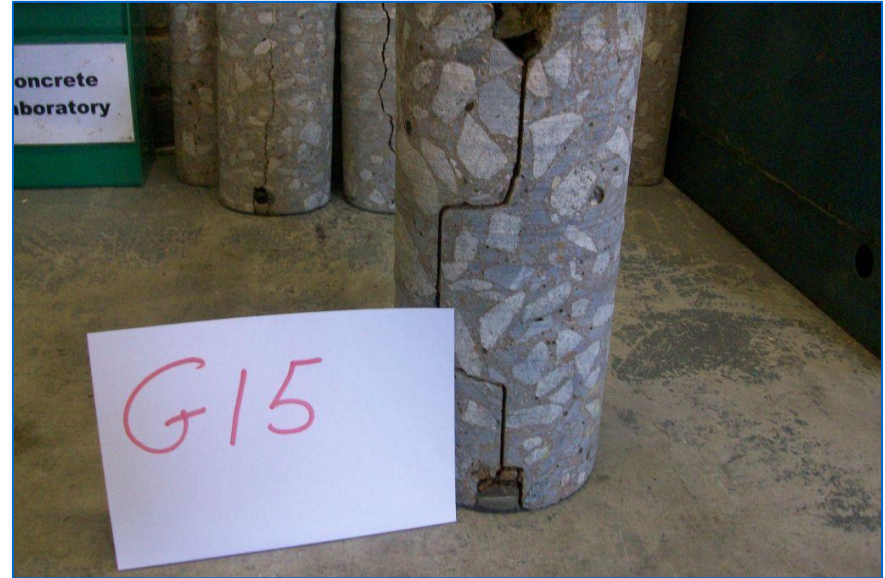
Keyed construction joint

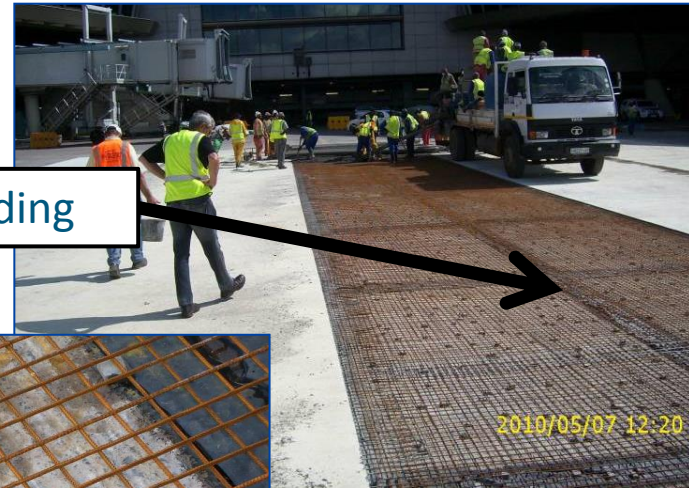
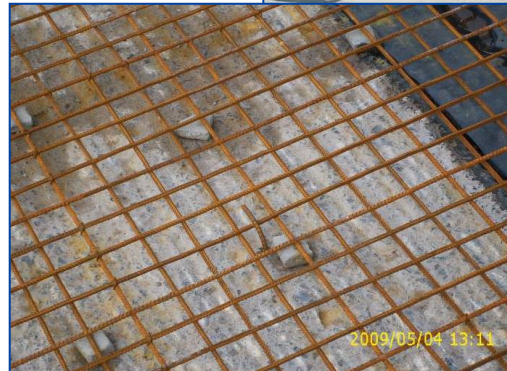
200mm debonding

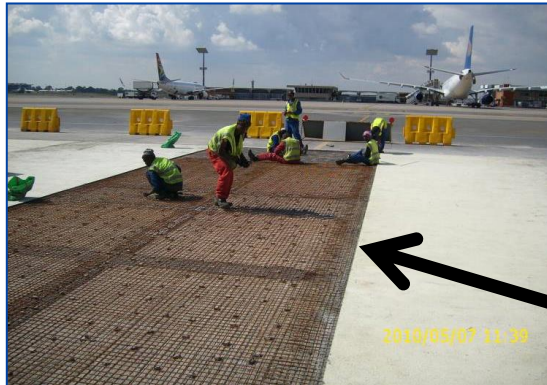
Double steel @ construction joint

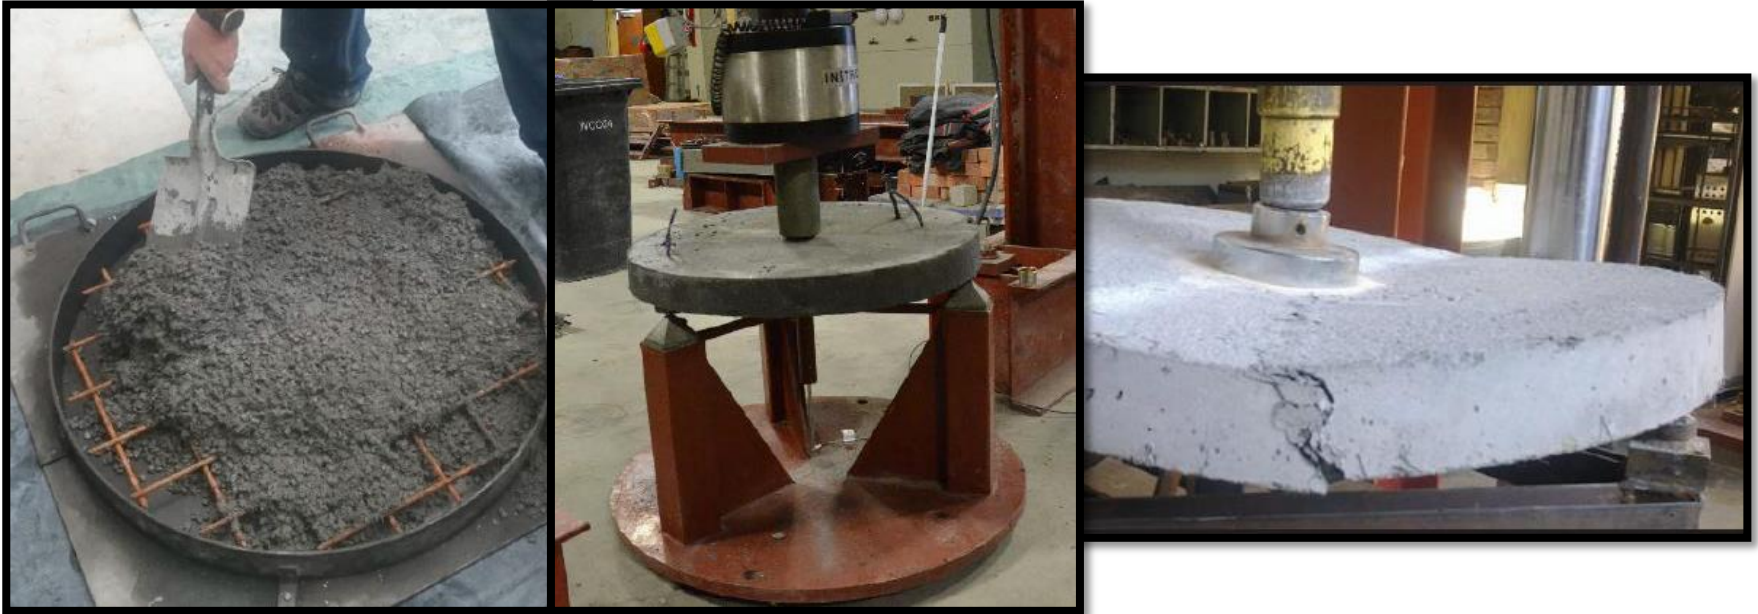
Energy Absorption Test (EAT) – Standard ASTM test - Adapted round disc test
(Round panel test) (Kearsley and Mostert)

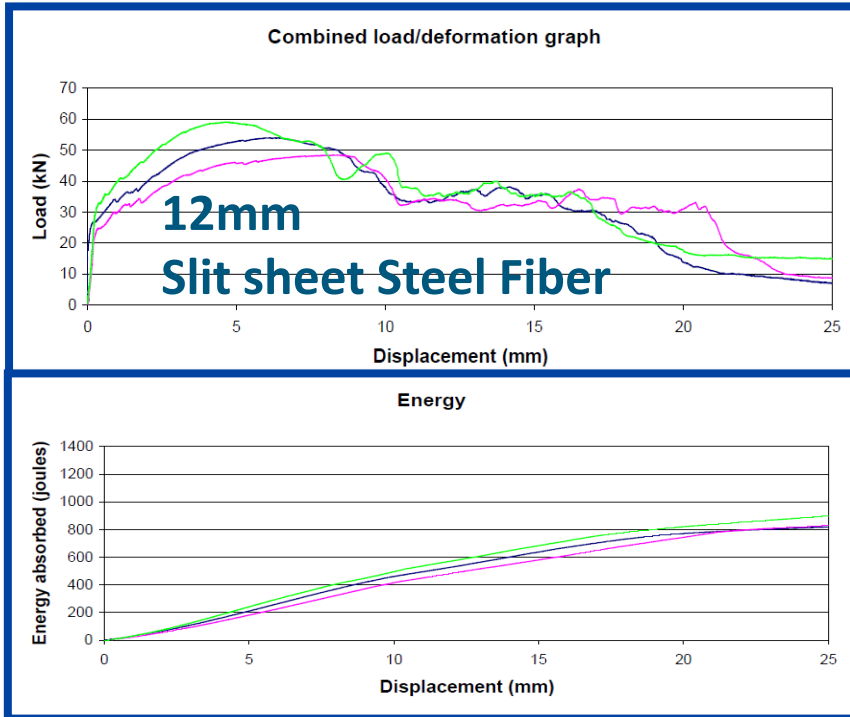
Stand A6

Energy Absorption Test (EAT) as adapted.

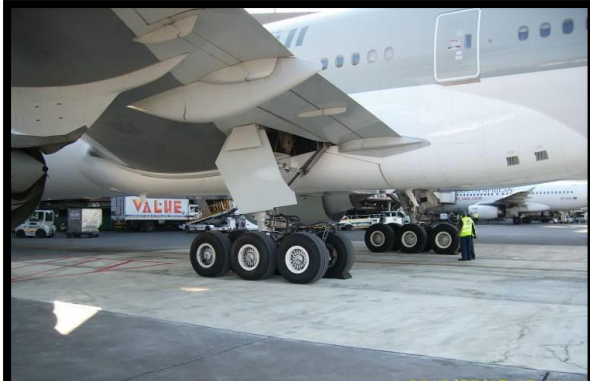
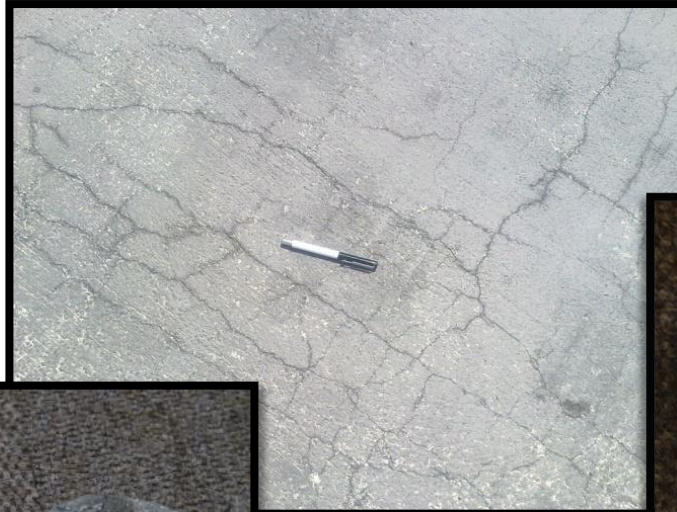
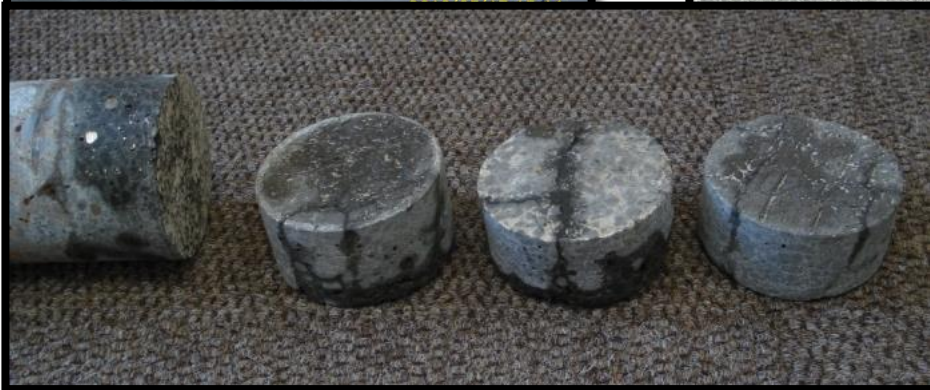
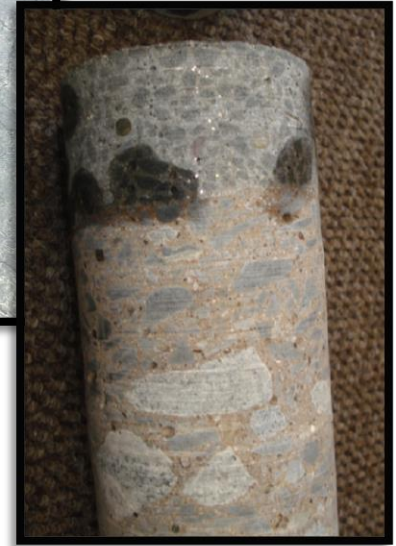
- 2012 - Crack Pattern After 4000 Load Applications

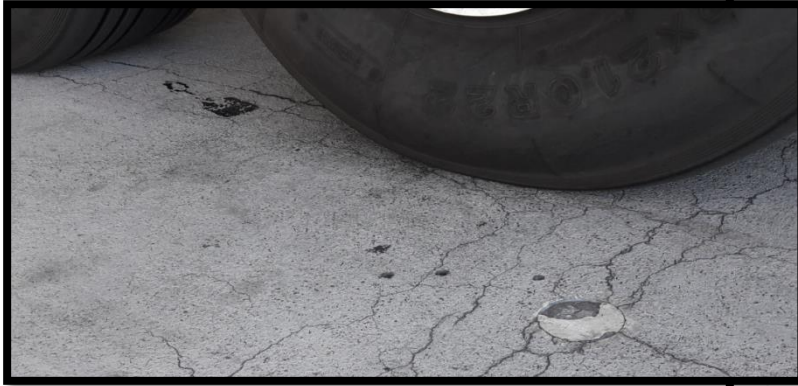
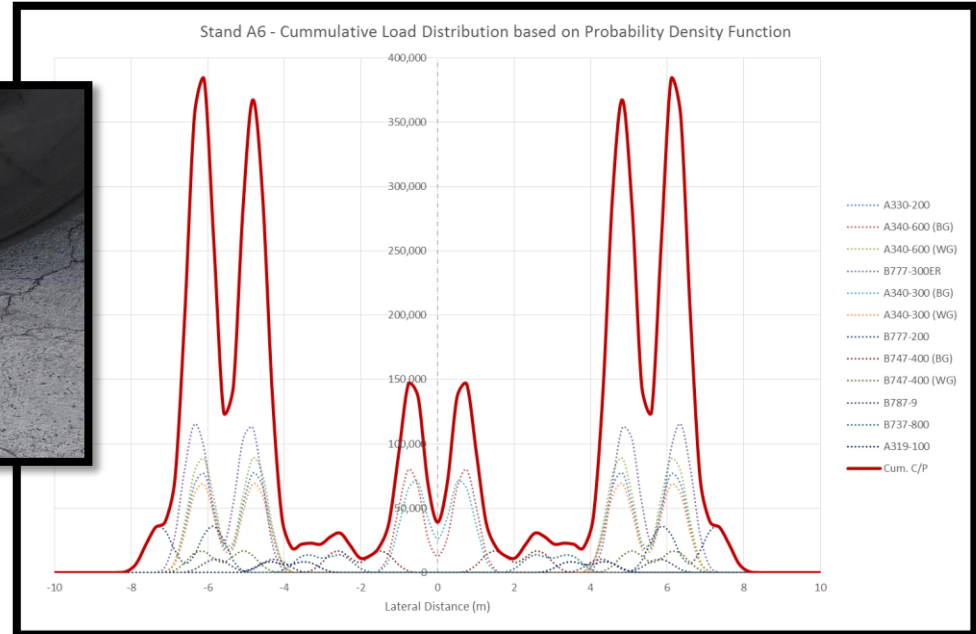
- 2017 - Crack Pattern After 10 500 Load Applications (7 years)

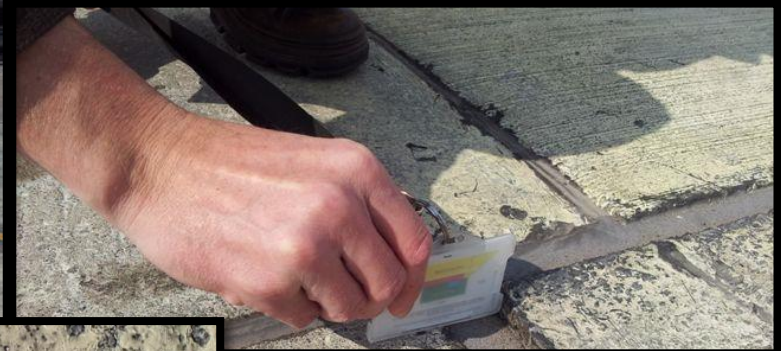
Corner curling of debonded slab after construction

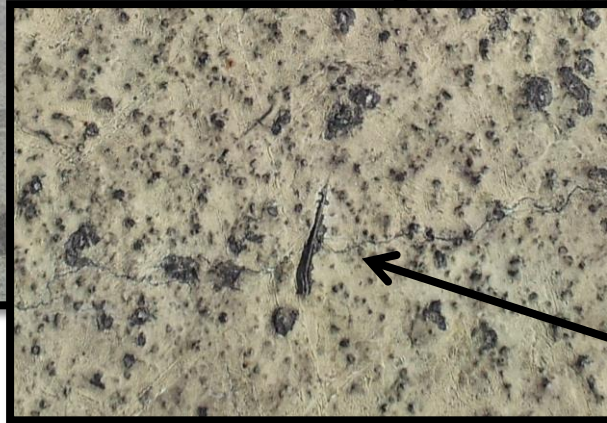
Fine hairline crack after construction

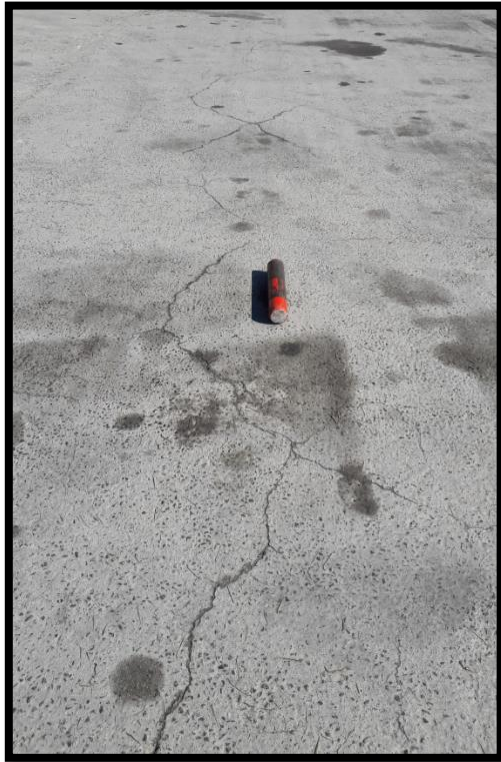
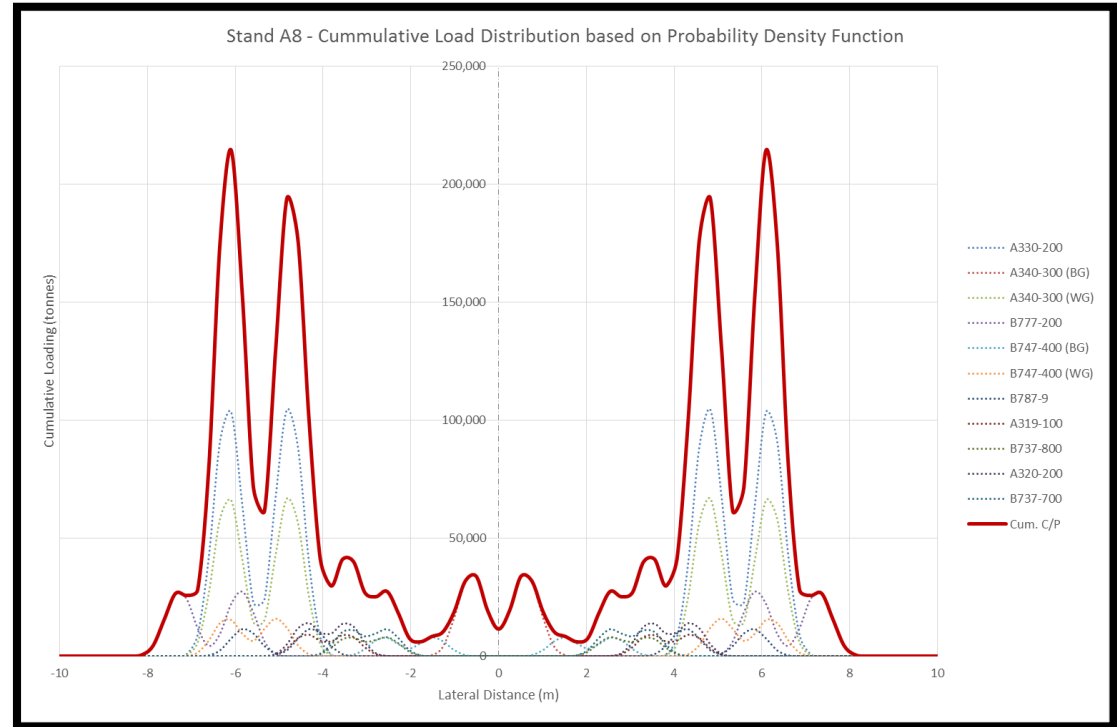
- 2017 - Crack Pattern After 7 500 Load Applications (5 years)

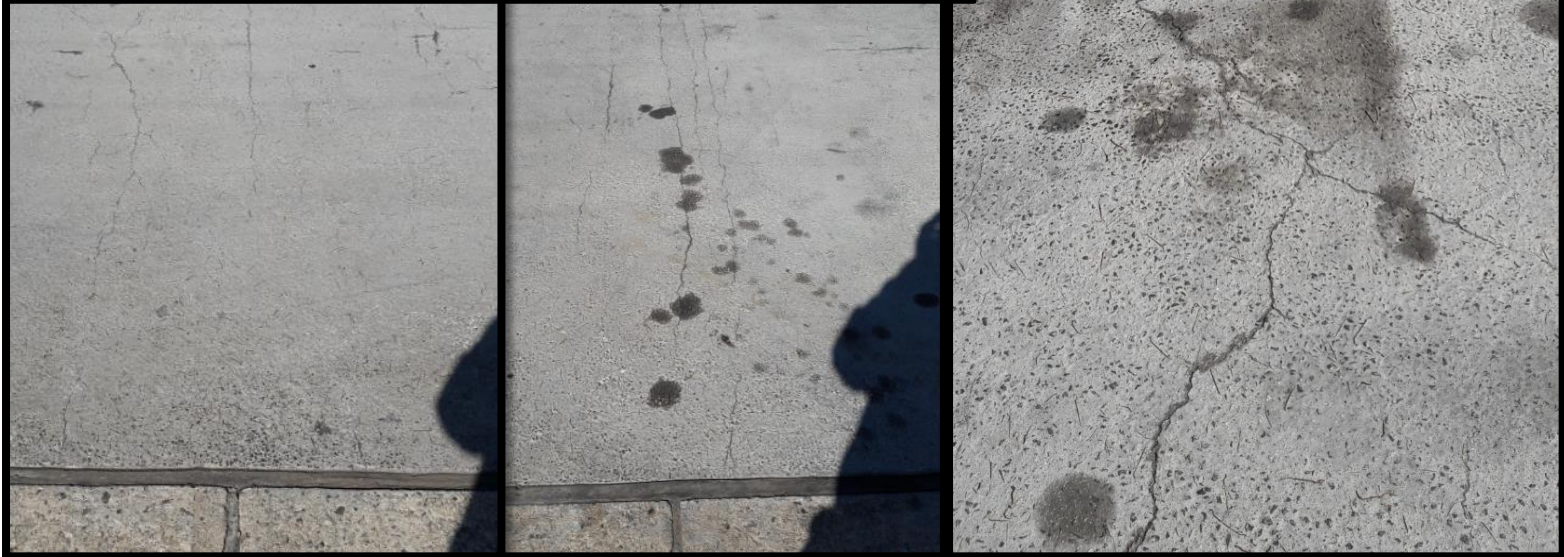
■ Crack Pattern After 7 300 Load Applications

- Significantly less cracking
- One pronounced staggered crack along joint
- 1,2 – 1,5m debonding
