**ROAD PAVEMENT FORUM 2019**

**Basic Crystalline Material Durability**

Izak Breytenbach

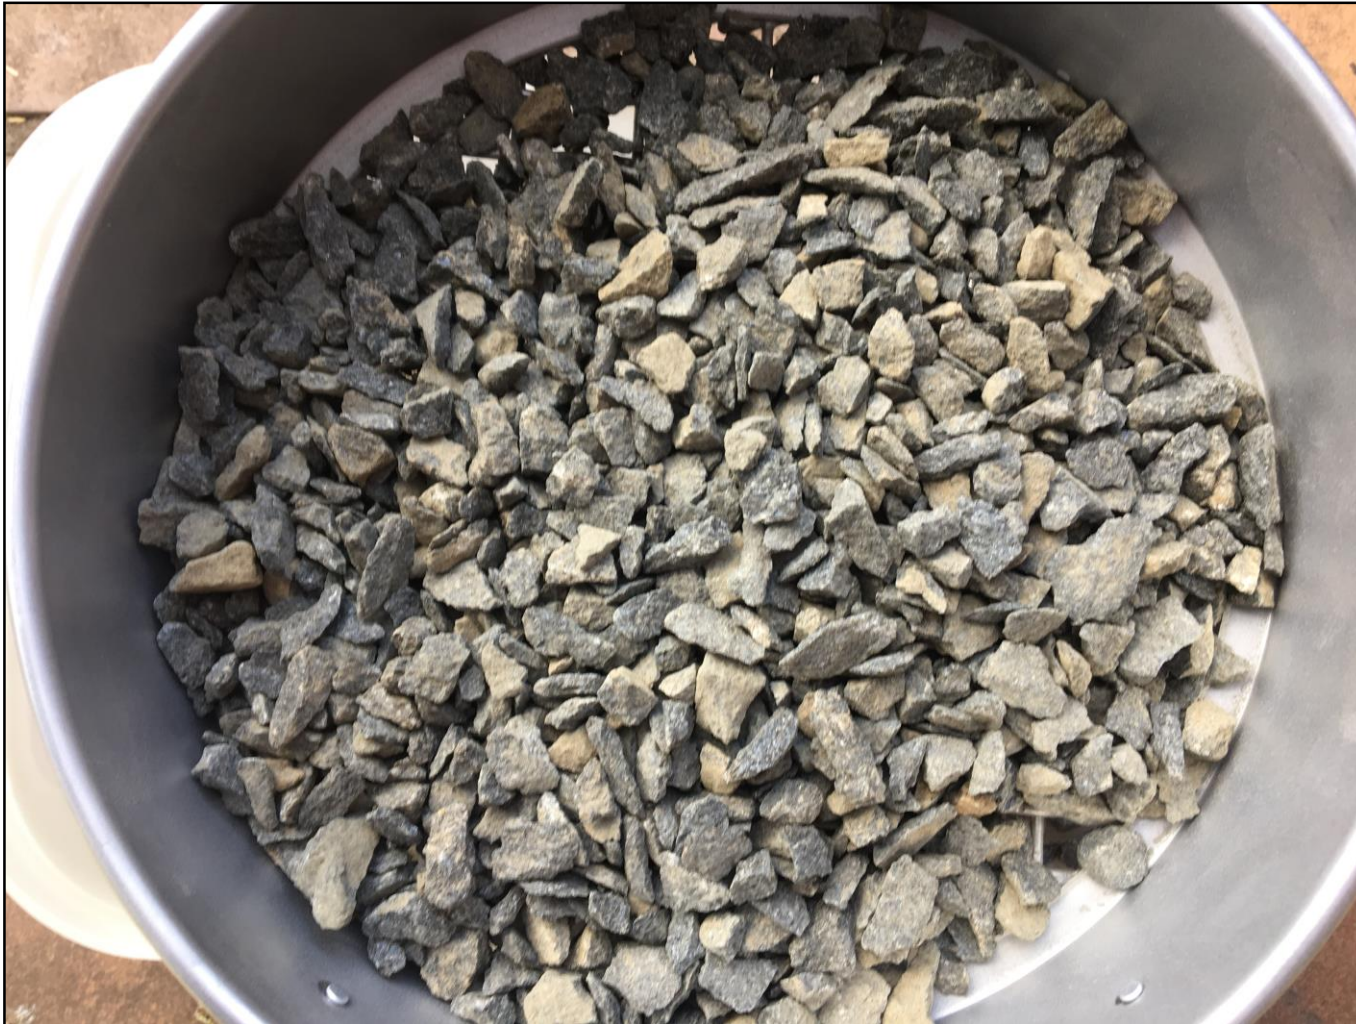
- Definitely not!
- Section 3602 (a) of COLTO (1998) for aggregate:
  - “...It shall not contain any deleterious material such as weathered rock, clay, shale or mica...”
- Consider the geological origin of dolerite/basalt: mostly intrudes through country rock (e.g. sandstone, shale, tillite, etc.)
- Materials are often contaminated by assimilated sedimentary rock originating from the country rock (i.e. xenoliths)
- Know your geology!
