Heavy Vehicle Simulator evaluation of the Super-Slab® pre-fabricated concrete panels for pavement rehabilitation

Louw du Plessis
20 – 21 May 2014

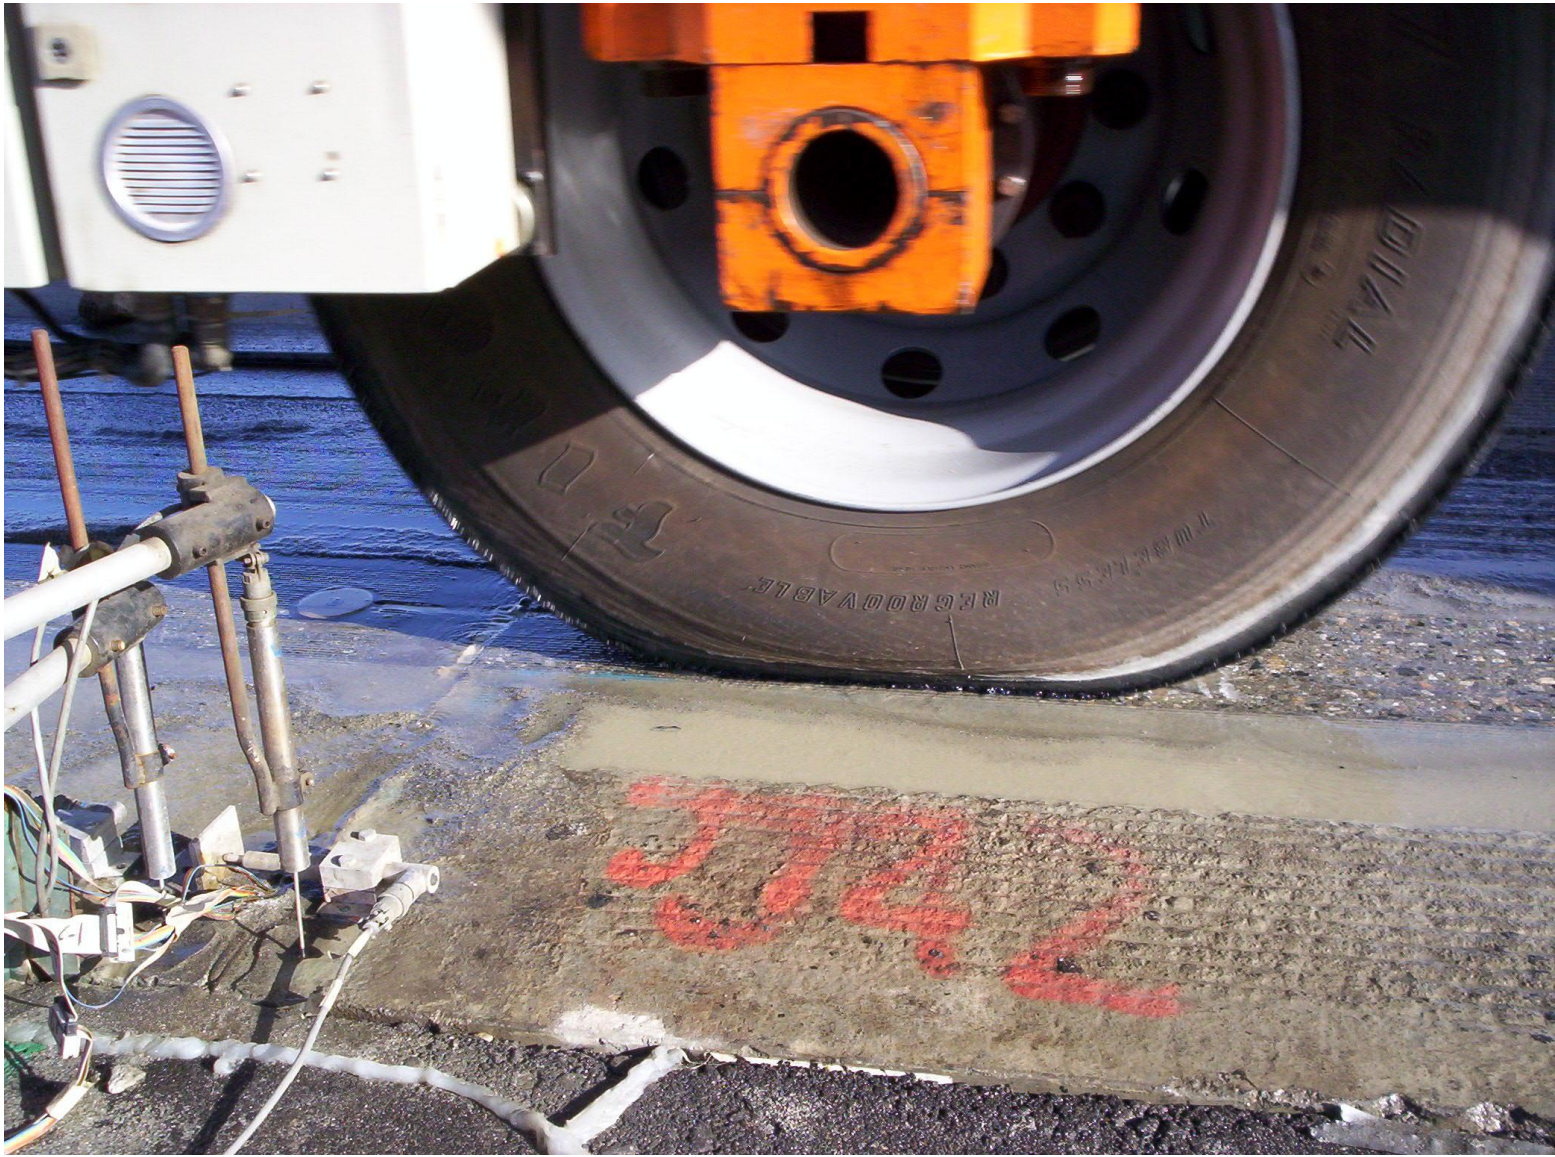
Section 2, wet

- Wet testing:
 - 43 million ESALs
 - 1.1 million reps
- Application of water at the joints (380l/week) = 7mm of rain per day on the 1 x 8m test section
- Results:
- Dry+wet loading:
 - 143 millions ESALs (3.46 million reps)
- Pumping but no other form of visual and structural distress

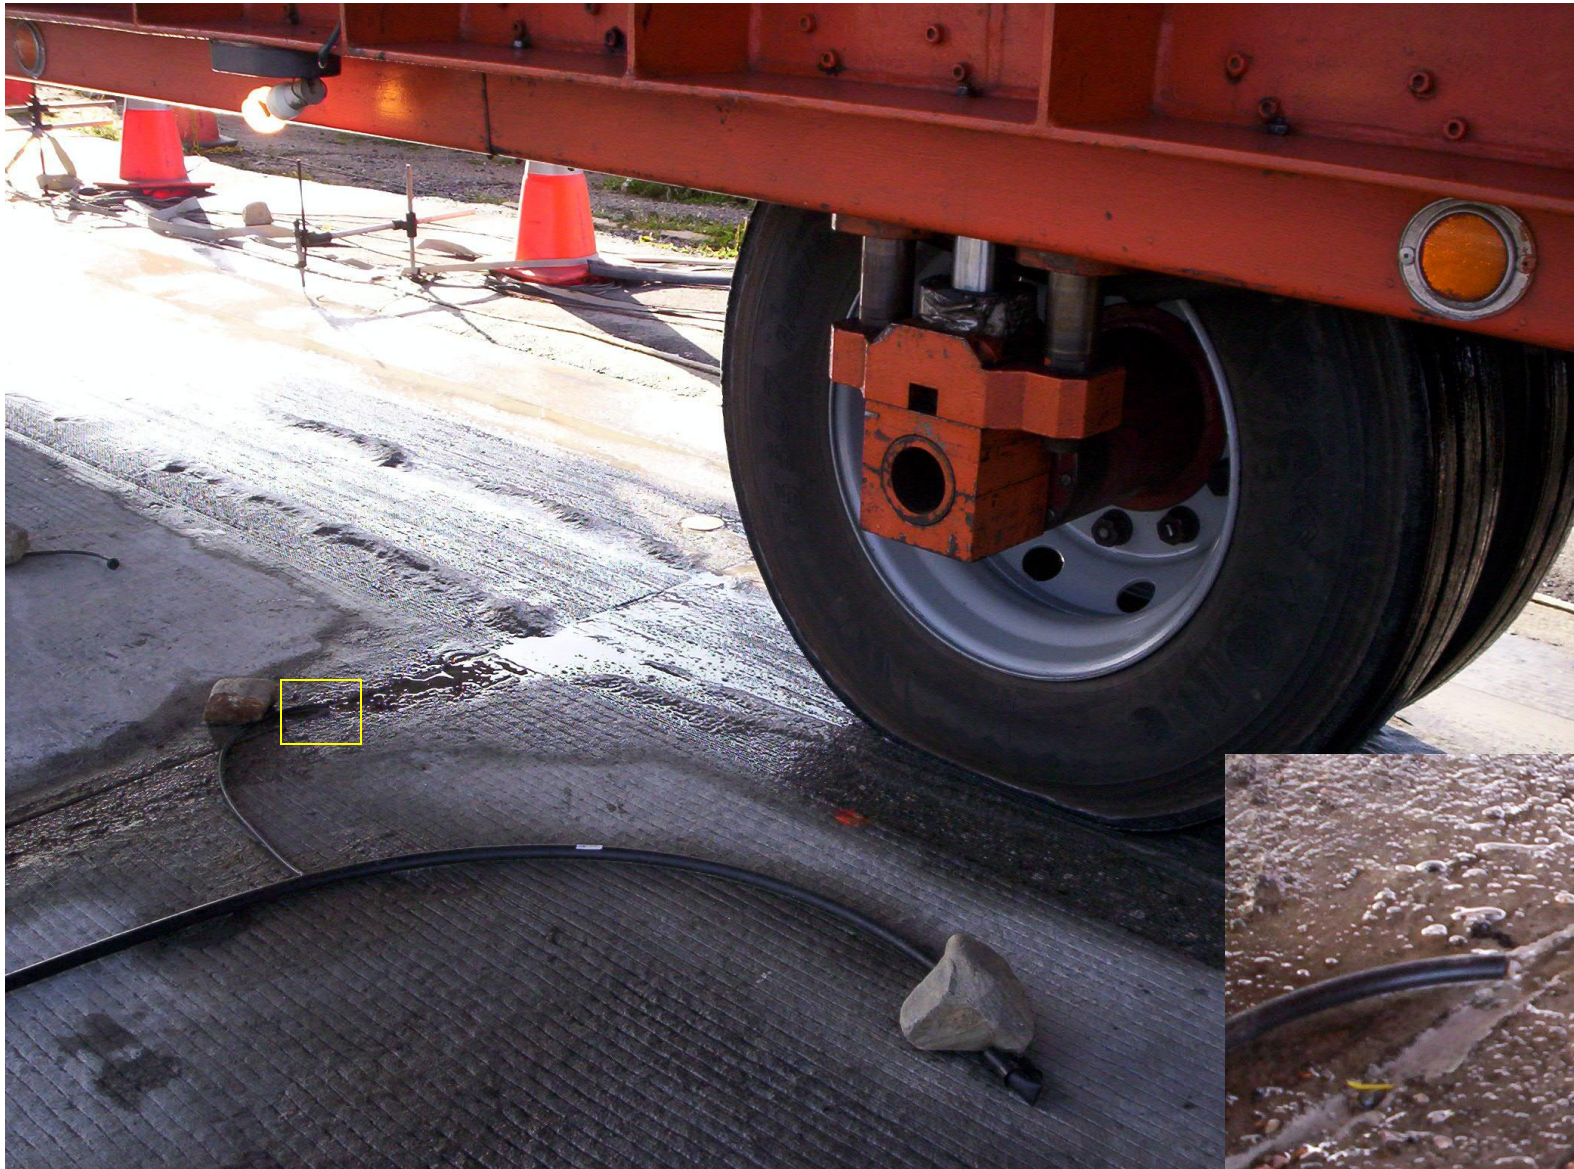
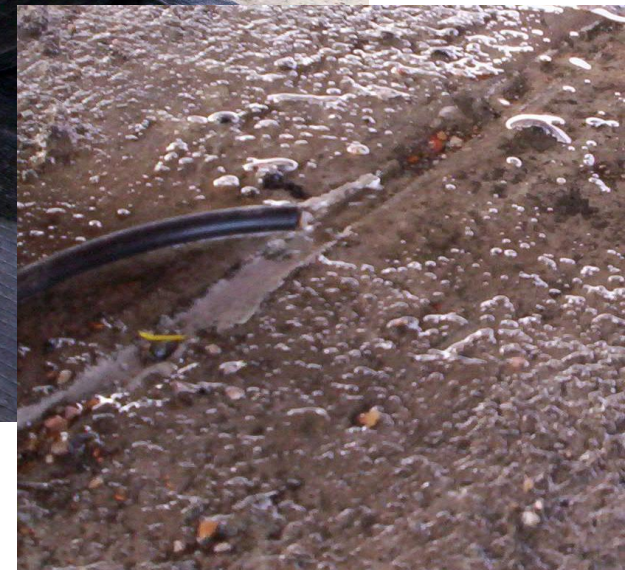
Wet trafficking

Water application (look at loaded tires!)

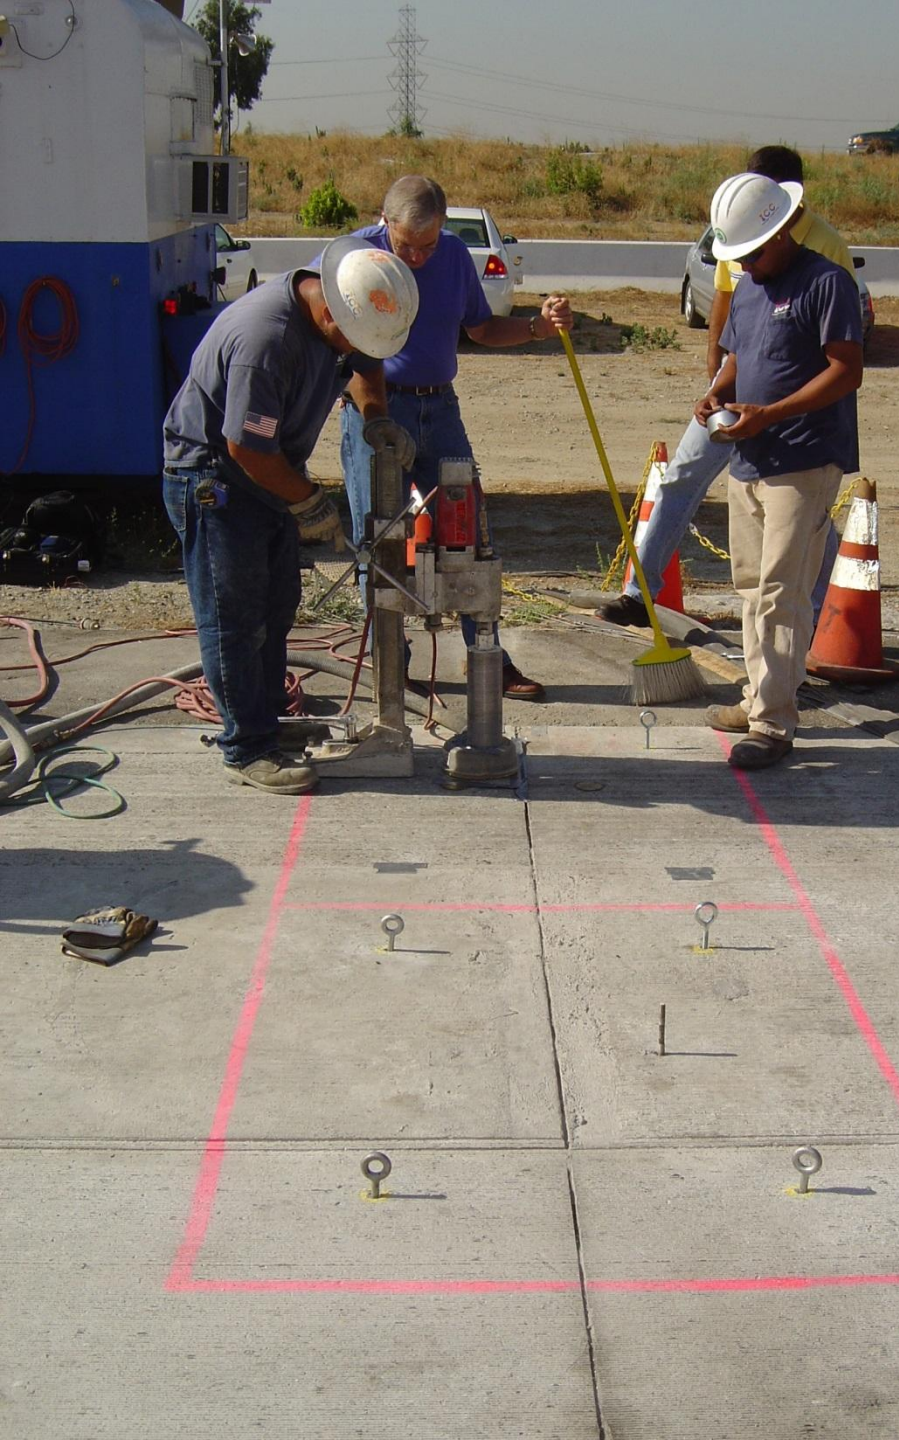
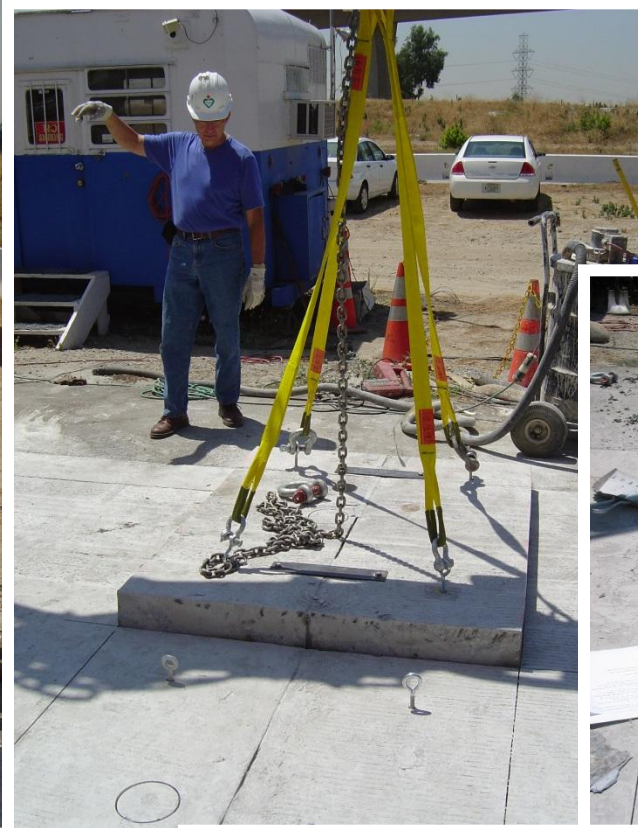
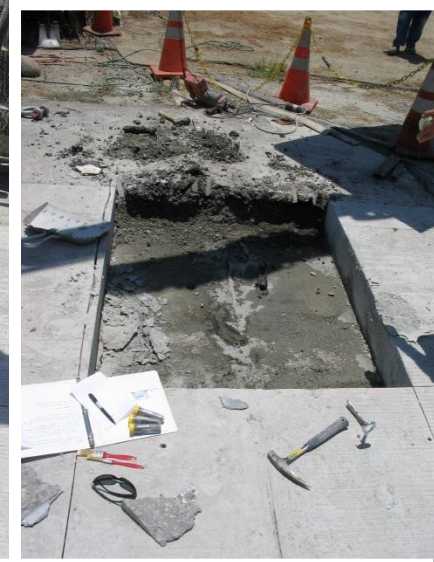
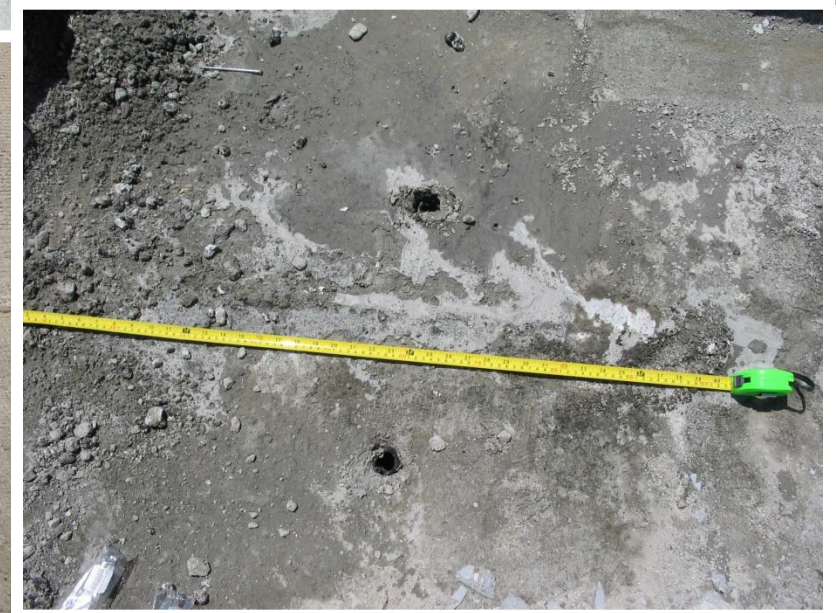
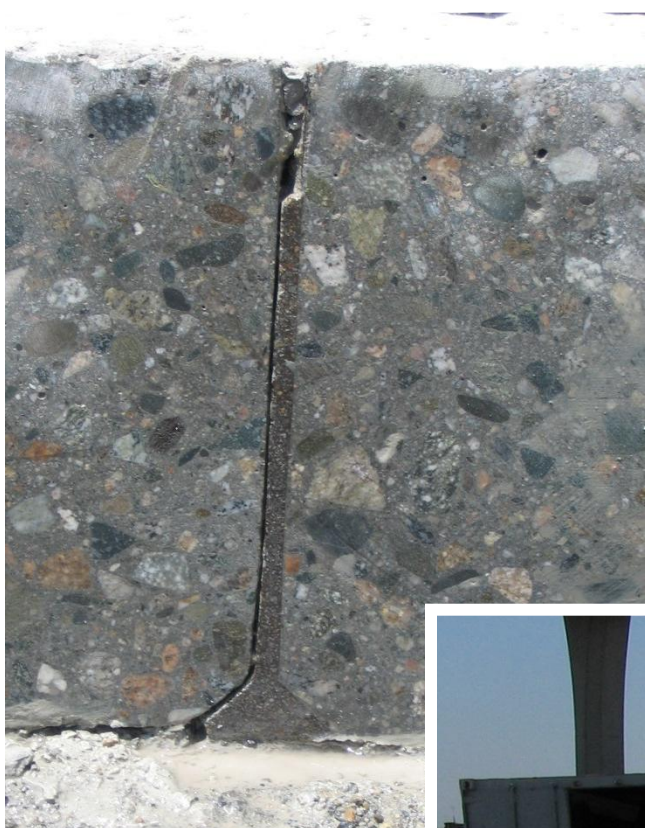
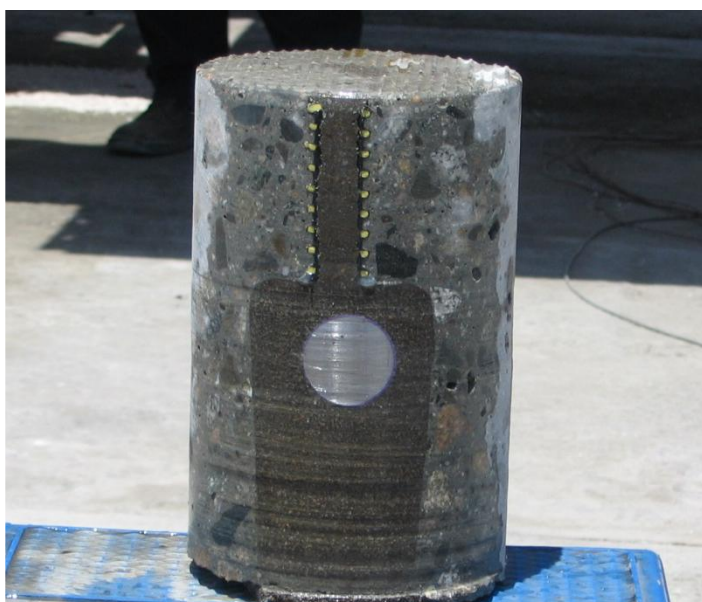
Post-mortem investigations: Void detection

- Considerable amount of material pumped from under the slab during wet trafficking
 - Void under the slab
- GPR (Ground Penetrating Radar) attempt
- Concrete segments removal
 - Dowel load transfer investigated after loading
 - Bedding material inspected
 - Transverse joint grout investigated
