## **National Route 2 Section 1: East of Baden Powell Interchange at Km 29.0 to East of the Broadway Boulevard Interchange at Km 40.202**

### **Using Bitumen Rubber Asphalt to Rehabilitate an Alkali-Silica Affected Jointed Concrete Pavement**

### **Reflection Cracking & Structural Performance**

**Thirty-Sixth Road Pavements Forum  
13 November 2018**

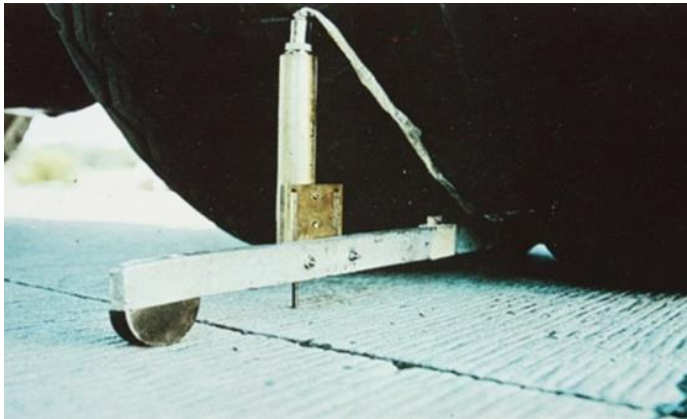
- In the absence of a Falling Weight Deflectometer (FWD) in the 1980's, a modified Benkelman beam was used to measure deflection and RVM;
- a Geophone attached 150 mm from the end of the beam, was used to measure the RVM as the wheel load passed across the transverse contraction joint;

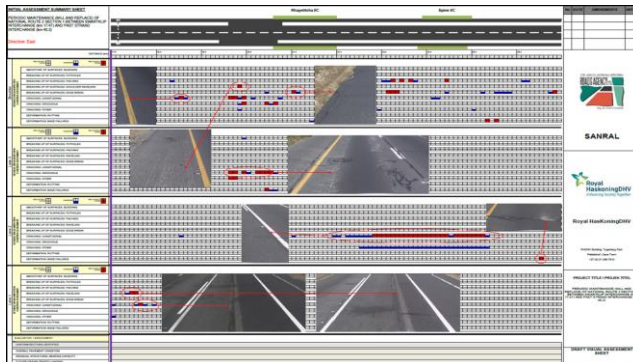
- a Profilometer survey was conducted with a DYNATEST RSP MK3 – ASTM (Class 1) profiler, which produced the following outputs:
  - International Roughness Index (IRI) – [mm/m or m/km];
  - Rutting [mm];
  - Mean Profile Depth (MPD) [mm];
  - Gradient & Cross fall; and
  - JPEG Images at 2 m intervals (down and front images)

- The visual condition was thereafter recorded in detail from the profilometer survey outputs as part of the initial assessment.
