ROAD PAVEMENT FORUM

Certification of Cold Premixed Asphalt Mixtures

Dennis Rossmann

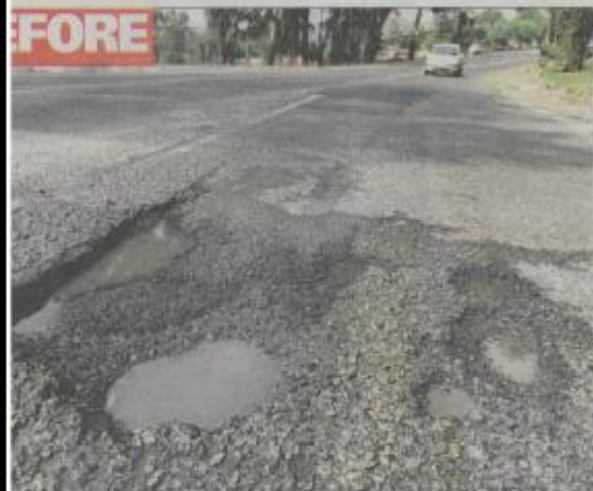
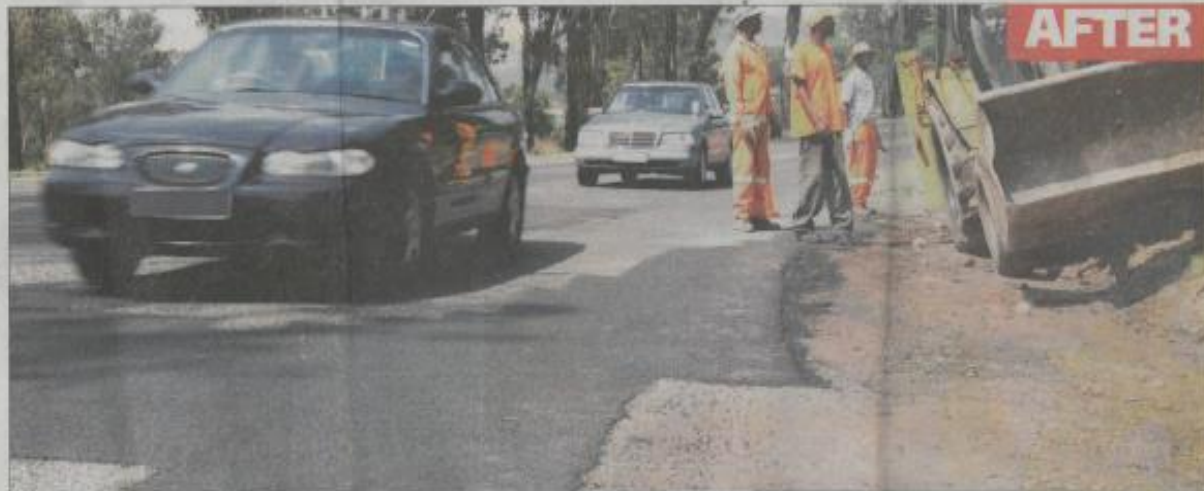
ERFONTEIN: These series of potholes on Modderfontein Road, opposite the Sandringham police station, were reported on September 21. A re-visit on October 6 revealed they had been patched up. Workers from the Joburg Roads Agency were still on site attending to piping on the side of the road.
